호남고속선 계룡터널 - 181(30.878~30.888km, S181)

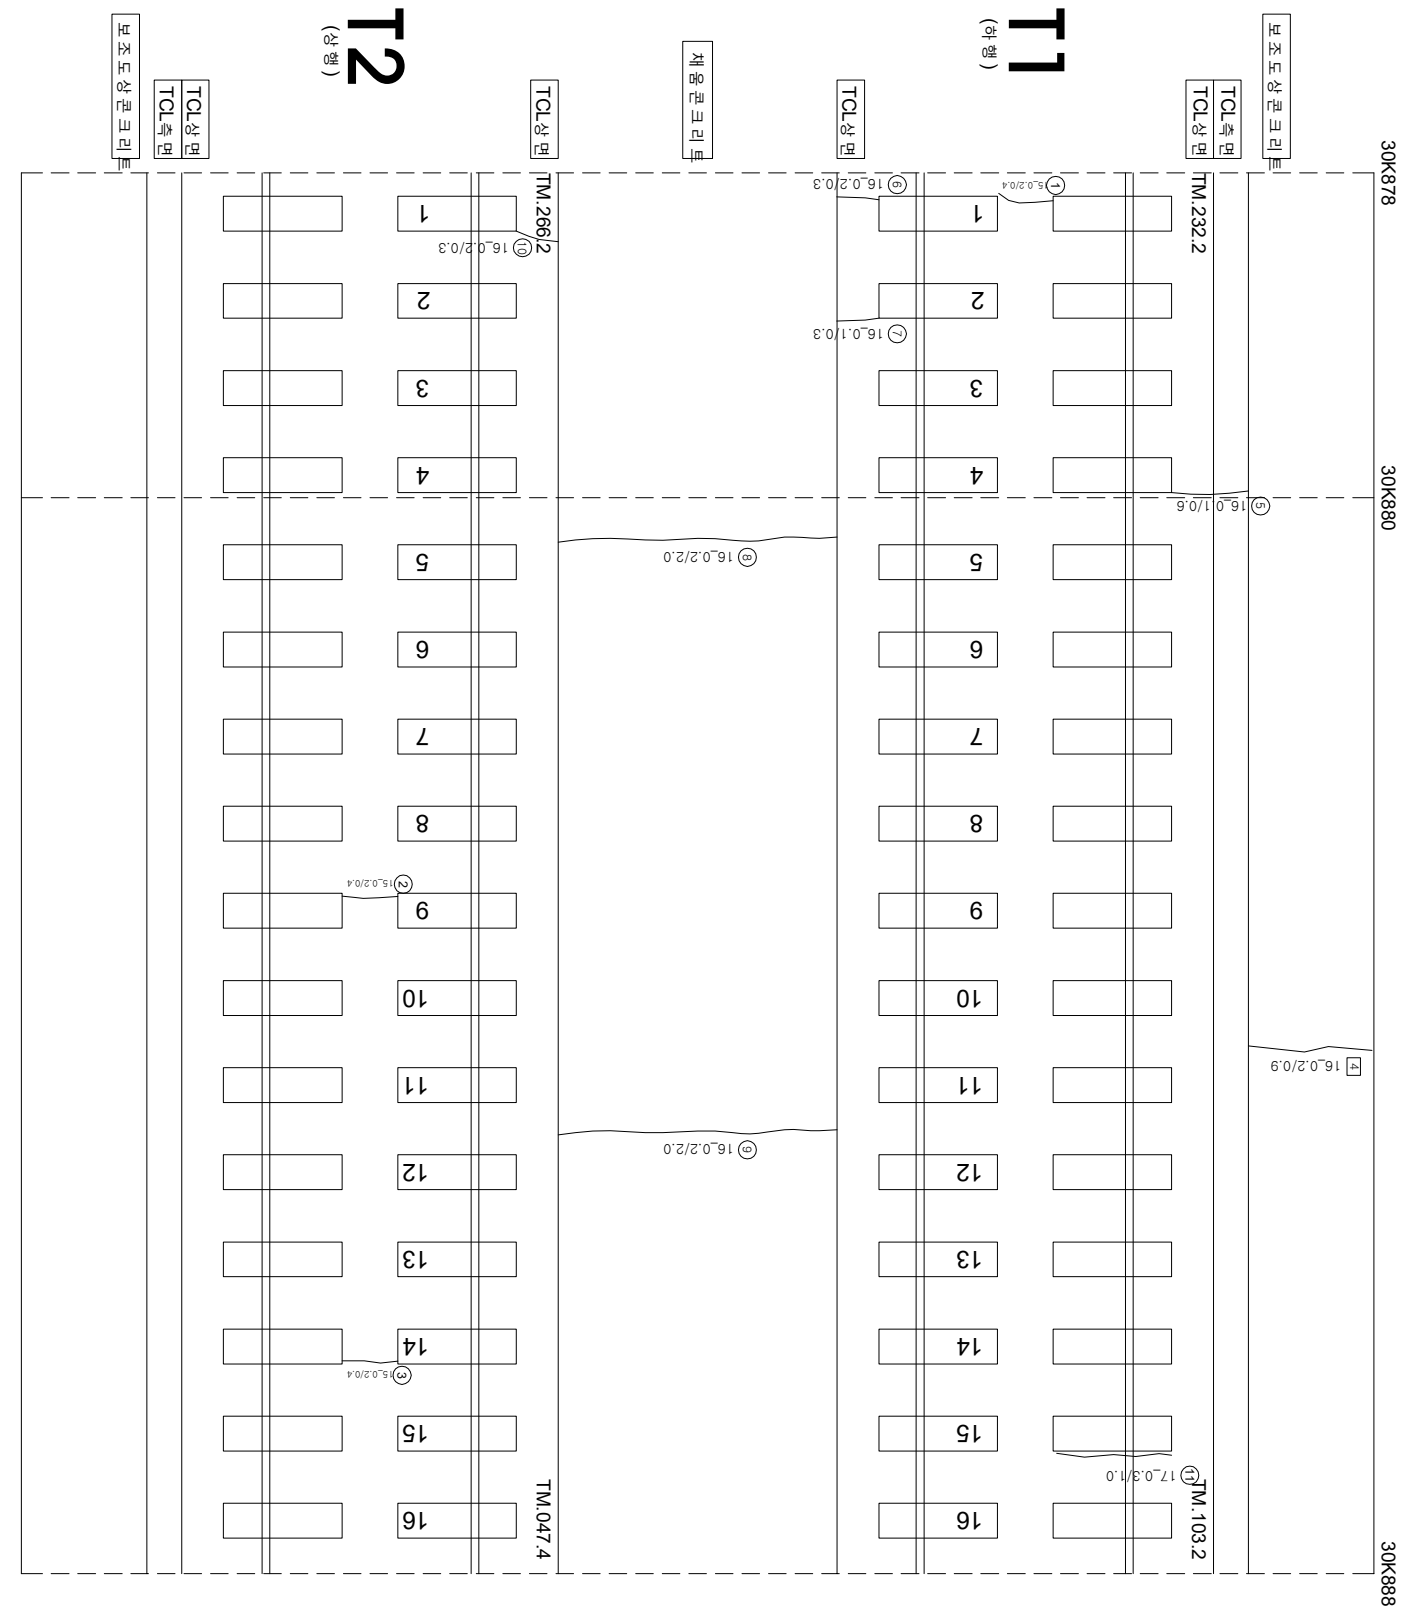
| 연번 | 순상 | 폭 | 연장 | 비고 | 연번 | 순상 | 폭 | 연장 | 비고 |
|---|---|---|---|---|---|---|---|---|---|
| 1 | 균열 | 0.2 mm | 0.4 m | | 56 | | | | |
| 2 | 균열 | 0.2 mm | 0.4 m | | 57 | | | | |
| 3 | 균열 | 0.2 mm | 0.4 m | | 58 | | | | |
| 4 | 균열 | 0.2 mm | 0.9 m | 2017년도 보수 | 59 | | | | |
| 5 | 균열 | 0.1 mm | 0.6 m | | 60 | | | | |
| 6 | 균열 | 0.2 mm | 0.3 m | | 61 | | | | |
| 7 | 균열 | 0.1 mm | 0.3 m | | 62 | | | | |
| 8 | 균열 | 0.2 mm | 2.0 m | | 63 | | | | |
| 9 | 균열 | 0.2 mm | 2.0 m | | 64 | | | | |
| 10 | 균열 | 0.2 mm | 0.3 m | | 65 | | | | |
| 11 | 경계부 균열 | 0.3 mm | 1.0 m | 신규 | 66 | | | | |
