호남고속선 원동터널-15(37.032~37.042km, S15)

| 시 | 행 | 사 | 용 | 역 | 영 | 사 | 단 | | |
|---|---|---|---|---|---|---|---|---|---|
| KORAIL<br>KOREA RAILROAD | 한국철도공사 | 2017년도 호남고속선 오송-광주승정간 콘크리트케도 점검용역 | (주) 한국구조물안전연구원<br>(주) 한국도로안전연구원<br>(재) 한국건설품질연구원 | 이 복 영 | 간 원 강<br>김 경 기<br>문 준 기 | 영원 | 02220 (0.3m이하 : 목박) | 철로받판리 | 철로받판리 |

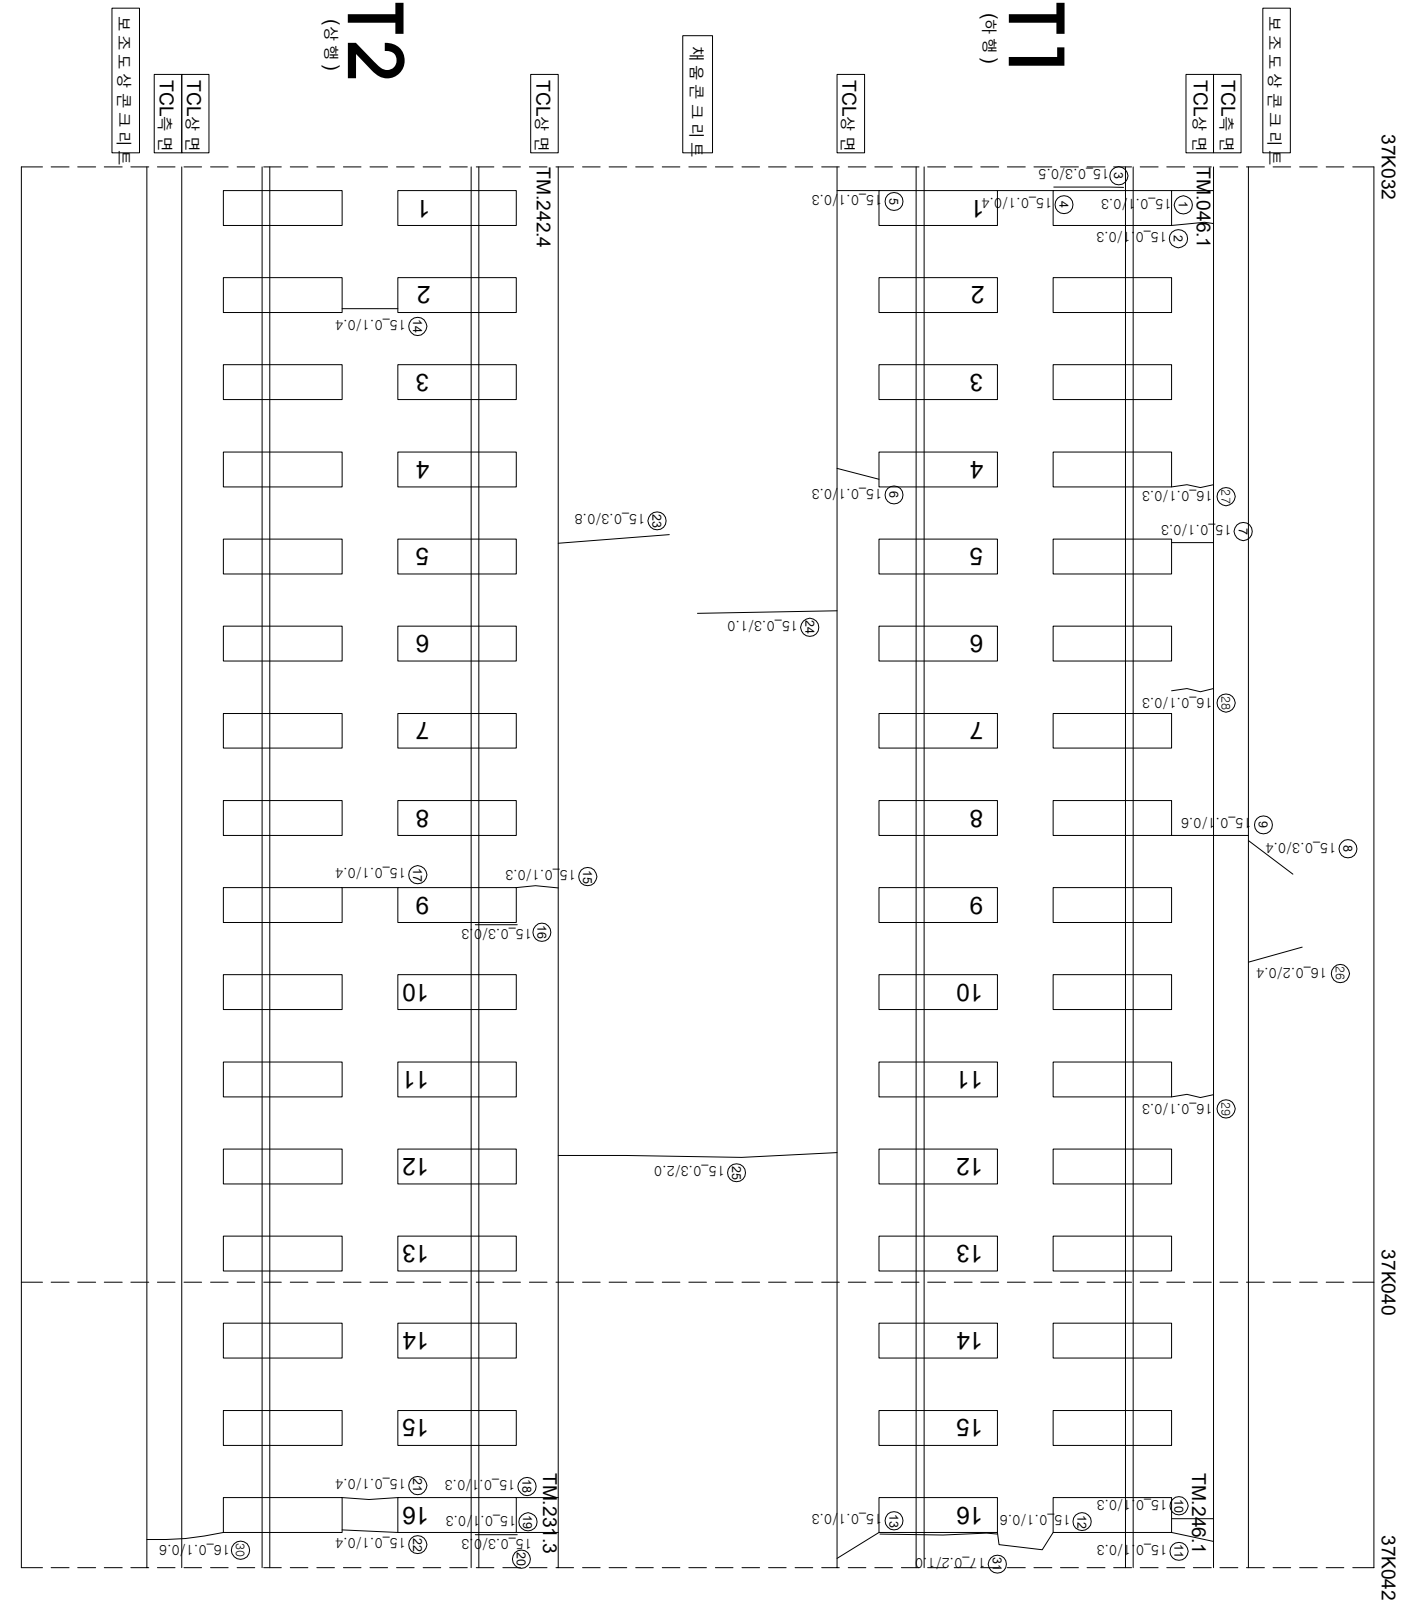
| 연번 | 순차 | 폭 | 연장 | 비고 | 연번 | 순차 | 폭 | 연장 | 비고 |
|---|---|---|---|---|---|---|---|---|---|
| 1 | 균열 | 0.1 | 0.3 | m | 56 | | | | |
| 3 | 장계부 균열 | 0.3 | 0.5 | m | 58 | | | | |
| 16 | 장계부 균열 | 0.3 | 0.3 | m | 71 | | | | |
| 20 | 장계부 균열 | 0.3 | 0.3 | m | 75 | | | | |
| 23 | 균열 | 0.3 | 0.8 | m | 78 | | | | |
| 24 | 균열 | 0.3 | 1.0 | m | 79 | | | | |
| 25 | 균열 | 0.3 | 2.0 | m | 80 | | | | |
| 31 | 장계부 균열 | 0.2 | 1.0 | m | 86 | | | | |
