한남고속선 평면터널\_41(38.407~38.417km, S41)

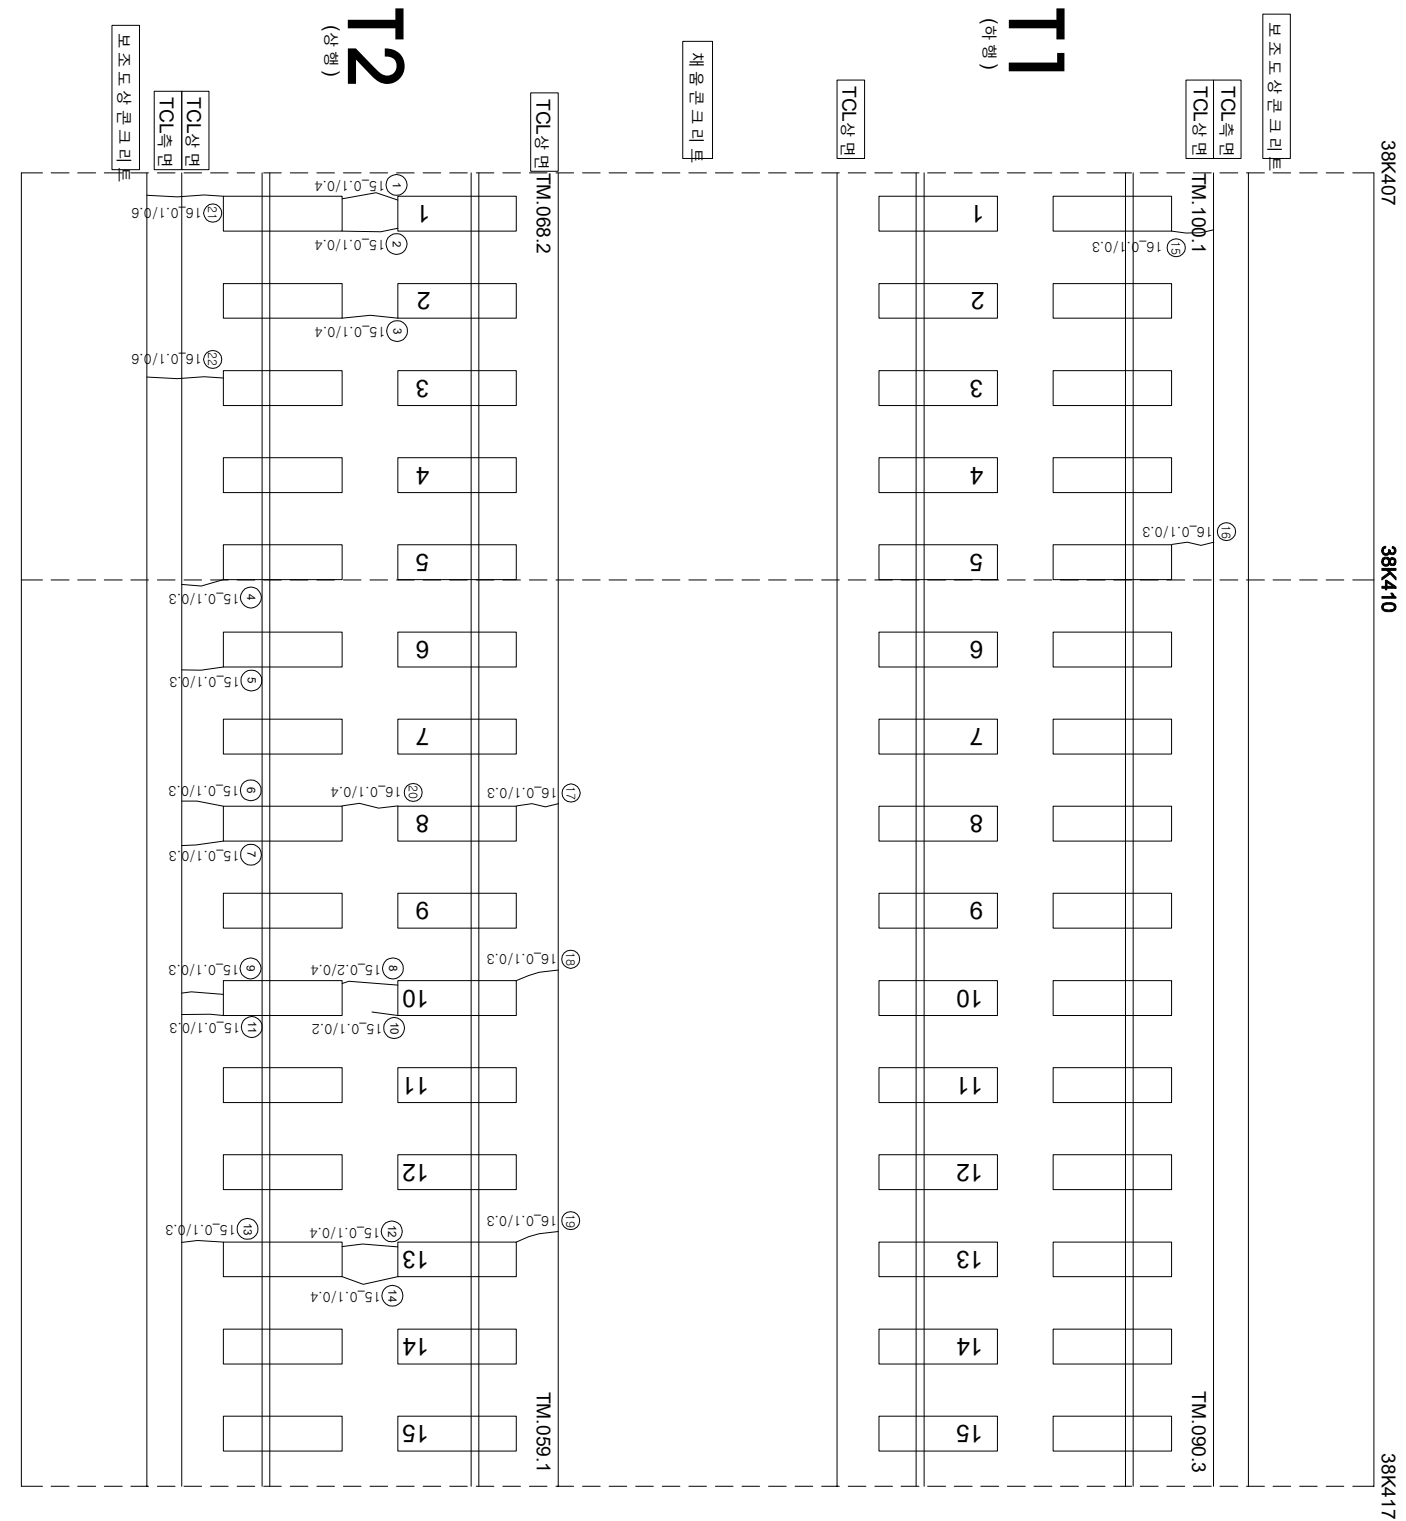
| 연번 | 순상 | 폭 | 연장 | 비고 | 연번 | 순상 | 폭 | 연장 | 비고 |
|---|---|---|---|---|---|---|---|---|---|
| 1 | 균열 | 0.1 mm | 0.4 m | | 56 | | | | |
| 2 | 균열 | 0.1 mm | 0.4 m | | 57 | | | | |
| 3 | 균열 | 0.1 mm | 0.4 m | | 58 | | | | |
| 4 | 균열 | 0.1 mm | 0.3 m | | 59 | | | | |
| 5 | 균열 | 0.1 mm | 0.3 m | | 60 | | | | |
| 6 | 균열 | 0.1 mm | 0.3 m | | 61 | | | | |
| 7 | 균열 | 0.1 mm | 0.3 m | | 62 | | | | |
| 8 | 균열 | 0.2 mm | 0.4 m | | 63 | | | | |
| 9 | 균열 | 0.1 mm | 0.3 m | | 64 | | | | |
| 10 | 균열 | 0.1 mm | 0.2 m | | 65 | | | | |
| 11 | 균열 | 0.1 mm | 0.3 m | | 66 | | | | |
| 12 | 균열 | 0.1 mm | 0.4 m | | 67 | | | | |
| 13 | 균열 | 0.1 mm | 0.3 m | | 68 | | | | |
| 14 | 균열 | 0.1 mm | 0.4 m | | 69 | | | | |
| 15 | 균열 | 0.1 mm | 0.3 m | | 70 | | | | |
| 16 | 균열 | 0.1 mm | 0.3 m | | 71 | | | | |
| 17 | 균열 | 0.1 mm | 0.3 m | | 72 | | | | |
| 18 | 균열 | 0.1 mm | 0.3 m | | 73 | | | | |
| 19 | 균열 | 0.1 mm | 0.3 m | | 74 | | | | |
| 20 | 균열 | 0.1 mm | 0.4 m | | 75 | | | | |
| 21 | 균열 | 0.1 mm | 0.6 m | | 76 | | | | |
| 22 | 균열 | 0.1 mm | 0.6 m | | 77 | | | | |
