호남고속선 영동터널\_132(39k317.~39k326.km, S132)

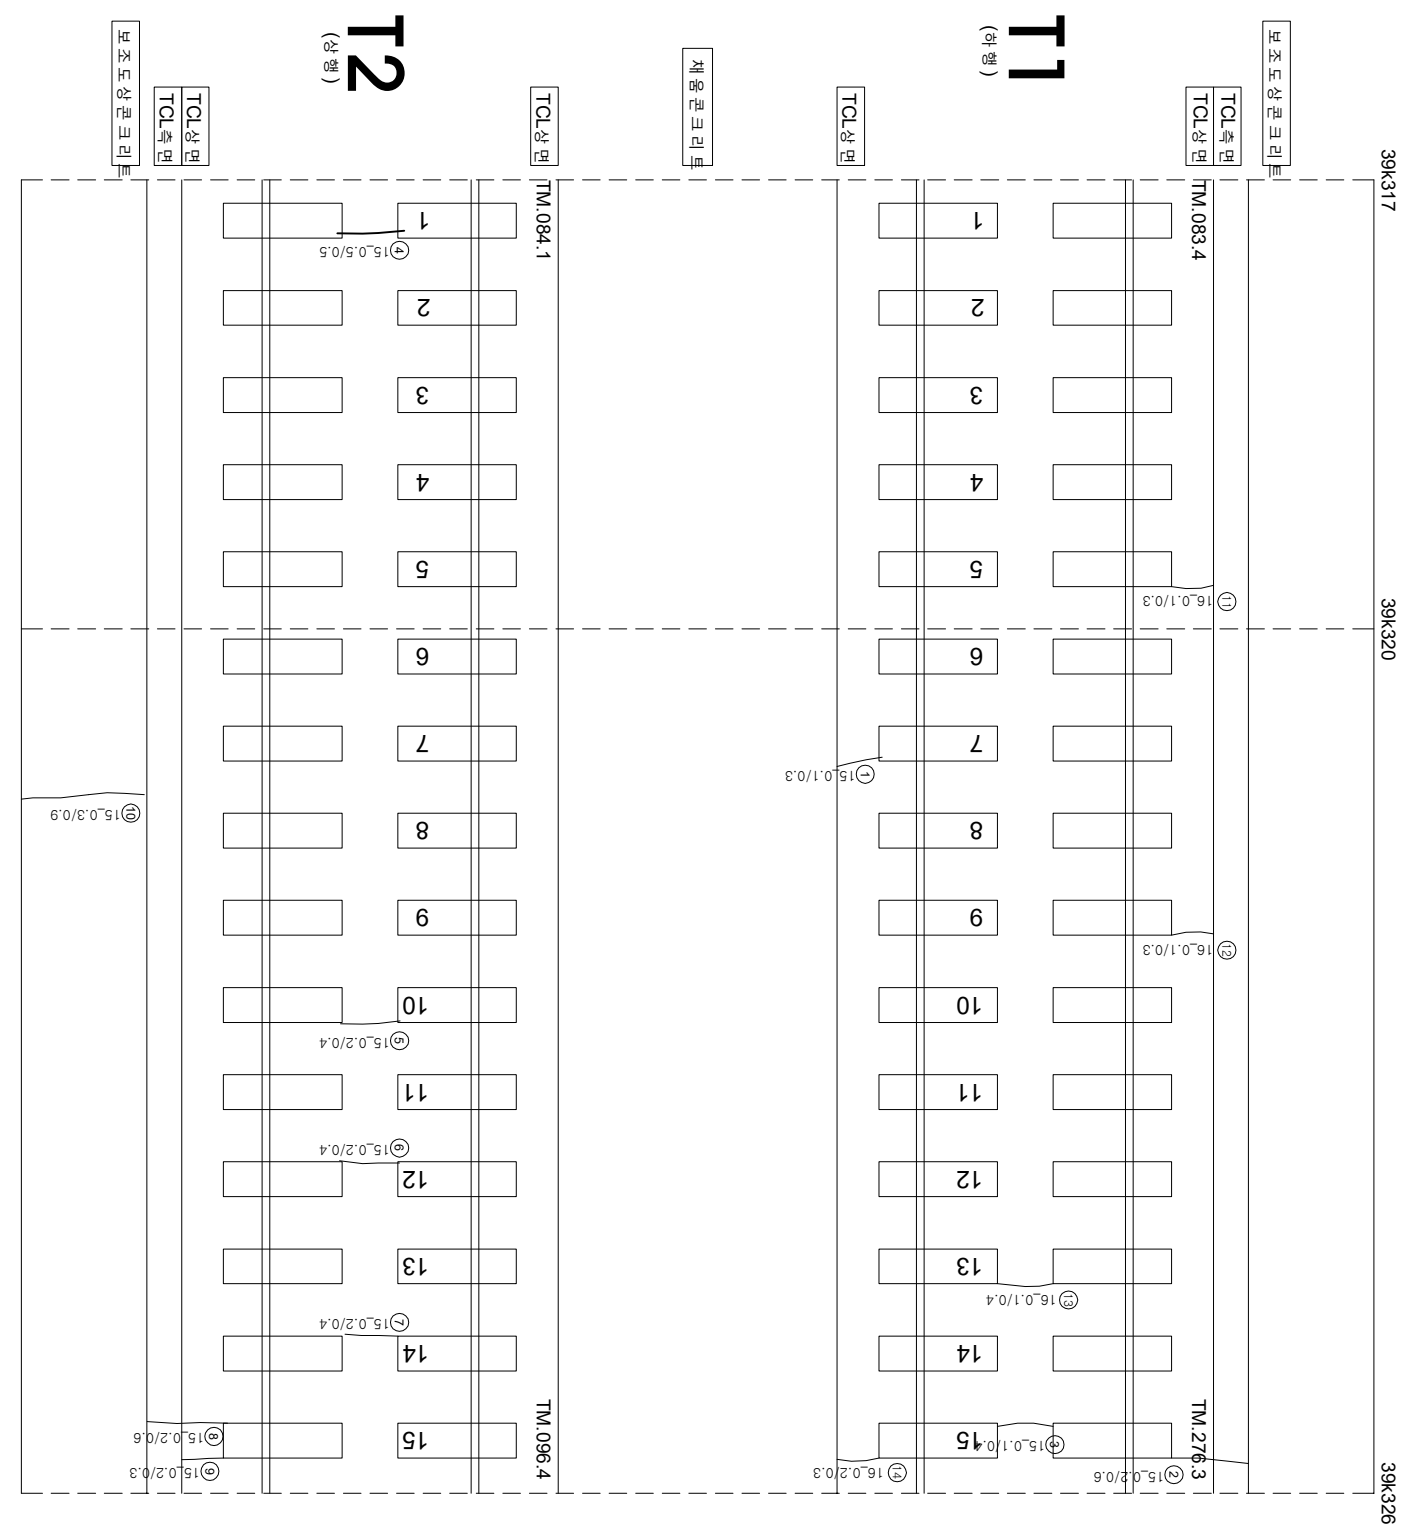
| 연번 | 순상 | 폭 | 연장 | 비고 | 연번 | 순상 | 폭 | 연장 | 비고 |
|---|---|---|---|---|---|---|---|---|---|
| 1 | 균열 | 0.1 mm | 0.3 m | | 56 | | | | |
| 2 | 균열 | 0.2 mm | 0.6 m | | 57 | | | | |
| 3 | 균열 | 0.1 mm | 0.4 m | | 58 | | | | |
| 4 | 균열 | 0.5 mm | 0.5 m | | 59 | | | | |
| 5 | 균열 | 0.2 mm | 0.4 m | | 60 | | | | |
| 6 | 균열 | 0.2 mm | 0.4 m | | 61 | | | | |
| 7 | 균열 | 0.2 mm | 0.4 m | | 62 | | | | |
| 8 | 균열 | 0.2 mm | 0.6 m | | 63 | | | | |
| 9 | 균열 | 0.2 mm | 0.3 m | | 64 | | | | |
| 10 | 균열 | 0.3 mm | 0.9 m | | 65 | | | | |
| 11 | 균열 | 0.1 mm | 0.3 m | | 66 | | | | |
| 12 | 균열 | 0.1 mm | 0.3 m | | 67 | | | | |
| 13 | 균열 | 0.1 mm | 0.4 m | | 68 | | | | |
| 14 | 균열 | 0.2 mm | 0.3 m | | 69 | | | | |
