호남고속선 동명터널-167(39.666~39.676km, S167)

| 시 | 행 | 사 | 용 | 역 | 영 | 사 | 단 | | | | |
|---|---|---|---|---|---|---|---|---|---|---|---|
| KORAIL<br>KOREA RAILROAD | 한국철도공사 | 2017년도 호남고속선 오송-광주승정간 콘크리트케도 점검용역 | (주) 한국구조물안전연구원<br>(주) 한국도로안전연구원<br>(재) 한국건설품질연구원 | 이 복 영 | 간 원 강<br>김 경 기<br>문 준 기 | 영원 | 02220 (0.3m이하 : 목박) | 점도도상판리 | | 재료판리 | |

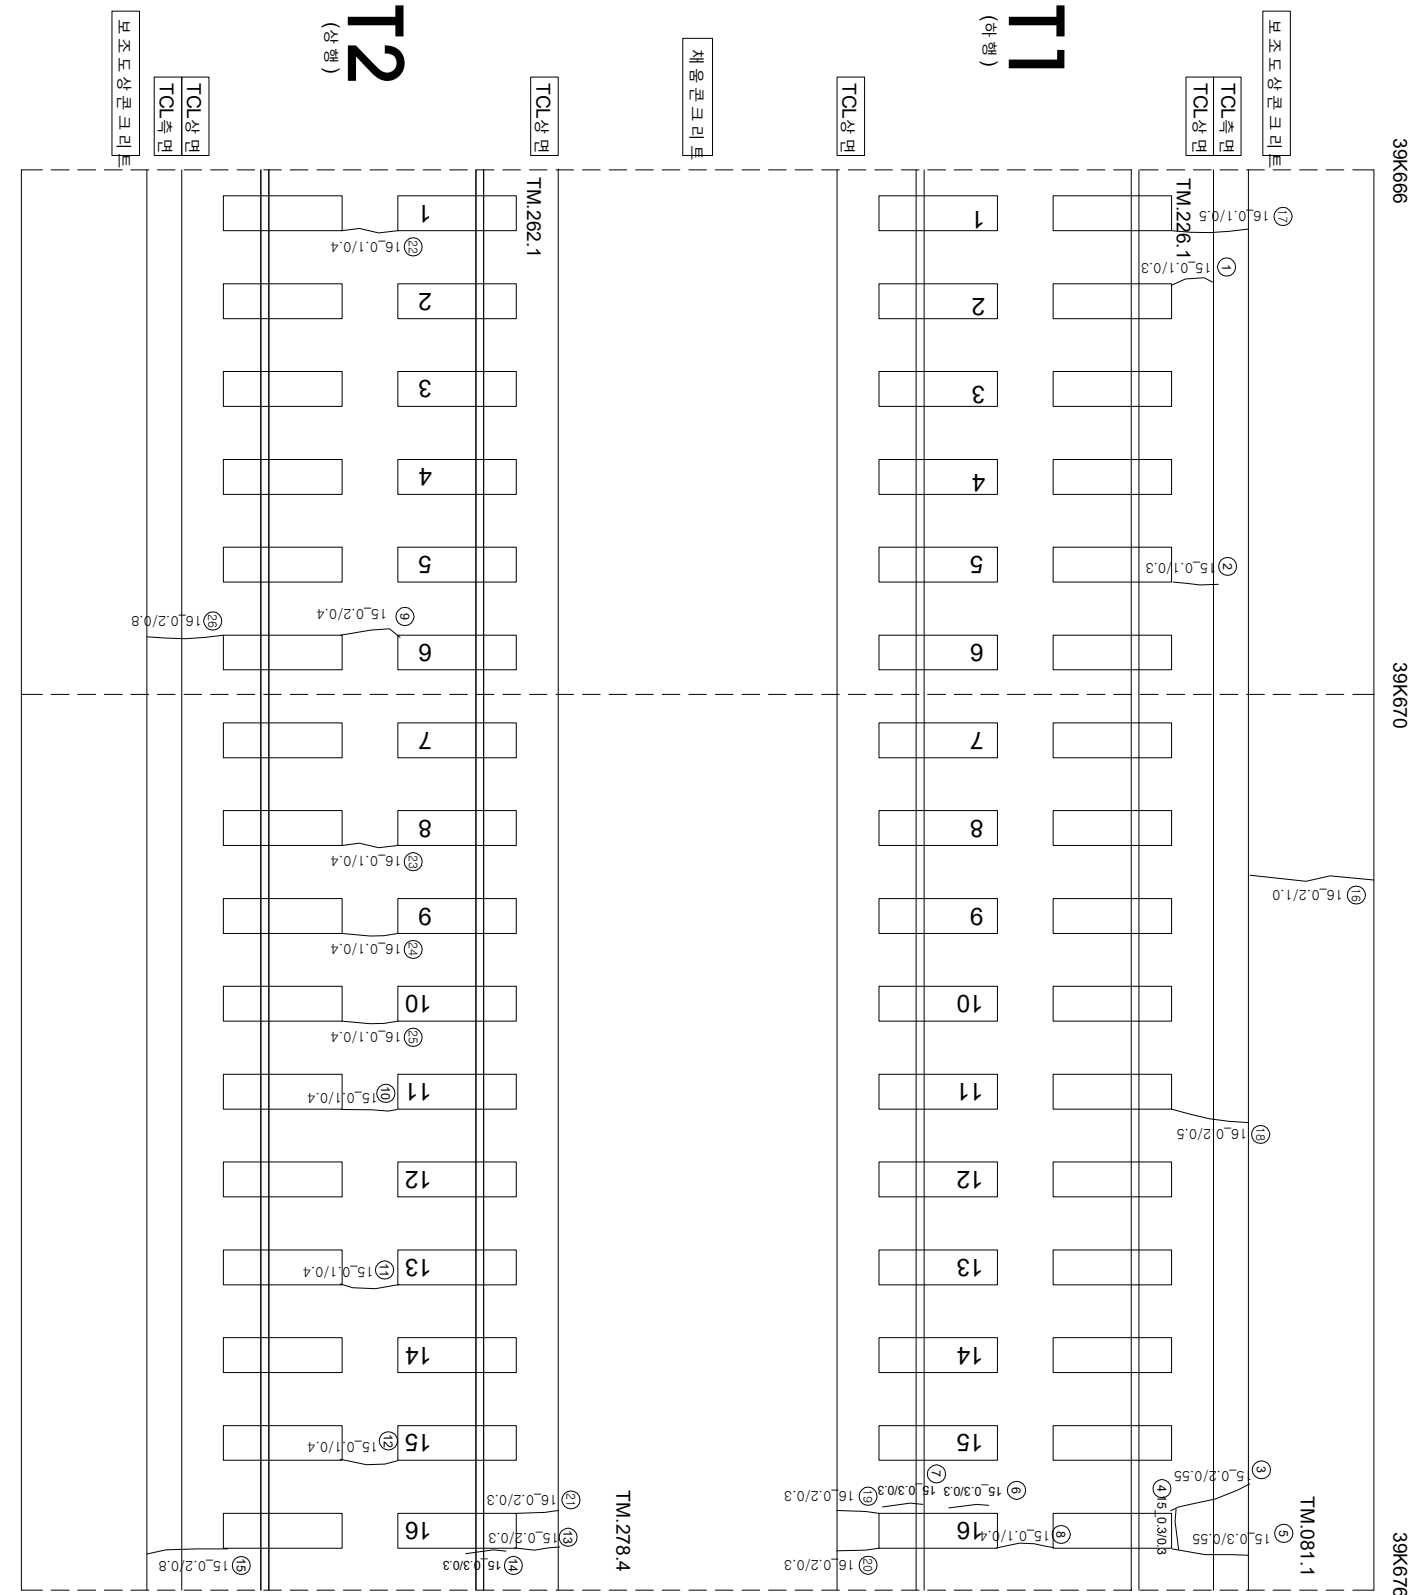
| 연번 | 순상 | 폭 | 연장 | 비고 | 연번 | 순상 | 폭 | 연장 | 비고 |
|---|---|---|---|---|---|---|---|---|---|
| 1 | 균열 | 0.1 mm | 0.3 m | | 56 | | | | |
| 2 | 균열 | 0.1 mm | 0.3 m | | 57 | | | | |
| 3 | 균열 | 0.2 mm | 0.55 m | | 58 | | | | |
| 4 | 경계부 균열 | 0.3 mm | 0.3 m | | 59 | | | | |
| 5 | 균열 | 0.3 mm | 0.55 m | 복중기 | 60 | | | | |
| 6 | 균열 | 0.3 mm | 0.3 m | | 61 | | | | |
| 7 | 균열 | 0.3 mm | 0.3 m | | 62 | | | | |
| 8 | 균열 | 0.1 mm | 0.4 m | | 63 | | | | |
| 9 | 균열 | 0.2 mm | 0.4 m | | 64 | | | | |
| 10 | 균열 | 0.1 mm | 0.4 m | | 65 | | | | |
| 11 | 균열 | 0.1 mm | 0.4 m | | 66 | | | | |
| 12 | 균열 | 0.1 mm | 0.4 m | | 67 | | | | |
| 13 | 균열 | 0.2 mm | 0.3 m | | 68 | | | | |
| 14 | 경계부 균열 | 0.3 mm | 0.3 m | | 69 | | | | |
| 15 | 균열 | 0.2 mm | 0.8 m | | 70 | | | | |
| 16 | 균열 | 0.2 mm | 1.0 m | | 71 | | | | |
| 17 | 균열 | 0.1 mm | 0.5 m | | 72 | | | | |
| 18 | 균열 | 0.2 mm | 0.5 m | | 73 | | | | |
| 19 | 균열 | 0.2 mm | 0.3 m | | 74 | | | | |
| 20 | 균열 | 0.2 mm | 0.3 m | | 75 | | | | |
| 21 | 균열 | 0.2 mm | 0.3 m | | 76 | | | | |
| 22 | 균열 | 0.1 mm | 0.4 m | | 77 | | | | |
| 23 | 균열 | 0.1 mm | 0.4 m | | 78 | | | | |
| 24 | 균열 | 0.1 mm | 0.4 m | | 79 | | | | |
| 25 | 균열 | 0.1 mm | 0.4 m | | 80 | | | | |
| 26 | 균열 | 0.2 mm | 0.8 m | | 81 | | | | |
