호남고수전 공동터널 - 183(39.826~39.836km, S183)

| 시 | 행 | 사 | 용 | 역 | 영 | 사 | 단 | | |
|---|---|---|---|---|---|---|---|---|---|
| KORAIL<br>KOREA RAILROAD | 한국철도공사 | 2017년도 호남고속선 오송-광주승정간 콘크리트케도 점검용역 | (주) 한국구조물안전연구원<br>(주) 한국도로안전연구원<br>(재) 한국건설품질연구원 | 이 복 영 | 간 원 강<br>김 경 기<br>문 준 기 | 영원 | 02220 (0.3m이하 : 목박) | 철로받판리 | 철로받판리 |

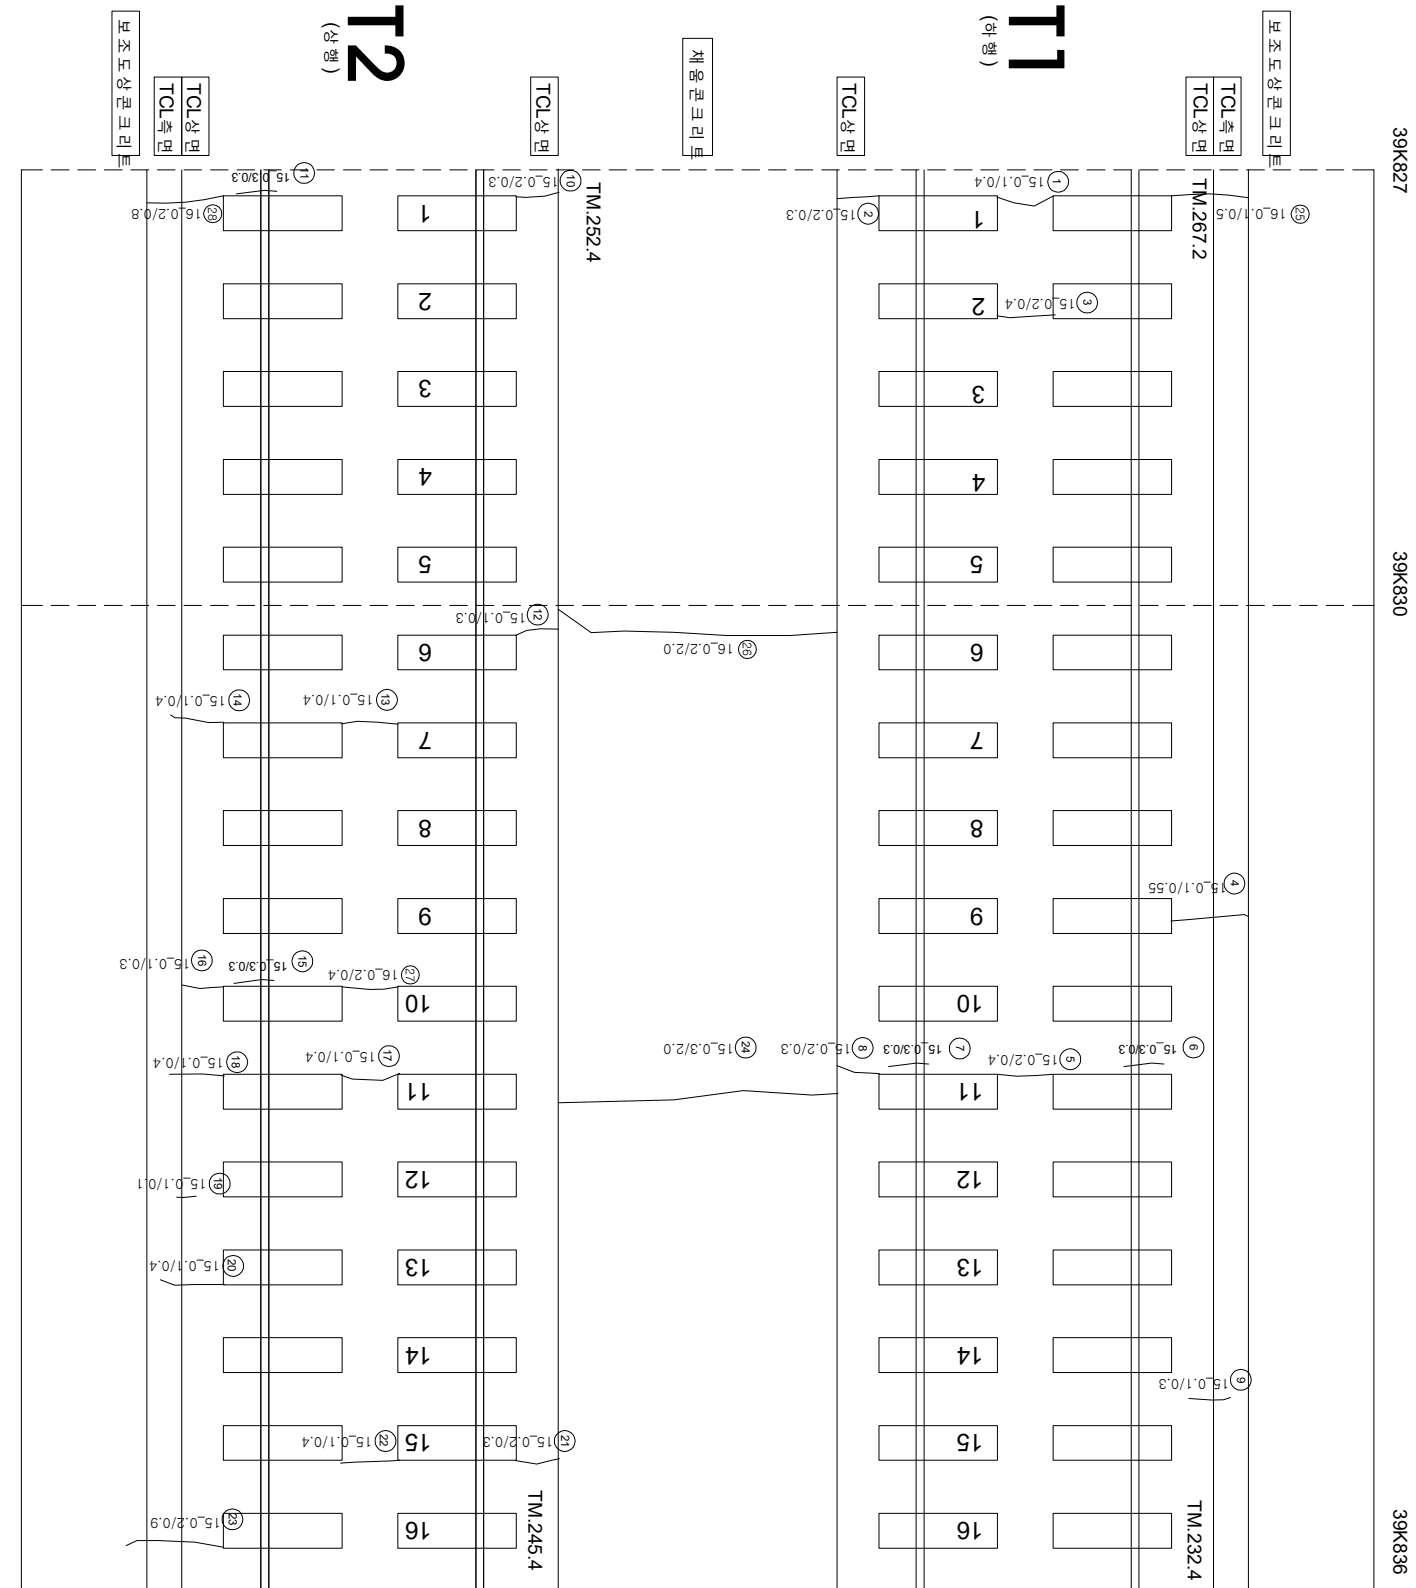
| 연번 | 순차 | 폭 | 연장 | 비고 | 연번 | 순차 | 폭 | 연장 | 비고 |
|---|---|---|---|---|---|---|---|---|---|
| 1 | 균열 | 0.2 mm | 0.4 m | m | 56 | | | | |
| 2 | 균열 | 0.2 mm | 0.3 m | | 57 | | | | |
| 3 | 균열 | 0.2 mm | 0.4 m | m | 58 | | | | |
| 4 | 균열 | 0.1 mm | 0.55 m | | 59 | | | | |
| 5 | 균열 | 0.2 mm | 0.4 m | m | 60 | | | | |
| 6 | 경계부 균열 | 0.3 mm | 0.3 m | | 61 | | | | |
| 7 | 경계부 균열 | 0.3 mm | 0.3 m | | 62 | | | | |
| 8 | 균열 | 0.2 mm | 0.3 m | | 63 | | | | |
| 9 | 균열 | 0.1 mm | 0.3 m | | 64 | | | | |
| 10 | 균열 | 0.2 mm | 0.3 m | | 65 | | | | |
| 11 | 경계부 균열 | 0.3 mm | 0.3 m | | 66 | | | | |
| 12 | 균열 | 0.1 mm | 0.3 m | | 67 | | | | |
| 13 | 균열 | 0.1 mm | 0.4 m | | 68 | | | | |
| 14 | 균열 | 0.1 mm | 0.4 m | | 69 | | | | |
| 15 | 경계부 균열 | 0.3 mm | 0.3 m | | 70 | | | | |
| 16 | 균열 | 0.1 mm | 0.3 m | | 71 | | | | |
| 17 | 균열 | 0.1 mm | 0.4 m | | 72 | | | | |
| 18 | 균열 | 0.1 mm | 0.4 m | | 73 | | | | |
| 19 | 균열 | 0.1 mm | 0.1 m | | 74 | | | | |
| 20 | 균열 | 0.1 mm | 0.4 m | | 75 | | | | |
| 21 | 균열 | 0.2 mm | 0.3 m | | 76 | | | | |
| 22 | 균열 | 0.1 mm | 0.4 m | | 77 | | | | |
| 23 | 균열 | 0.2 mm | 0.8 m | | 78 | | | | |
| 24 | 균열 | 0.3 mm | 2.0 m | | 79 | | | | |
| 25 | 균열 | 0.1 mm | 0.5 m | | 80 | | | | |
| 26 | 균열 | 0.2 mm | 2.0 m | | 81 | | | | |
| 27 | 균열 | 0.2 mm | 0.4 m | | 82 | | | | |
| 28 | 균열 | 0.2 mm | 0.8 m | | 83 | | | | |
