호남고속선향저터널-1 (40.580~40.590km, L=10m)

| 시 | 행 | 사 | 용 | 역 | 영 | 사 | 단 | | |
|---|---|---|---|---|---|---|---|---|---|
| KORAIL<br>KOREA RAILROAD | 한국철도공사 | 2017년도 호남고속선 오송-광주승정간 콘크리트케도 점검용역 | (주) 한국구조물안전연구원<br>(주) 한국도로안전연구원<br>(재) 한국건설품질연구원 | 이 복 영 | 간 윤 강<br>김 경 기<br>문 준 기 | 영원 | 02220 (0.3m이하 : 목책) | 점도도상판리 | 차로판리 |

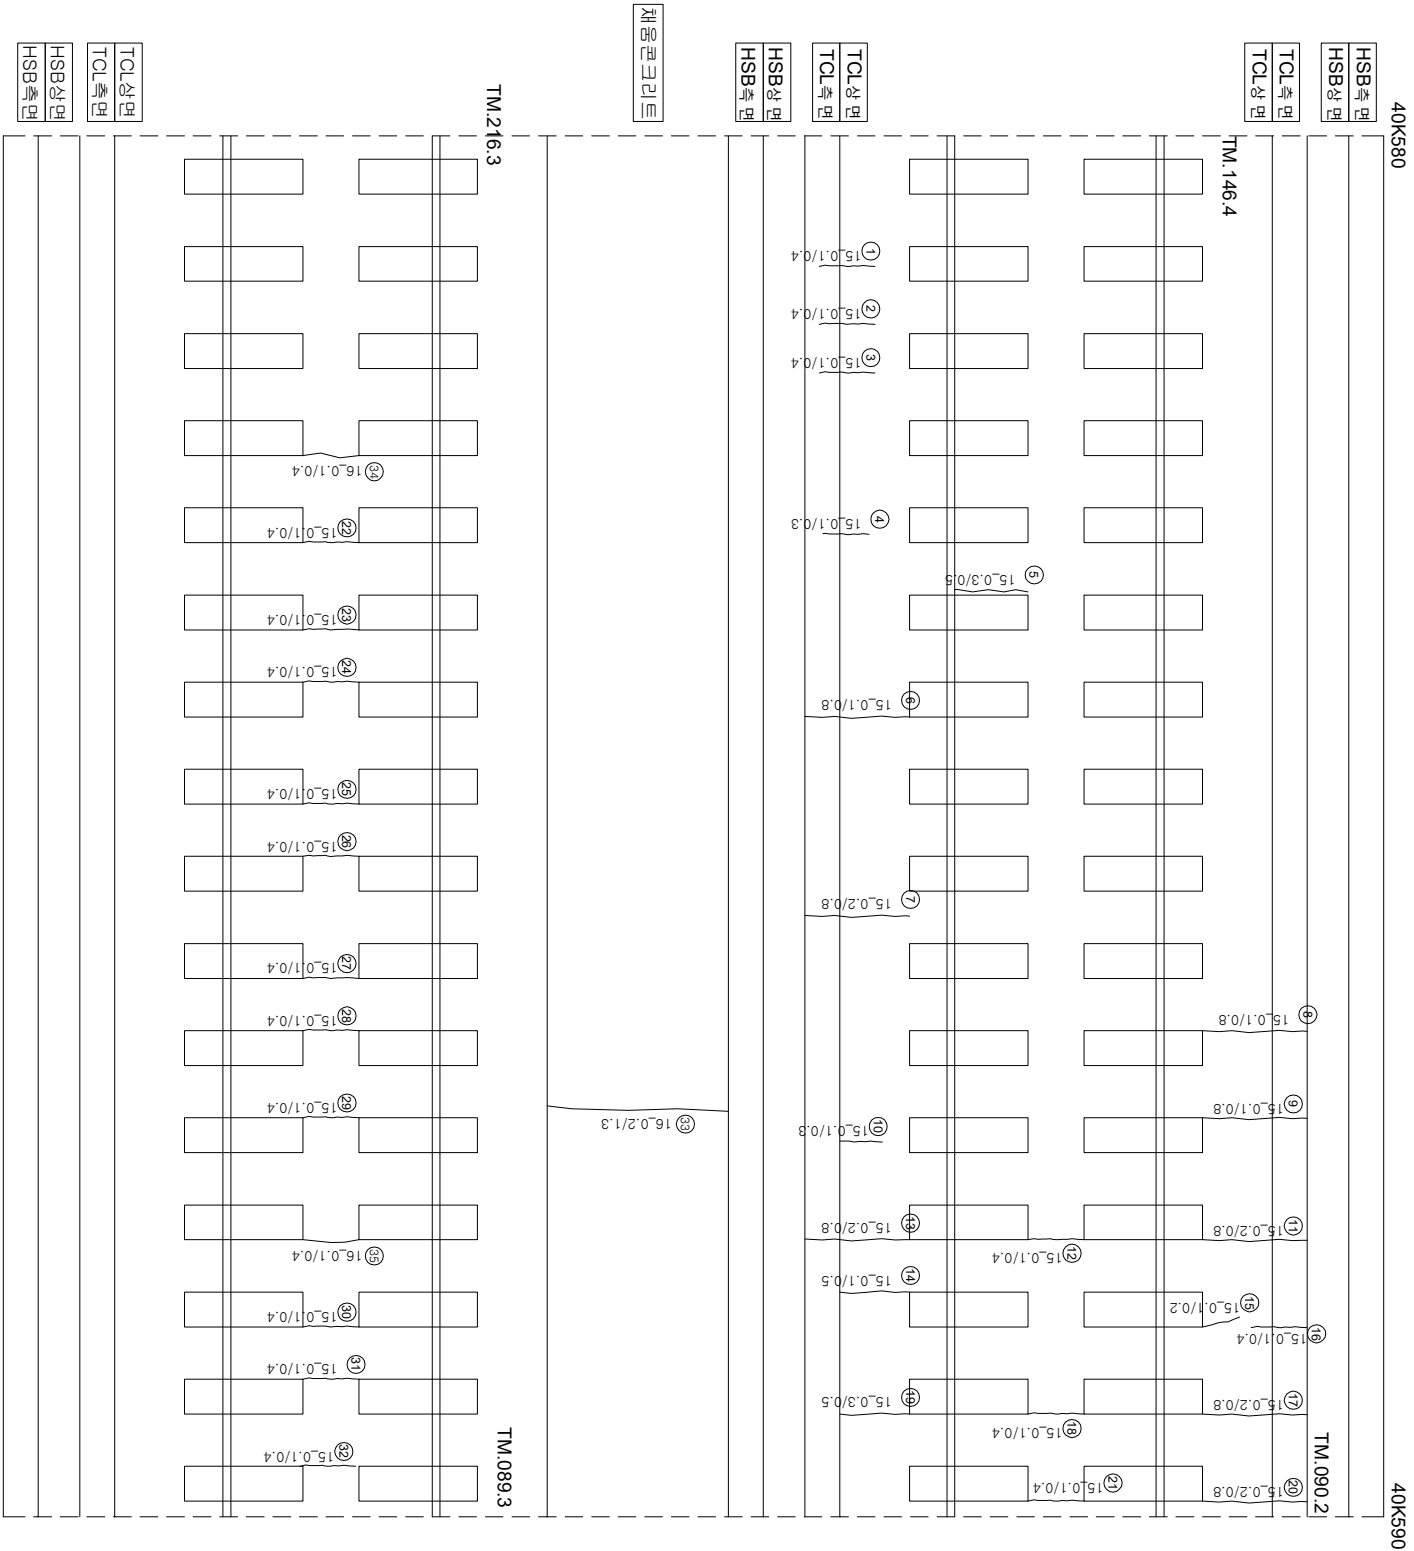
| 연번 | 순상 | 폭 | 연장 | 비고 | 연번 | 순상 | 폭 | 연장 | 비고 |
|---|---|---|---|---|---|---|---|---|---|
| 1 | 균열 | 0.1 mm | 0.4 m | | 56 | | | | |
| 2 | 균열 | 0.1 mm | 0.4 m | | 57 | | | | |
| 3 | 균열 | 0.1 mm | 0.4 m | | 58 | | | | |
| 4 | 균열 | 0.1 mm | 0.3 m | | 59 | | | | |
| 5 | 경계부 균열 | 0.3 mm | 0.5 m | | 60 | | | | |
| 6 | 균열 | 0.1 mm | 0.8 m | | 61 | | | | |
| 7 | 균열 | 0.2 mm | 0.8 m | | 62 | | | | |
| 8 | 균열 | 0.1 mm | 0.8 m | | 63 | | | | |
| 9 | 균열 | 0.1 mm | 0.8 m | | 64 | | | | |
| 10 | 균열 | 0.1 mm | 0.3 m | | 65 | | | | |
| 11 | 균열 | 0.2 mm | 0.8 m | | 66 | | | | |
| 12 | 균열 | 0.1 mm | 0.4 m | | 67 | | | | |
| 13 | 균열 | 0.2 mm | 0.8 m | | 68 | | | | |
| 14 | 균열 | 0.1 mm | 0.5 m | | 69 | | | | |
| 15 | 균열 | 0.1 mm | 0.2 m | | 70 | | | | |
| 16 | 균열 | 0.1 mm | 0.4 m | | 71 | | | | |
| 17 | 균열 | 0.2 mm | 0.8 m | | 72 | | | | |
| 18 | 균열 | 0.1 mm | 0.4 m | | 73 | | | | |
| 19 | 균열 | 0.3 mm | 0.5 m | | 74 | | | | |
| 20 | 균열 | 0.2 mm | 0.8 m | | 75 | | | | |
| 21 | 균열 | 0.1 mm | 0.4 m | | 76 | | | | |
| 22 | 균열 | 0.1 mm | 0.4 m | | 77 | | | | |
| 23 | 균열 | 0.1 mm | 0.4 m | | 78 | | | | |
| 24 | 균열 | 0.1 mm | 0.4 m | | 79 | | | | |
| 25 | 균열 | 0.1 mm | 0.4 m | | 80 | | | | |
| 26 | 균열 | 0.1 mm | 0.4 m | | 81 | | | | |
| 27 | 균열 | 0.1 mm | 0.4 m | | 82 | | | | |
| 28 | 균열 | 0.1 mm | 0.4 m | | 83 | | | | |
| 29 | 균열 | 0.1 mm | 0.4 m | | 84 | | | | |
| 30 | 균열 | 0.1 mm | 0.4 m | | 85 | | | | |
| 31 | 균열 | 0.1 mm | 0.4 m | | 86 | | | | |
| 32 | 균열 | 0.1 mm | 0.4 m | | 87 | | | | |
| 33 | 균열 | 0.2 mm | 1.3 m | | 88 | | | | |
| 34 | 균열 | 0.1 mm | 0.4 m | | 89 | | | | |
| 35 | 균열 | 0.1 mm | 0.4 m | | 90 | | | | |
