호남고속선 영천터널\_18(41.711~41.721km, S18)

| 시 | 행 | 사 | 용 | 역 | 영 | 사 | 간 | | 영 | | | |
|---|---|---|---|---|---|---|---|---|---|---|---|---|
| KORAIL<br>KOREA RAILROAD | 한국철도공사 | 2017년도 | 호남고속선 | 오송-광주승정리 | 콘크리트케도 | 점검용역 | (주) 한국구조물안전연구원<br>(주) 한국도로안전연구원<br>(재) 한국건설품질연구원 | | | | | |

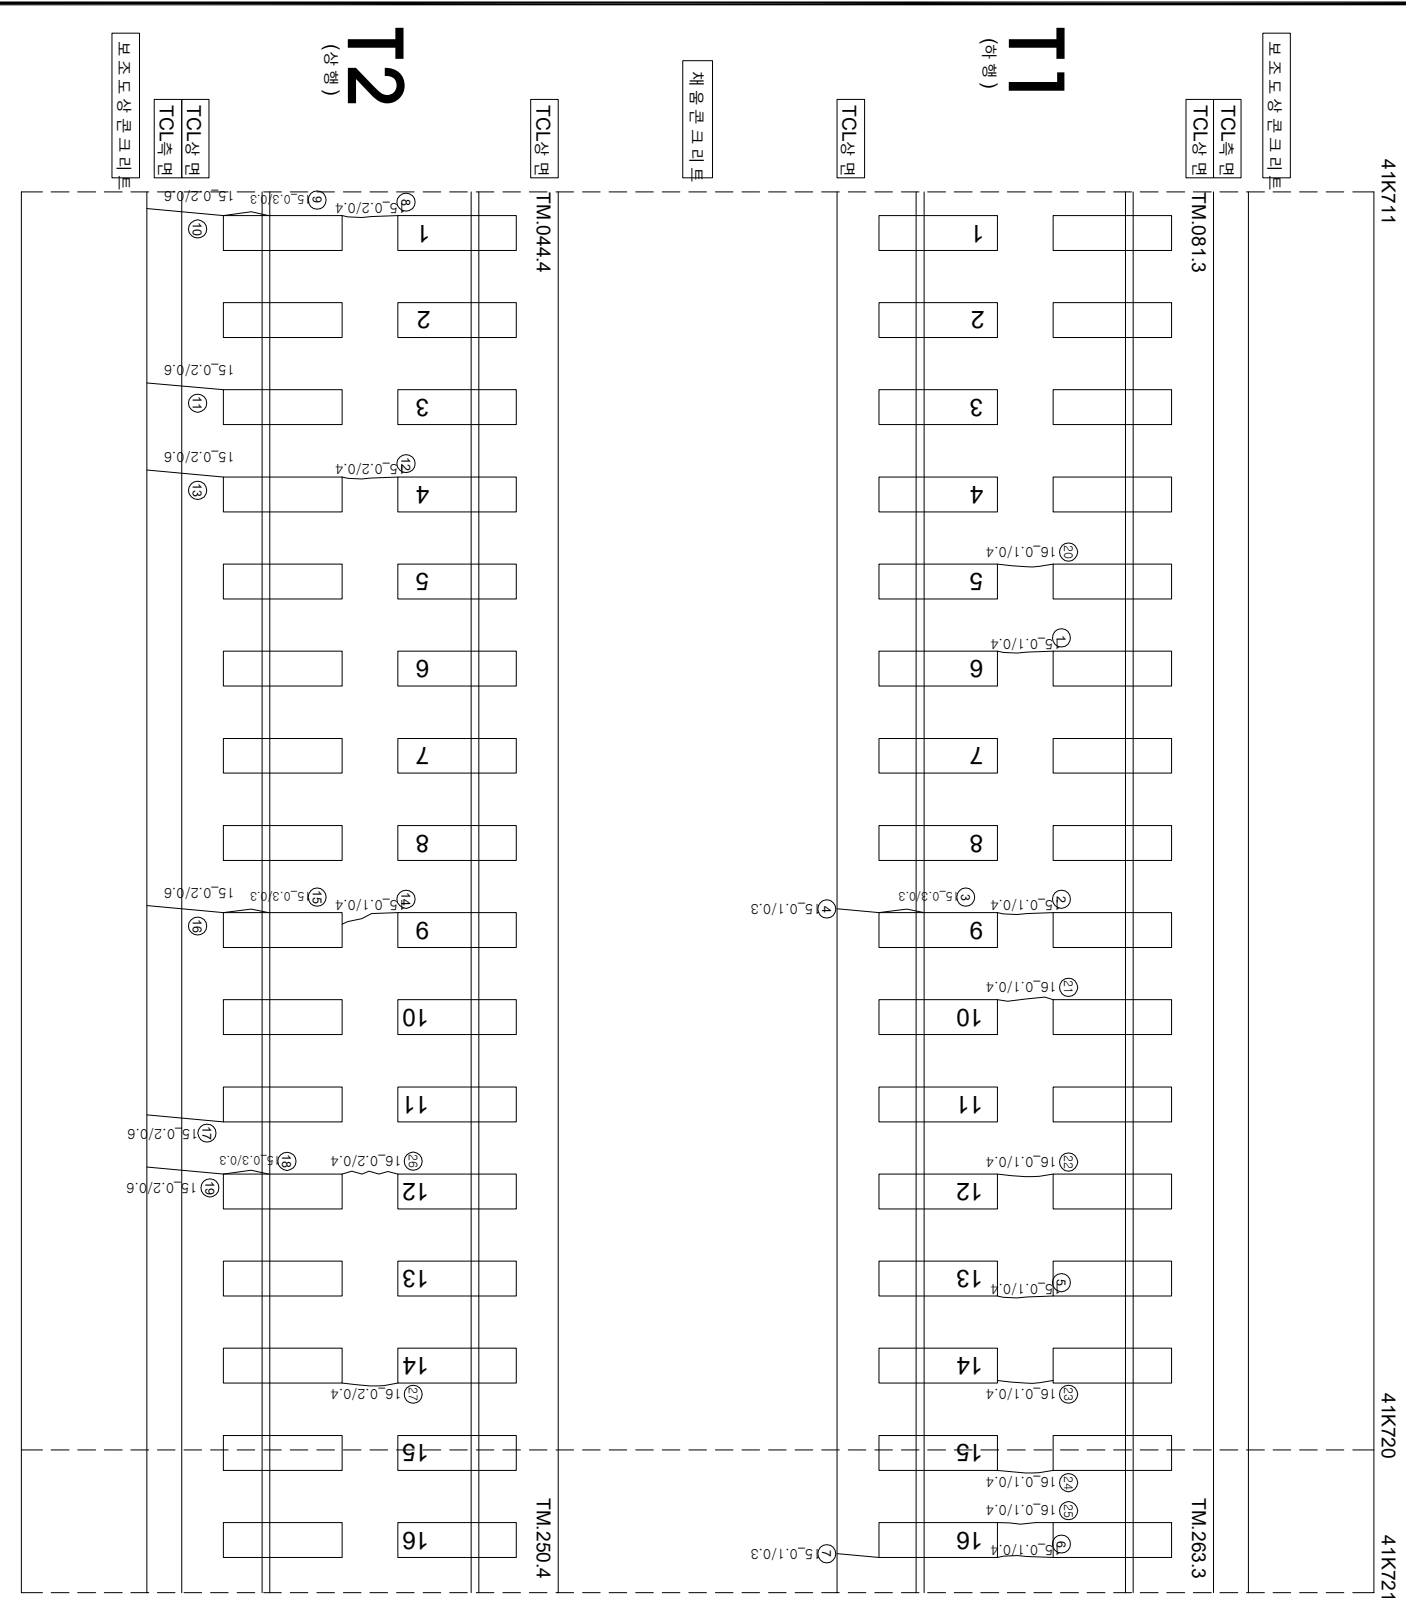
| 연번 | 순차 | 폭 | 연장 | 비고 | 연번 | 순차 | 폭 | 연장 | 비고 |
|---|---|---|---|---|---|---|---|---|---|
| 1 | 균열 | 0.1 mm | 0.4 m | | 57 | | | | |
| 2 | 균열 | 0.1 mm | 0.4 m | | 58 | | | | |
| 3 | 장계부 균열 | 0.3 mm | 0.3 m | | 59 | | | | |
| 4 | 균열 | 0.1 mm | 0.3 m | | 60 | | | | |
| 5 | 균열 | 0.1 mm | 0.4 m | | 61 | | | | |
| 6 | 균열 | 0.1 mm | 0.4 m | | 62 | | | | |
| 7 | 균열 | 0.1 mm | 0.3 m | | 63 | | | | |
| 8 | 균열 | 0.2 mm | 0.4 m | | 64 | | | | |
| 9 | 장계부 균열 | 0.3 mm | 0.3 m | | 65 | | | | |
| 10 | 균열 | 0.2 mm | 0.6 m | | 66 | | | | |
| 11 | 균열 | 0.2 mm | 0.6 m | | 67 | | | | |
| 12 | 균열 | 0.2 mm | 0.4 m | | 68 | | | | |
| 13 | 균열 | 0.2 mm | 0.6 m | | 69 | | | | |
| 14 | 균열 | 0.1 mm | 0.3 m | | 70 | | | | |
| 15 | 장계부 균열 | 0.3 mm | 0.3 m | | 71 | | | | |
| 16 | 장계부 균열 | 0.2 mm | 0.6 m | | 72 | | | | |
| 17 | 균열 | 0.2 mm | 0.6 m | | 73 | | | | |
| 18 | 장계부 균열 | 0.3 mm | 0.3 m | | 74 | | | | |
| 19 | 균열 | 0.2 mm | 0.6 m | | 75 | | | | |
| 20 | 균열 | 0.1 mm | 0.4 m | | 76 | | | | |
| 21 | 균열 | 0.1 mm | 0.4 m | | 77 | | | | |
| 22 | 균열 | 0.1 mm | 0.4 m | | 78 | | | | |
| 23 | 균열 | 0.1 mm | 0.4 m | | 79 | | | | |
| 24 | 균열 | 0.1 mm | 0.4 m | | 80 | | | | |
| 25 | 균열 | 0.1 mm | 0.4 m | | 81 | | | | |
| 26 | 균열 | 0.2 mm | 0.4 m | | 82 | | | | |
| 27 | 균열 | 0.2 mm | 0.4 m | | 83 | | | | |
