호남고속선 영천터널-6(41.591~41.601km, S6)

| 시 | 행 사 | 용 의 | 영 역 | 사 | 건 | | | |
|---|---|---|---|---|---|---|---|---|
| KORAIL<br>KOREA RAILROAD | 한국철도공사 | 2017년도 호남고속선 오송-광주승정간 콘크리트케도 점검용역 | (주) 한국구조물안전연구원<br>(주) 한국도로안전연구원<br>(재) 한국건설품질연구원 | 이복영<br>김윤강<br>김경기<br>문은석 | 원형 | 0220 (0.3m이하 : 목박) | 점로판리 | |

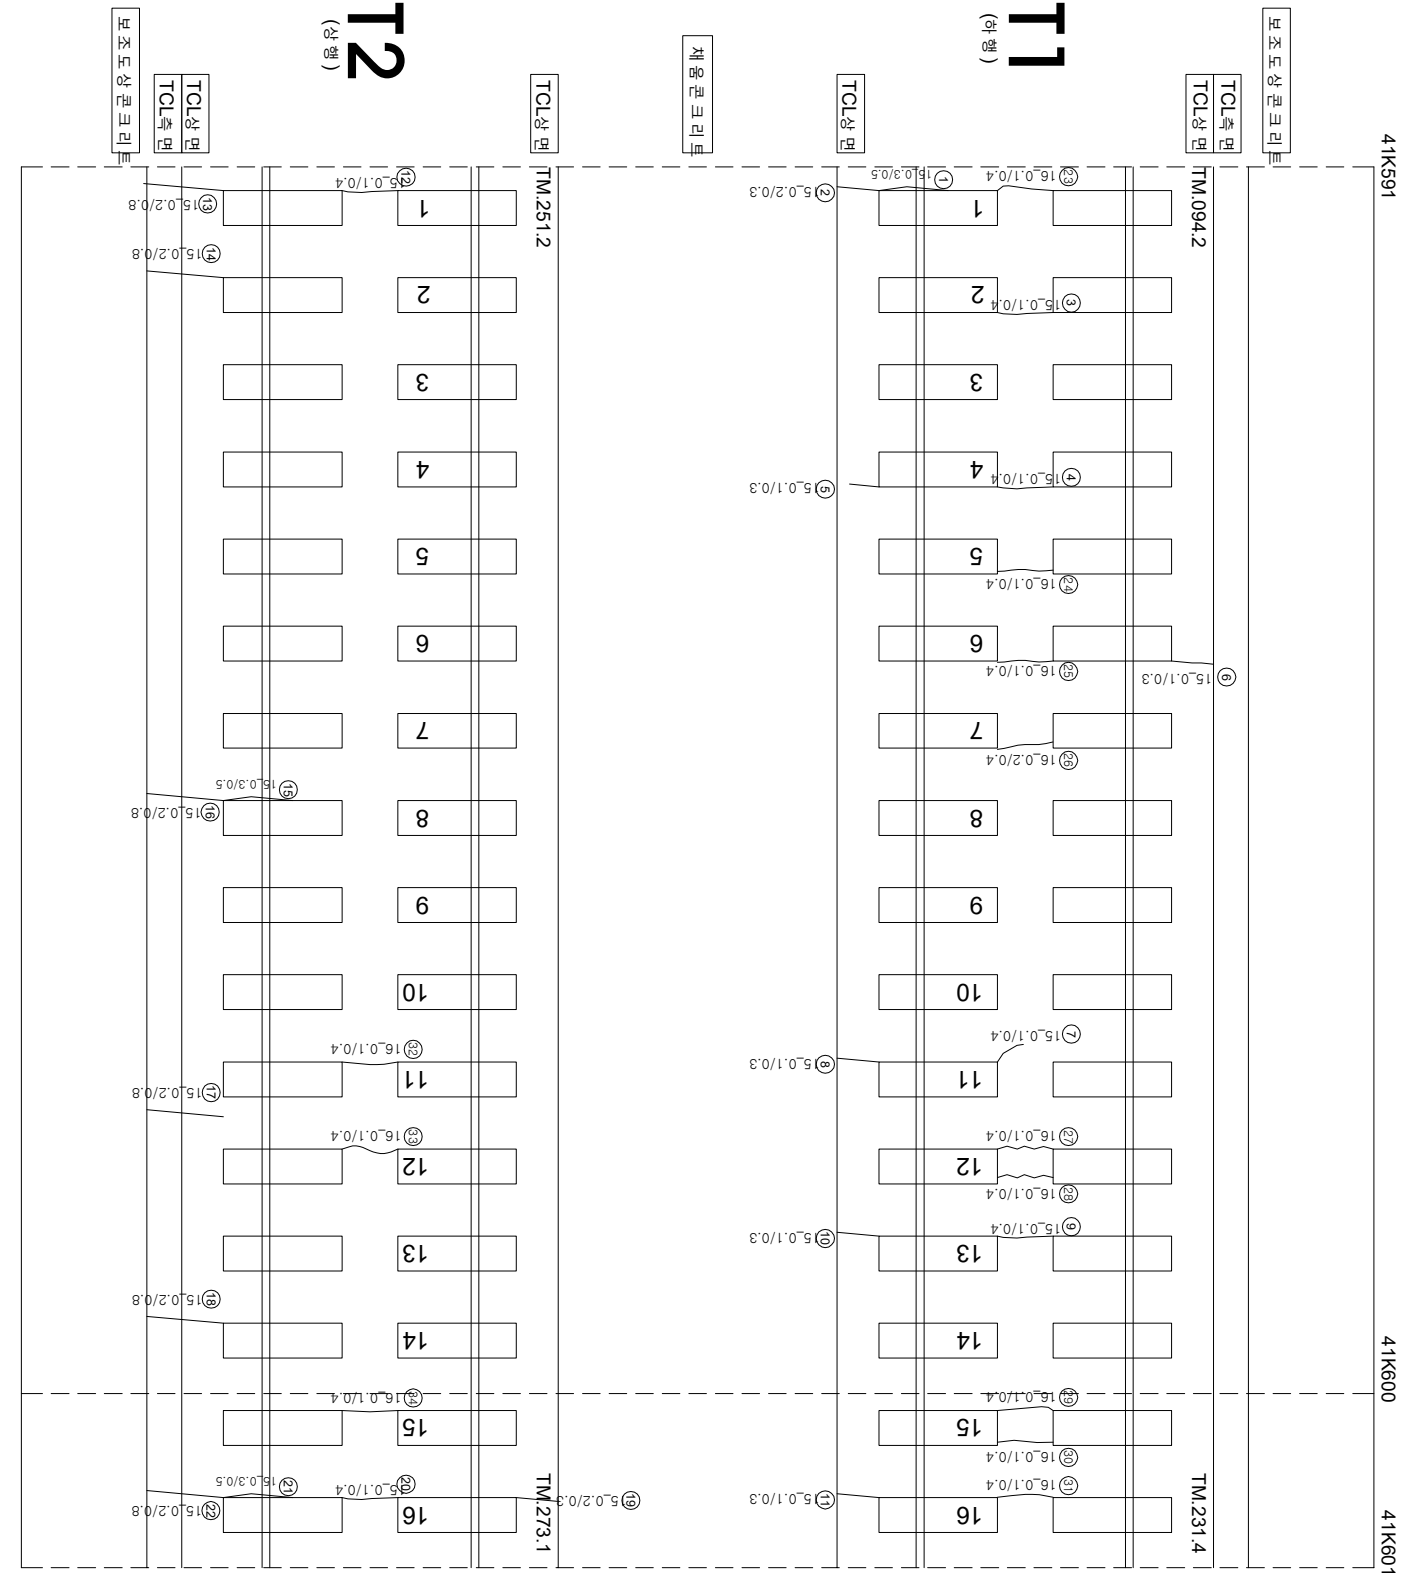
| 연번 | 순차 | 폭 | 연장 | 비고 | 연번 | 순차 | 폭 | 연장 | 비고 |
|---|---|---|---|---|---|---|---|---|---|
| 1 | 균열 | 0.2 mm | 0.3 m | | 56 | | | | |
| 2 | 균열 | 0.2 mm | 0.3 m | | 57 | | | | |
| 3 | 균열 | 0.1 mm | 0.4 m | | 58 | | | | |
| 4 | 균열 | 0.1 mm | 0.4 m | | 59 | | | | |
| 5 | 균열 | 0.1 mm | 0.3 m | | 60 | | | | |
| 6 | 균열 | 0.1 mm | 0.3 m | | 61 | | | | |
| 7 | 균열 | 0.1 mm | 0.4 m | | 62 | | | | |
| 8 | 균열 | 0.1 mm | 0.3 m | | 63 | | | | |
| 9 | 균열 | 0.1 mm | 0.4 m | | 64 | | | | |
| 10 | 균열 | 0.1 mm | 0.3 m | | 65 | | | | |
| 11 | 균열 | 0.1 mm | 0.3 m | | 66 | | | | |
| 12 | 균열 | 0.1 mm | 0.4 m | | 67 | | | | |
| 13 | 균열 | 0.2 mm | 0.6 m | | 68 | | | | |
| 14 | 균열 | 0.2 mm | 0.55 m | | 69 | | | | |
| 15 | 경계부 균열 | 0.3 mm | 0.5 m | | 70 | | | | |
| 16 | 균열 | 0.2 mm | 0.55 m | | 71 | | | | |
| 17 | 균열 | 0.2 mm | 0.55 m | | 72 | | | | |
| 18 | 균열 | 0.2 mm | 0.55 m | | 73 | | | | |
| 19 | 균열 | 0.2 mm | 0.3 m | | 74 | | | | |
| 20 | 균열 | 0.1 mm | 0.4 m | | 75 | | | | |
| 21 | 경계부 균열 | 0.3 mm | 0.5 m | | 76 | | | | |
| 22 | 균열 | 0.2 mm | 0.55 m | | 77 | | | | |
| 23 | 균열 | 0.1 mm | 0.4 m | | 78 | | | | |
| 24 | 균열 | 0.1 mm | 0.4 m | | 79 | | | | |
| 25 | 균열 | 0.1 mm | 0.4 m | | 80 | | | | |
| 26 | 균열 | 0.2 mm | 0.4 m | | 81 | | | | |
| 27 | 균열 | 0.1 mm | 0.4 m | | 82 | | | | |
| 28 | 균열 | 0.1 mm | 0.4 m | | 83 | | | | |
| 29 | 균열 | 0.1 mm | 0.4 m | | 84 | | | | |
| 30 | 균열 | 0.1 mm | 0.4 m | | 85 | | | | |
| 31 | 균열 | 0.1 mm | 0.4 m | | 86 | | | | |
| 32 | 균열 | 0.1 mm | 0.4 m | | 87 | | | | |
| 33 | 균열 | 0.1 mm | 0.4 m | | 88 | | | | |
| 34 | 균열 | 0.1 mm | 0.4 m | | 89 | | | | |
