한남고속선 여천터널 - 토양노반 - 9(42.390~42.400km, L=10m)

| 시 | 행 | 사 | 영 | 역 | 명 | 영 | 역 | 사 | 이 | | 영 | | | | | |
|---|---|---|---|---|---|---|---|---|---|---|---|---|---|---|---|---|
| <div><div>한국철도공사</div><div>KOREA RAILROAD</div></div> | | | 2017년도 호남고속선 오송-광주승정간 콘크리트케도 점검구역 | | | (주) 한국구조물안전연구원<br>(주) 한국도로안전연구원<br>(재) 한국건설품질연구원 | 이 | 복 | 영 | 강 | 김경기<br>한석기 | 영 | (0.3m이하 : 흑색) | (0.3m이하 : 황색) | 침목도상본리 | 지료본리 |

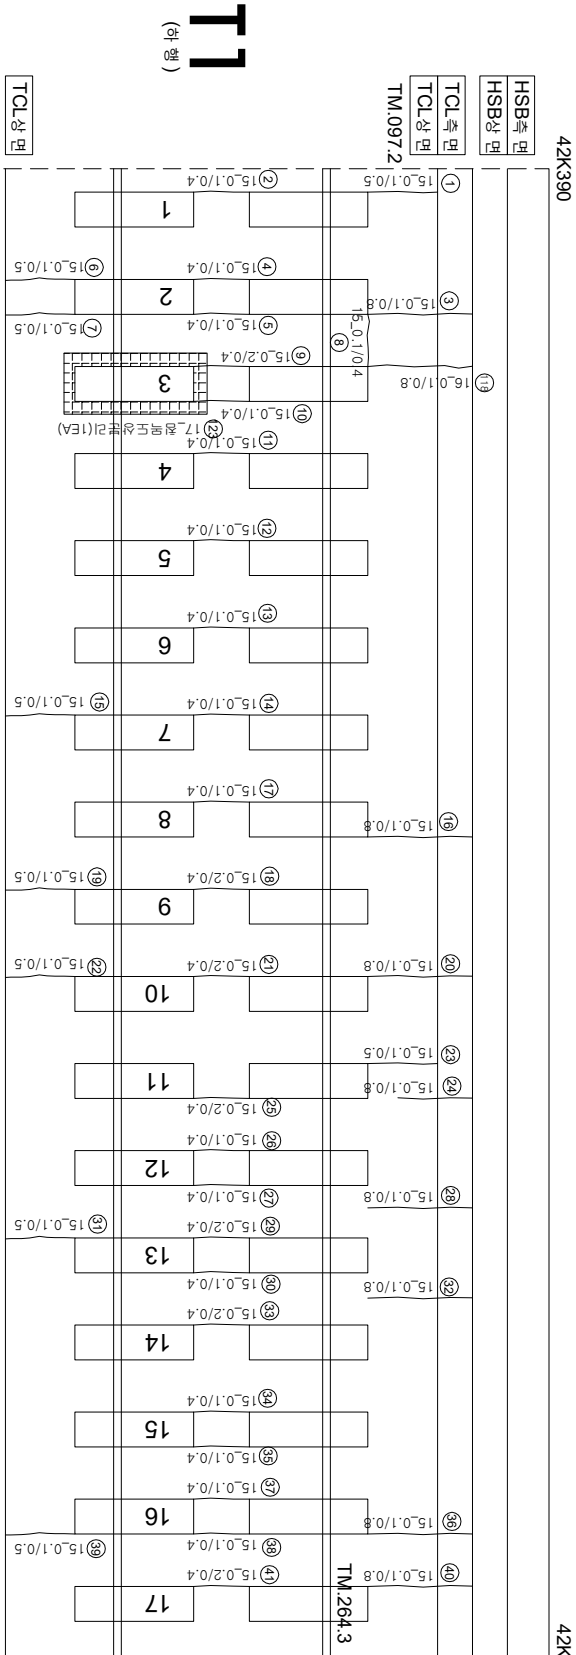
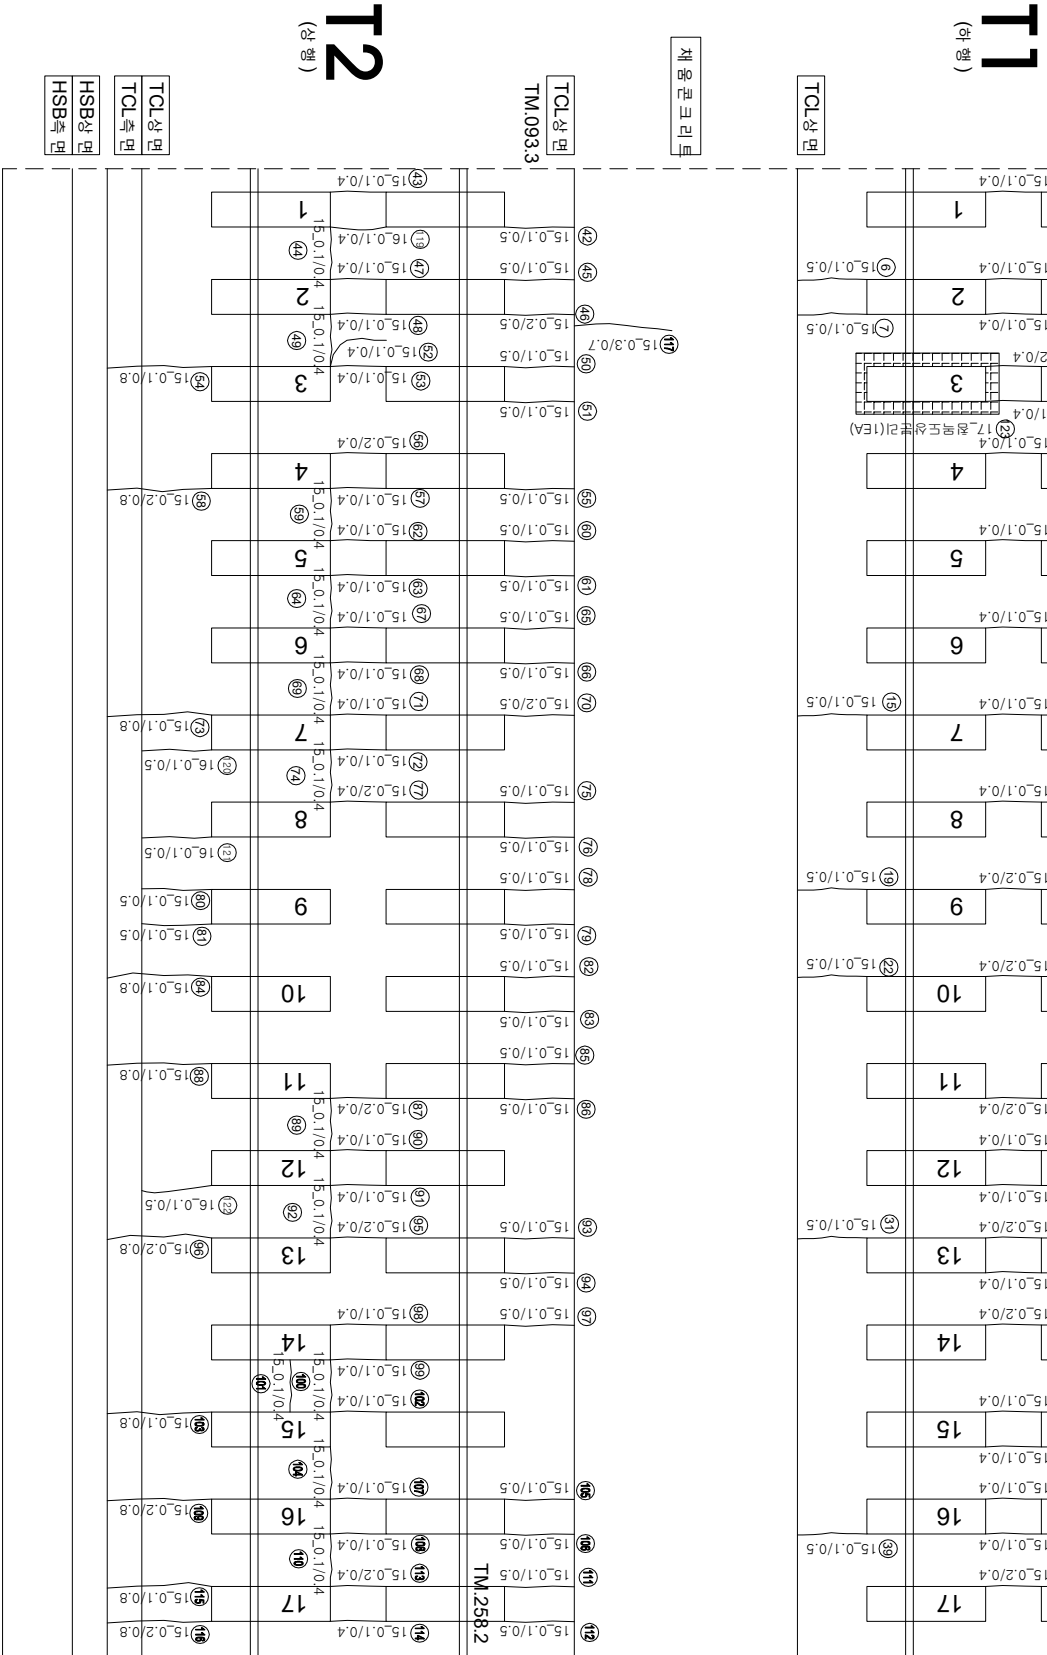
| 연번 | 순상 | 폭 | 연장 | 비고 | 연번 | 순상 | 폭 | 연장 | 비고 | 연번 | 순상 | 폭 | 연장 | 비고 |
|---|---|---|---|---|---|---|---|---|---|---|---|---|---|---|
| 1 | 균열 | 0.1 mm | 0.5 m | m | 56 | 균열 | 0.2 mm | 0.4 m | | 111 | 균열 | 0.1 mm | 0.5 m | |
| 2 | 균열 | 0.1 mm | 0.4 m | m | 57 | 균열 | 0.1 mm | 0.4 m | | 112 | 균열 | 0.1 mm | 0.5 m | |
| 3 | 균열 | 0.1 mm | 0.8 m | m | 58 | 균열 | 0.2 mm | 0.8 m | | 113 | 균열 | 0.2 mm | 0.4 m | |
| 4 | 균열 | 0.1 mm | 0.4 m | m | 59 | 균열 | 0.1 mm | 0.4 m | | 114 | 균열 | 0.1 mm | 0.4 m | |
| 5 | 균열 | 0.1 mm | 0.4 m | m | 60 | 균열 | 0.1 mm | 0.5 m | | 115 | 균열 | 0.1 mm | 0.8 m | |
| 6 | 균열 | 0.1 mm | 0.5 m | m | 61 | 균열 | 0.1 mm | 0.5 m | | 116 | 균열 | 0.2 mm | 0.8 m | |
| 7 | 균열 | 0.1 mm | 0.5 m | m | 62 | 균열 | 0.1 mm | 0.4 m | | 117 | 균열 | 0.3 mm | 0.7 m | |
| 8 | 균열 | 0.1 mm | 0.4 m | m | 63 | 균열 | 0.1 mm | 0.4 m | | 118 | 균열 | 0.1 mm | 0.8 m | |
| 9 | 균열 | 0.2 mm | 0.4 m | m | 64 | 균열 | 0.1 mm | 0.4 m | | 119 | 균열 | 0.1 mm | 0.8 m | |
| 10 | 균열 | 0.1 mm | 0.4 m | m | 65 | 균열 | 0.1 mm | 0.5 m | | 120 | 균열 | 0.1 mm | 0.5 m | |
| 11 | 균열 | 0.1 mm | 0.4 m | m | 66 | 균열 | 0.1 mm | 0.4 m | | 121 | 균열 | 0.1 mm | 0.5 m | |
| 12 | 균열 | 0.1 mm | 0.4 m | m | 67 | 균열 | 0.1 mm | 0.4 m | | 122 | 균열 | 0.1 mm | 0.5 m | |
| 13 | 균열 | 0.1 mm | 0.4 m | m | 68 | 균열 | 0.1 mm | 0.4 m | | 123 | 철목토상판리 | | 10 EA | 신규 |
