호남고속선 공주고가\_15(43.747~43.753km, S14)

| 시행사 | 용역명 | 용역사 | 개입장치 | | 장치분야별개입지 | 구간 | |
|---|---|---|---|---|---|---|---|
| KORAIL<br>KOREA RAILROAD<br>한국철도공사 | 2017년도 호남고속선 오송-광주승정간 콘크리트케도 점검공역 | (주) 한국국조물안전연구원<br>(주) 한국국토안전연구원<br>(재) 한국건설품질연구원 | 이복영 | 간원강<br>김경기<br>문준석 | 연 | 0220 (0.3m이하 : 철삭) | 차로분리 |

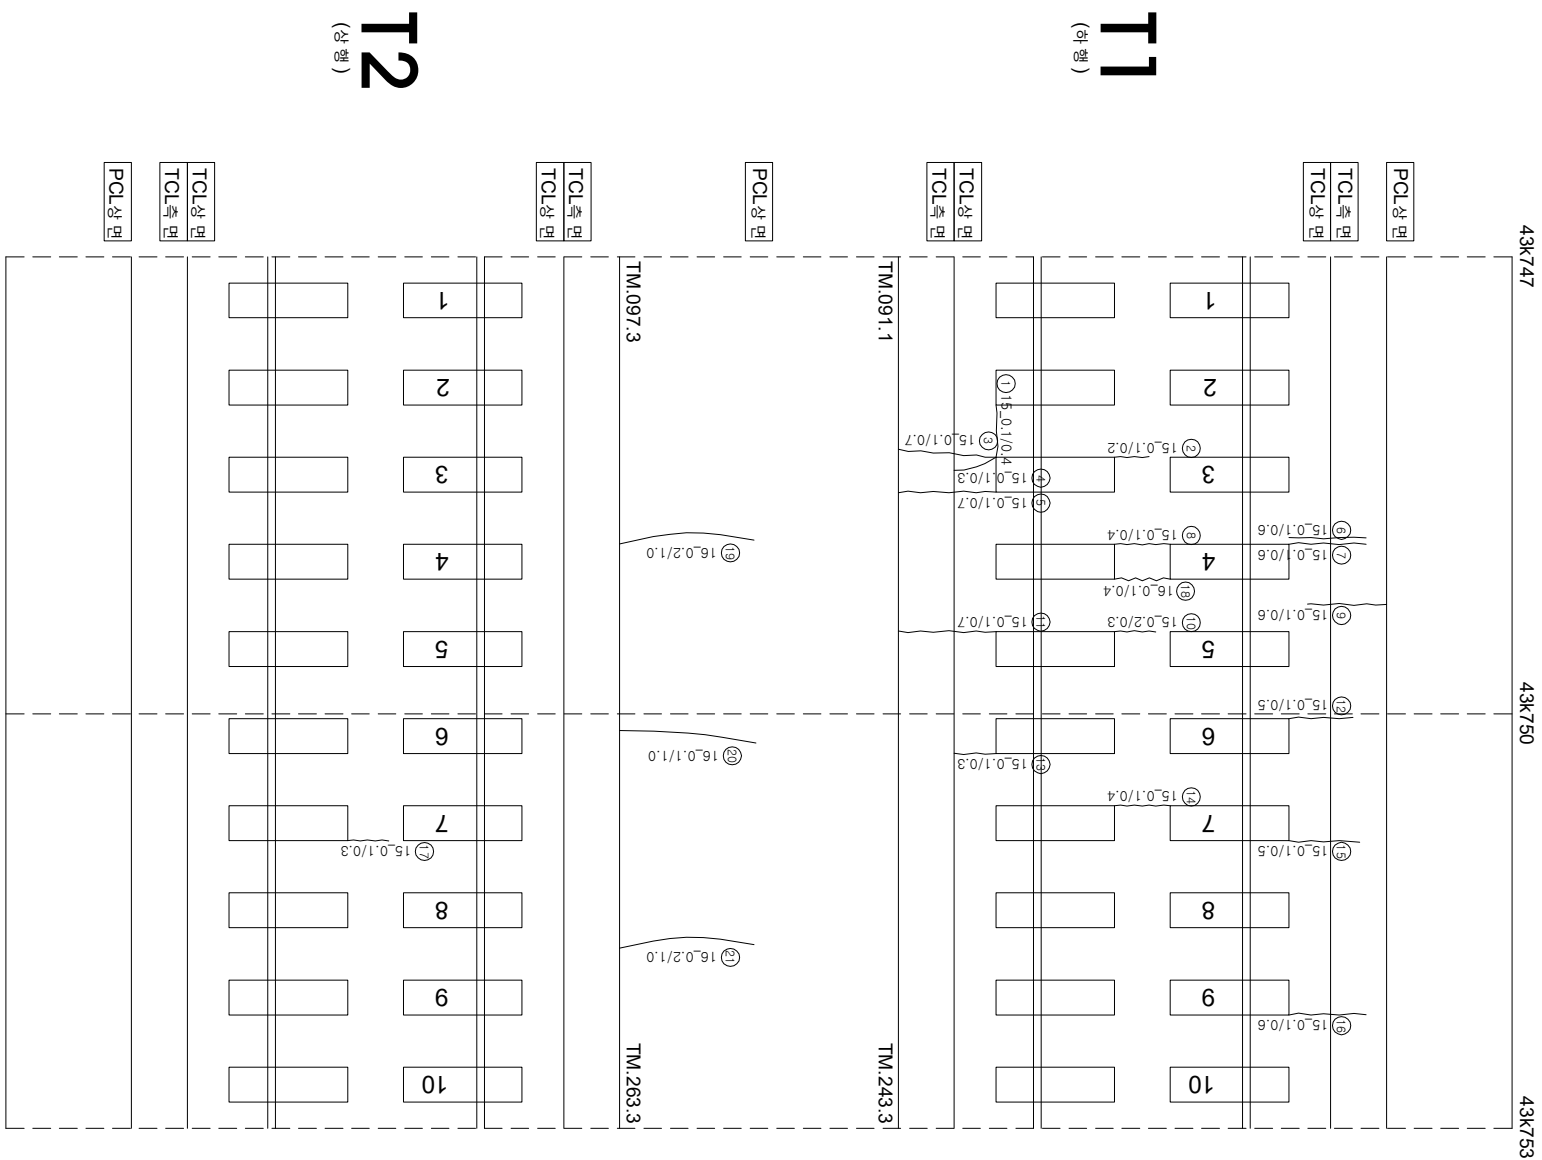
| 연번 | 순상 | 폭 | 연장 | 비고 | 연번 | 순상 | 폭 | 연장 | 비고 |
|---|---|---|---|---|---|---|---|---|---|
| 1 | 균열 | 0.1 mm | 0.4 m | | 56 | | | | |
| 2 | 균열 | 0.1 mm | 0.2 m | | 57 | | | | |
| 3 | 균열 | 0.1 mm | 0.7 m | | 58 | | | | |
| 4 | 균열 | 0.1 mm | 0.3 m | | 59 | | | | |
| 5 | 균열 | 0.1 mm | 0.7 m | | 60 | | | | |
| 6 | 균열 | 0.1 mm | 0.6 m | | 61 | | | | |
| 7 | 균열 | 0.1 mm | 0.6 m | | 62 | | | | |
| 8 | 균열 | 0.1 mm | 0.4 m | | 63 | | | | |
| 9 | 균열 | 0.1 mm | 0.6 m | | 64 | | | | |
| 10 | 균열 | 0.2 mm | 0.3 m | | 65 | | | | |
| 11 | 균열 | 0.1 mm | 0.7 m | | 66 | | | | |
| 12 | 균열 | 0.1 mm | 0.5 m | | 67 | | | | |
| 13 | 균열 | 0.1 mm | 0.3 m | | 68 | | | | |
| 14 | 균열 | 0.1 mm | 0.4 m | | 69 | | | | |
| 15 | 균열 | 0.1 mm | 0.5 m | | 70 | | | | |
| 16 | 균열 | 0.1 mm | 0.6 m | | 71 | | | | |
| 17 | 균열 | 0.1 mm | 0.3 m | | 72 | | | | |
| 18 | 균열 | 0.1 mm | 0.4 m | | 73 | | | | |
| 19 | 균열 | 0.2 mm | 1.0 m | | 74 | | | | |
| 20 | 균열 | 0.2 mm | 1.0 m | | 75 | | | | |
| 21 | 균열 | 0.2 mm | 1.0 m | | 76 | | | | |
