호남고속선 호암교\_106(47.054~47.061km, S21-5)

21 SPAN - 5

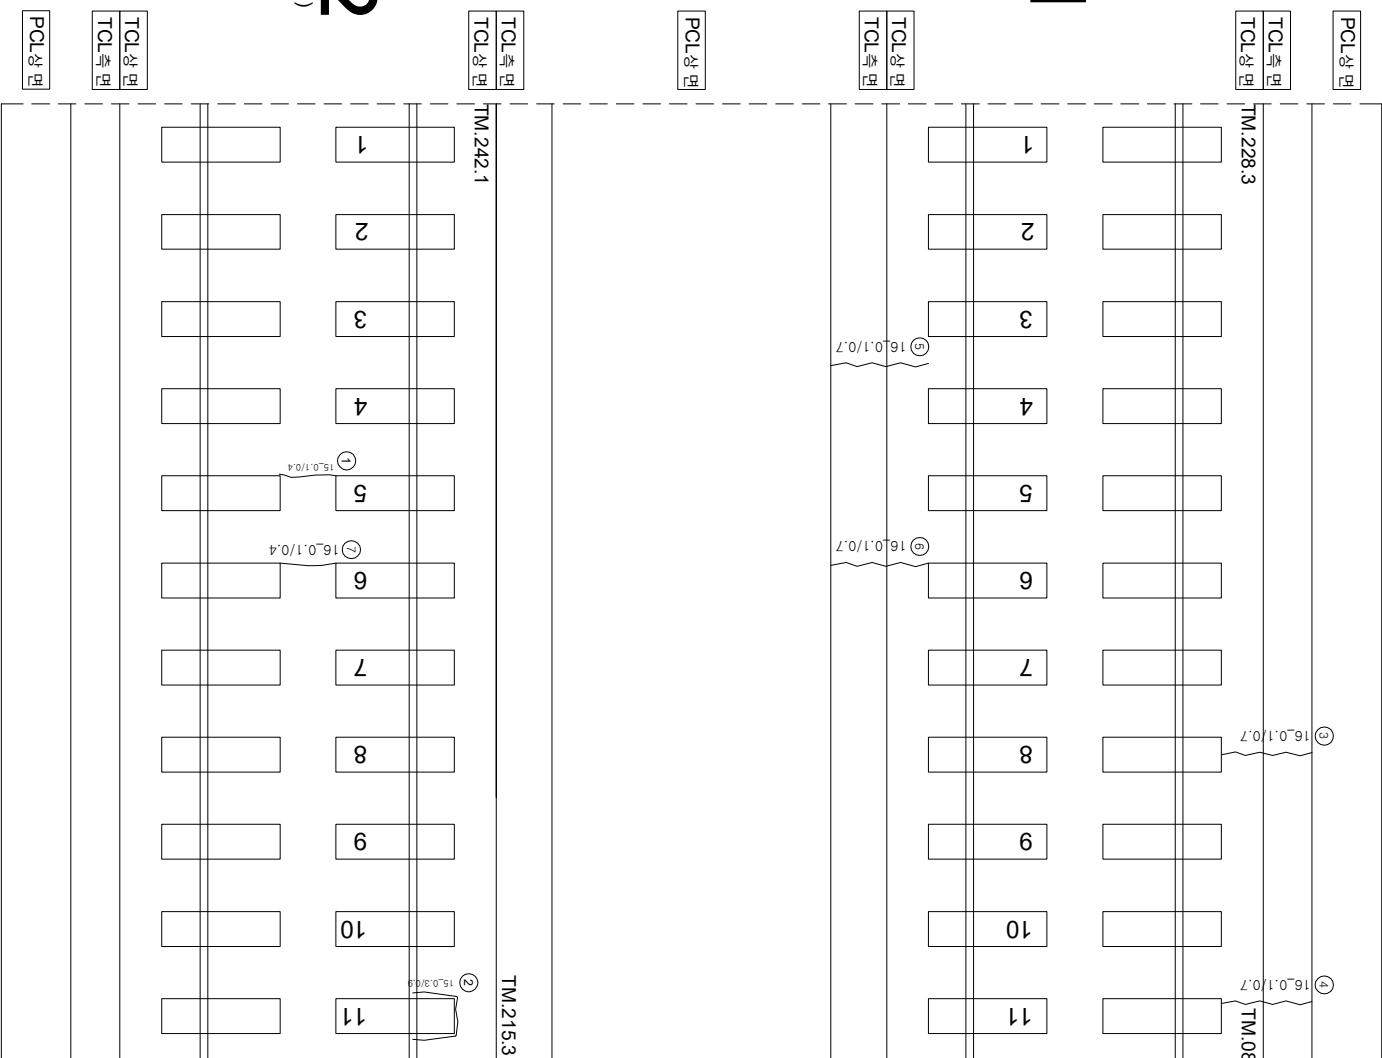
| 연번 | 순상 | 폭 | 연장 | 비고 | 연번 | 순상 | 폭 | 연장 | 비고 |
|---|---|---|---|---|---|---|---|---|---|
| 1 | 균열 | 0.1 mm | 0.4 m | | 56 | | | | |
| 2 | 갈래부 균열 | 0.3 mm | 0.9 m | | 57 | | | | |
| 3 | 균열 | 0.1 mm | 0.7 m | | 58 | | | | |
| 4 | 균열 | 0.1 mm | 0.7 m | | 59 | | | | |
| 5 | 균열 | 0.1 mm | 0.7 m | | 60 | | | | |
| 6 | 균열 | 0.1 mm | 0.7 m | | 61 | | | | |
| 7 | 균열 | 0.1 mm | 0.4 m | | 62 | | | | |
