호남고속선 호암교\_154(47.390~47.397km, S31-3)

47K397  
31 SPAN - 3

| 한국철도공사<br>KOREA RAILROAD | 2017년도 호남고속선 오송-광주승강간 콘크리트케도 정검용역 | (주) 한국구조물안전연구원<br>(주) 한국국토안전연구원<br>(재) 한국건설품질연구원 | 이복영 | 김경기 | 김은강 | 윤석기 | 영일 | | | |

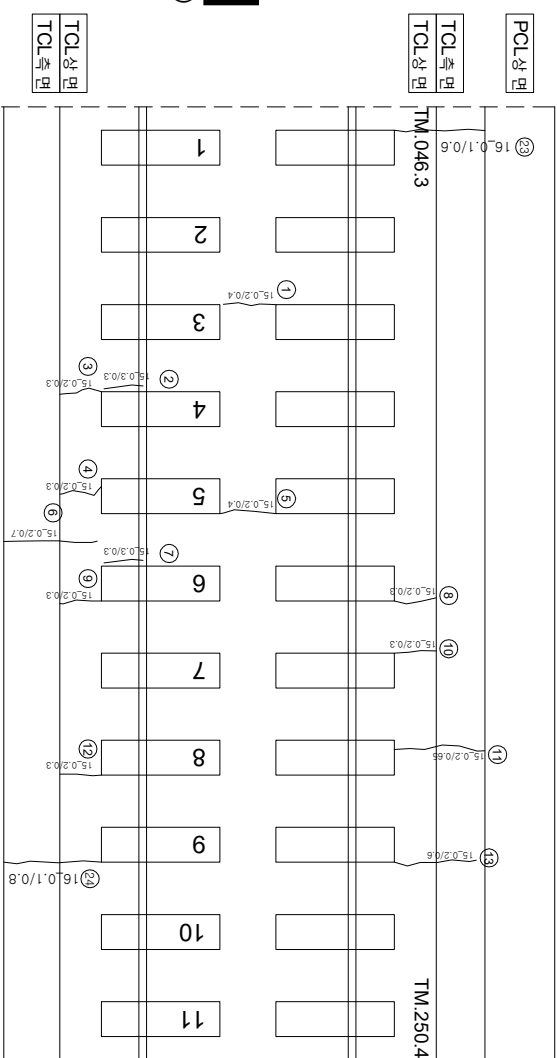
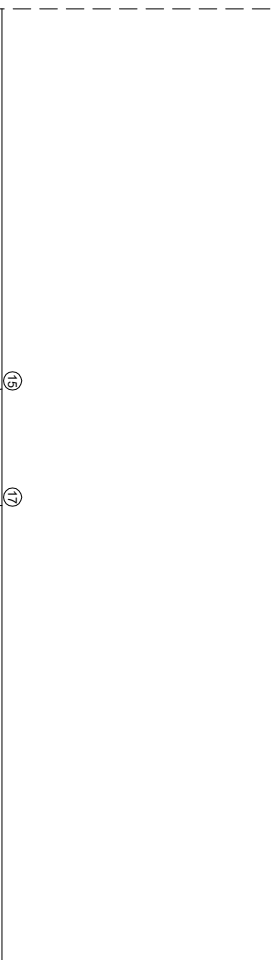
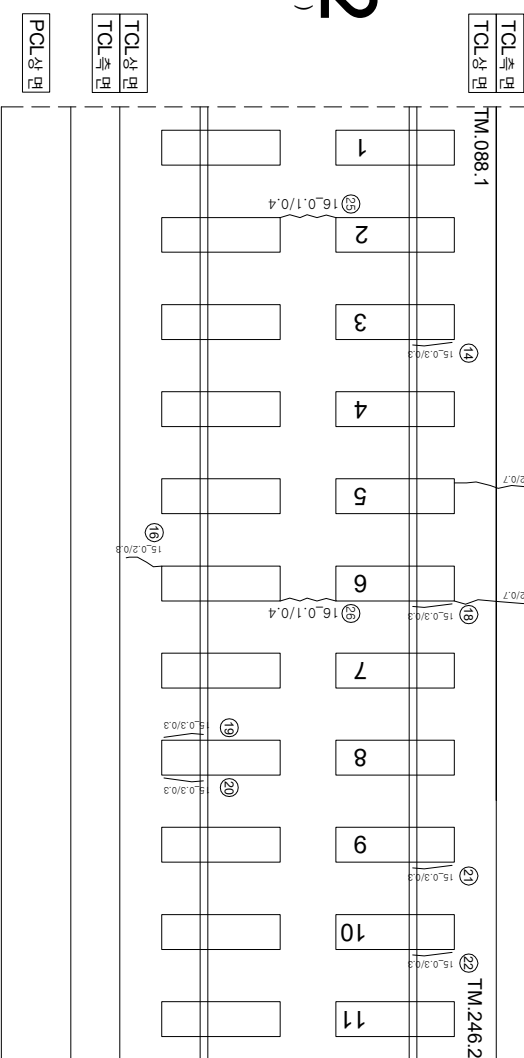
| 연번 | 순상 | 폭 | 연장 | 비고 | 연번 | 순상 | 폭 | 연장 | 비고 |
|---|---|---|---|---|---|---|---|---|---|
| 1 | 균열 | 0.2 mm | 0.4 m | | 56 | | | | |
| 2 | 경계부 균열 | 0.3 mm | 0.3 m | | 57 | | | | |
| 3 | 균열 | 0.2 mm | 0.3 m | | 58 | | | | |
| 4 | 균열 | 0.2 mm | 0.3 m | | 59 | | | | |
| 5 | 균열 | 0.2 mm | 0.4 m | | 60 | | | | |
| 6 | 균열 | 0.2 mm | 0.7 m | | 61 | | | | |
| 7 | 경계부 균열 | 0.3 mm | 0.3 m | | 62 | | | | |
| 8 | 균열 | 0.2 mm | 0.3 m | | 63 | | | | |
| 9 | 균열 | 0.2 mm | 0.3 m | | 64 | | | | |
| 10 | 균열 | 0.2 mm | 0.3 m | | 65 | | | | |
| 11 | 균열 | 0.2 mm | 0.7 m | | 66 | | | | |
| 12 | 균열 | 0.2 mm | 0.3 m | | 67 | | | | |
| 13 | 균열 | 0.2 mm | 0.6 m | | 68 | | | | |
| 14 | 경계부 균열 | 0.3 mm | 0.3 m | | 69 | | | | |
| 15 | 균열 | 0.2 mm | 0.7 m | | 70 | | | | |
| 16 | 균열 | 0.2 mm | 0.3 m | | 71 | | | | |
| 17 | 균열 | 0.2 mm | 0.7 m | | 72 | | | | |
| 18 | 경계부 균열 | 0.3 mm | 0.3 m | | 73 | | | | |
| 19 | 경계부 균열 | 0.3 mm | 0.3 m | | 74 | | | | |
| 20 | 경계부 균열 | 0.3 mm | 0.3 m | | 75 | | | | |
| 21 | 경계부 균열 | 0.3 mm | 0.3 m | | 76 | | | | |
| 22 | 경계부 균열 | 0.3 mm | 0.3 m | | 77 | | | | |
| 23 | 균열 | 0.1 mm | 0.6 m | | 78 | | | | |
| 24 | 균열 | 0.1 mm | 0.8 m | | 79 | | | | |
| 25 | 균열 | 0.1 mm | 0.4 m | | 80 | | | | |
| 26 | 균열 | 0.1 mm | 0.4 m | | 81 | | | | |
