한남고속도로 13(47.600~47.610km, L=10.0m)

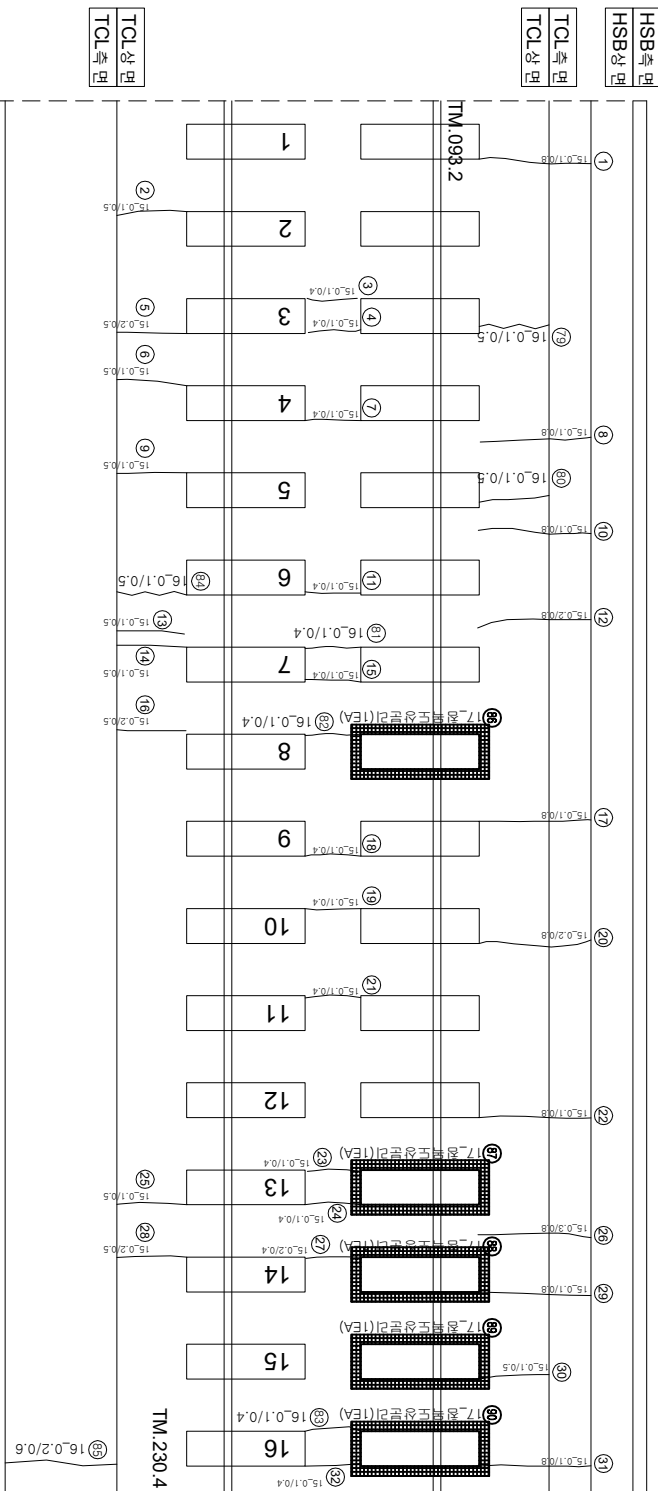
| 연번 | 순상 | 폭 | 연장 | 비고 | 연번 | 순상 | 폭 | 연장 | 비고 |
| 1 | 균열 | 0.1 | 0.8 | m | 56 | 균열 | 0.1 | 0.8 | m |
| 2 | 균열 | 0.1 | 0.5 | m | 57 | 균열 | 0.1 | 0.4 | m |
| 3 | 균열 | 0.1 | 0.4 | m | 58 | 균열 | 0.1 | 0.8 | m |
| 4 | 균열 | 0.1 | 0.4 | m | 59 | 균열 | 0.2 | 0.5 | m |
| 5 | 균열 | 0.2 | 0.5 | m | 60 | 균열 | 0.1 | 0.4 | m |
| 26 | 균열 | 0.3 | 0.8 | m | 81 | 균열 | 0.1 | 0.4 | m |
| 31 | 균열 | 0.1 | 0.8 | m | 86 | 철근도상분리 | | 10 | ea |
| 32 | 균열 | 0.1 | 0.4 | m | 87 | 철근도상분리 | | 10 | ea |
| 33 | 균열 | 0.1 | 0.5 | m | 88 | 철근도상분리 | | 10 | ea |
| 34 | 균열 | 0.1 | 0.4 | m | 89 | 철근도상분리 | | 10 | ea |
| 35 | 균열 | 0.1 | 0.5 | m | 90 | 철근도상분리 | | 10 | ea |
