한남고속선 화암교~토랑노반 26(47.730~47.740km, L=10.0m)

| 시 | 행 | 사 | 영 | 여 | 명 | 용 | 여 | 사 | 간 | |
|---|---|---|---|---|---|---|---|---|---|---|
| <br><b>KORAIL</b><br>KOREA RAILROAD | | 한국철도공사 | 2017년도 | 호남고속선 | 오송-광주순정간 콘크리트케도 점검용역 | (주) 한국구조물안전연구원<br>(주) 한국도로안전연구원<br>(재) 한국건설품질연구원 | 이복영 | 각공경기문원적기 | 영원 | |

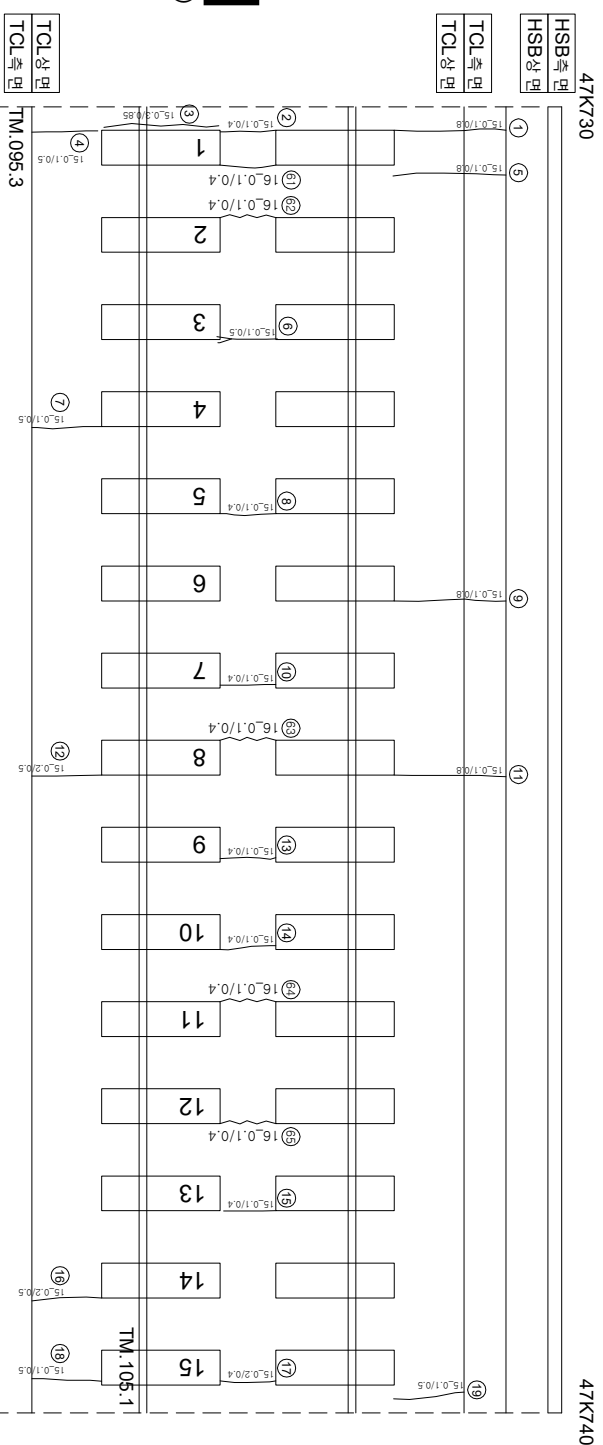
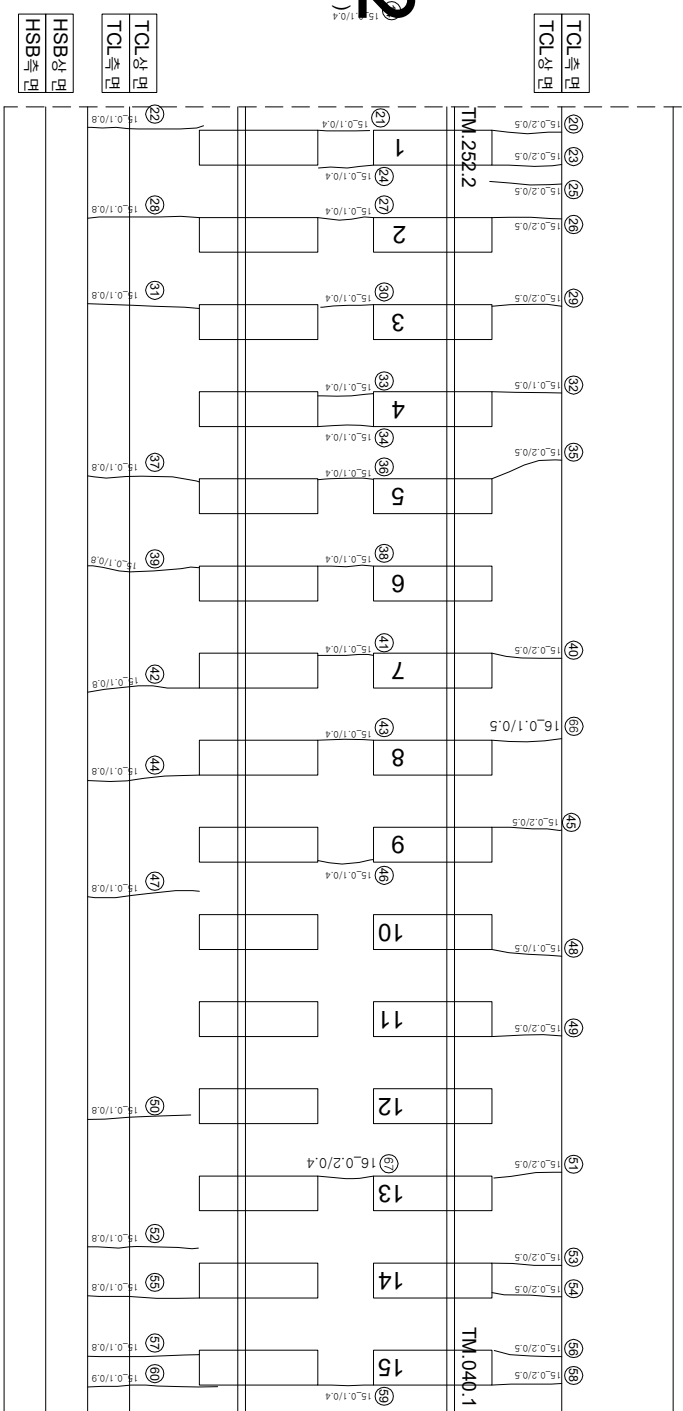
| 연번 | 순상 | 폭 | 연장 | 비고 | 연번 | 순상 | 폭 | 연장 | 비고 |
|---|---|---|---|---|---|---|---|---|---|
| 1 | 균열 | 0.1 mm | 0.8 m | | 56 | 균열 | 0.2 mm | 0.5 m | |
| 2 | 균열 | 0.1 mm | 0.4 m | | 57 | 균열 | 0.1 mm | 0.8 m | |
| 3 | 강제부 균열 | 0.3 mm | 0.9 m | | 58 | 균열 | 0.2 mm | 0.5 m | |
| 4 | 균열 | 0.1 mm | 0.5 m | | 59 | 균열 | 0.1 mm | 0.4 m | |
| 5 | 균열 | 0.1 mm | 0.5 m | | 60 | 균열 | 0.1 mm | 0.9 m | |
| 6 | 균열 | 0.1 mm | 0.5 m | | 61 | 균열 | 0.1 mm | 0.4 m | |
| 7 | 균열 | 0.1 mm | 0.5 m | | 62 | 균열 | 0.1 mm | 0.4 m | |
| 8 | 균열 | 0.1 mm | 0.4 m | | 63 | 균열 | 0.1 mm | 0.4 m | |
| 9 | 균열 | 0.1 mm | 0.8 m | | 64 | 균열 | 0.1 mm | 0.4 m | |
| 10 | 균열 | 0.1 mm | 0.4 m | | 65 | 균열 | 0.1 mm | 0.4 m | |
| 11 | 균열 | 0.1 mm | 0.8 m | | 66 | 균열 | 0.1 mm | 0.5 m | |
| 12 | 균열 | 0.2 mm | 0.5 m | | 67 | 균열 | 0.1 mm | 0.4 m | |
