한남고속도로 35(47.820~47.830km, L=10.0m)

| 시 | 행 | 사 | 용 | 역 | 영 | 사 | 단 | | |
|---|---|---|---|---|---|---|---|---|---|
| KORAIL<br>KOREA RAILROAD | 한국철도공사 | 2017년도 호남고속선 오송-광주승정리 콘크리트케도 점검용역 | (주) 한국구조물안전연구원<br>(주) 한국도로안전연구원<br>(재) 한국건설품질연구원 | 이 복 영 | 간윤강<br>김경기<br>문석기 | 영남 | 0220 (0.3mm이하 : 흑색) | 점도도상판리 | 재료판리 |

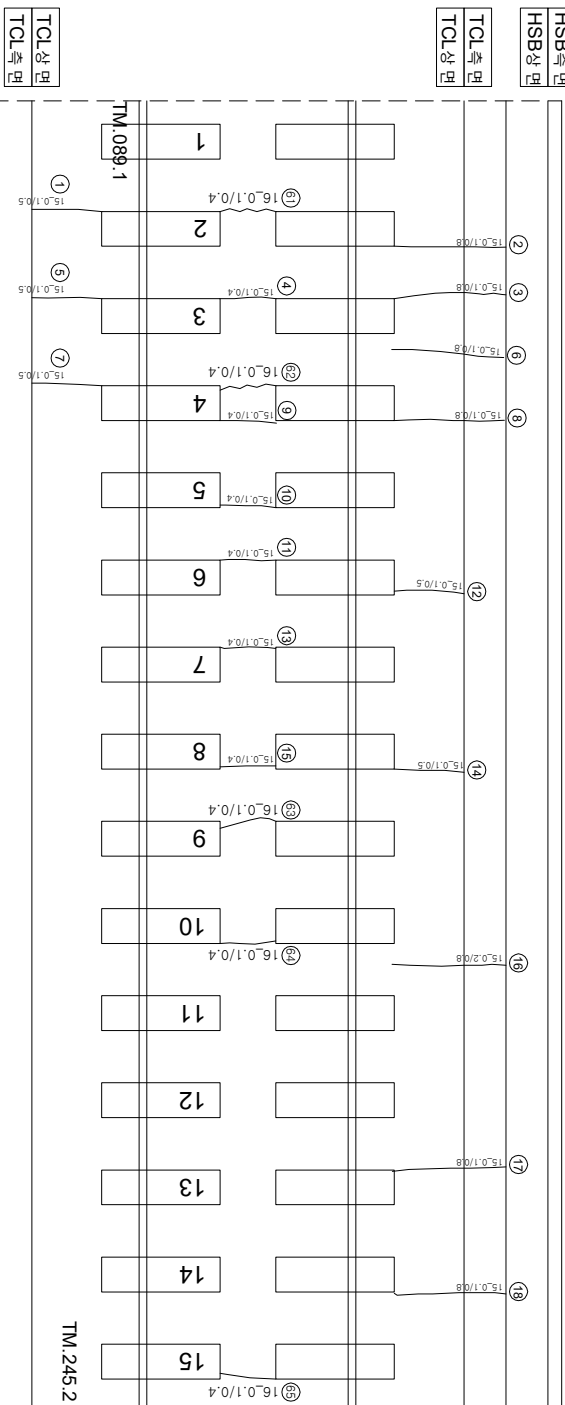
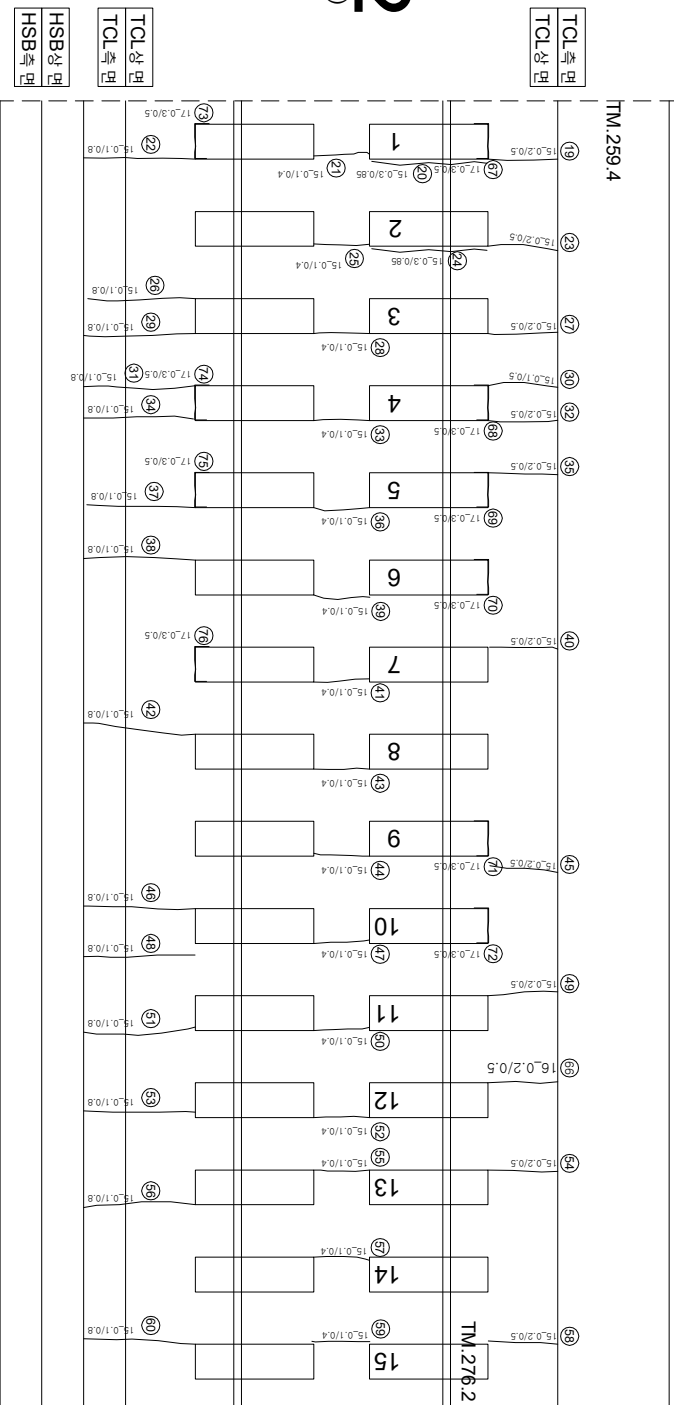
| 연번 | 순차 | 폭 | 연장 | 비고 | 연번 | 순차 | 폭 | 연장 | 비고 |
|---|---|---|---|---|---|---|---|---|---|
| 1 | 균열 | 0.1 | 0.5 | m | 56 | 균열 | 0.1 | 0.8 | m |
| 20 | 장폐부 균열 | 0.3 | 0.9 | m | 75 | 균열 | 0.3 | 0.5 | m |
| 24 | 장폐부 균열 | 0.3 | 0.9 | m | 79 | | | | |
