한남고속도로 38(47.850~47.860km, L=10.0m)

| 시 | 행 | 사 | 용 | 역 | 영 | 사 | 단 | | |
|---|---|---|---|---|---|---|---|---|---|
| KORAIL<br>KOREA RAILROAD | 한국철도공사 | 2017년도 호남고속선 오송-광주승정간 콘크리트케도 점검용역 | (주) 한국구조물안전연구원<br>(주) 한국도로안전연구원<br>(재) 한국건설품질연구원 | 이 복 영 | 간 윤 강<br>김 경 기<br>문 준 기 | 영원 | 02220 (0.3mm이하 : 흑색) | 점도도상판리 | 재료판리 |

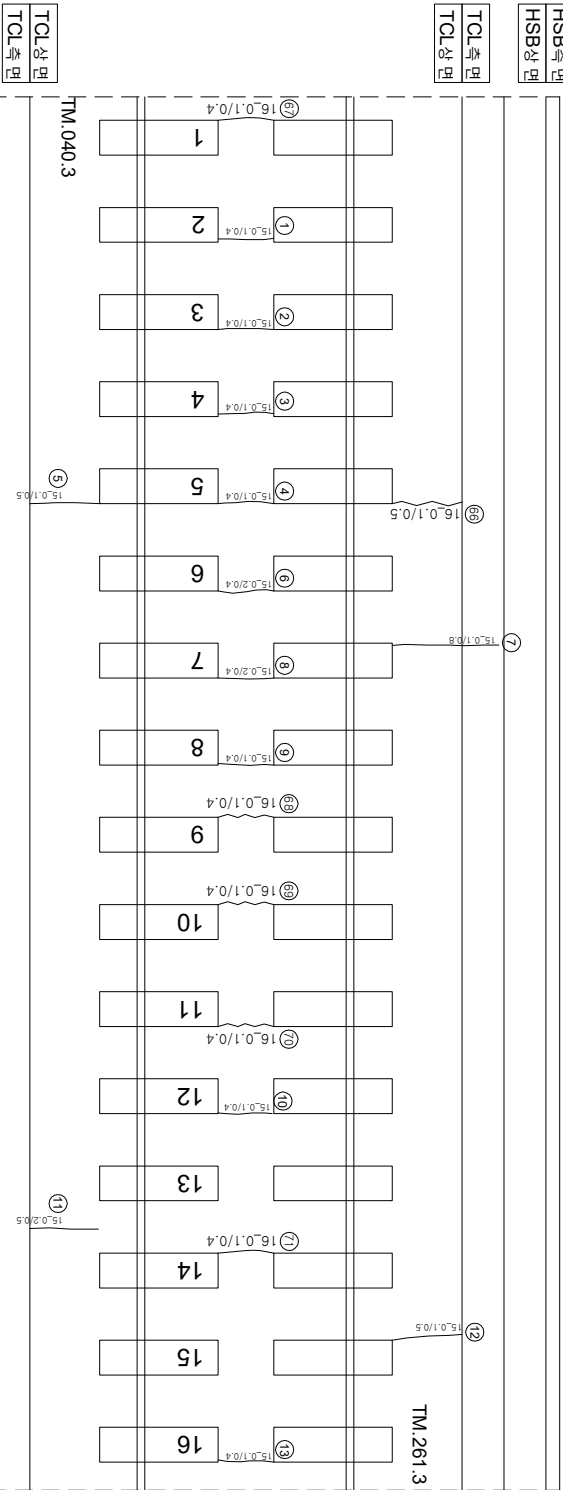
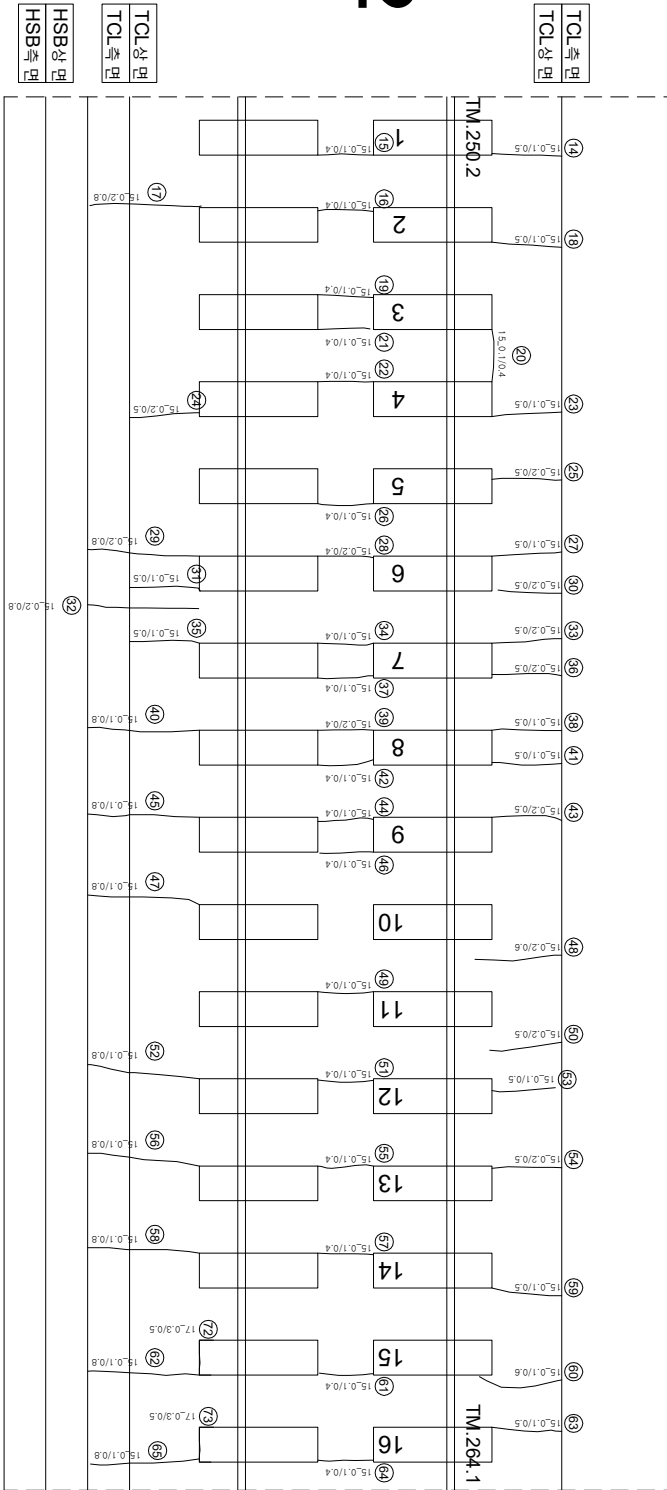
| 연번 | 순상 | 폭 | 연장 | 비고 | 연번 | 순상 | 폭 | 연장 | 비고 |
|---|---|---|---|---|---|---|---|---|---|
| 17 | 균열 0.2 | 0.8 m | | | 72 | 균열 0.3 | 0.5 m | 신규 | |
| 18 | 균열 0.1 | 0.5 m | | | 73 | 균열 0.3 | 0.5 m | 신규 | |
| 48 | 균열 0.3 | 0.6 m | | | 103 | | | | |
