한남고속선 서편코 - 토양노반 - 26(48.240~48.250km, L=10m)

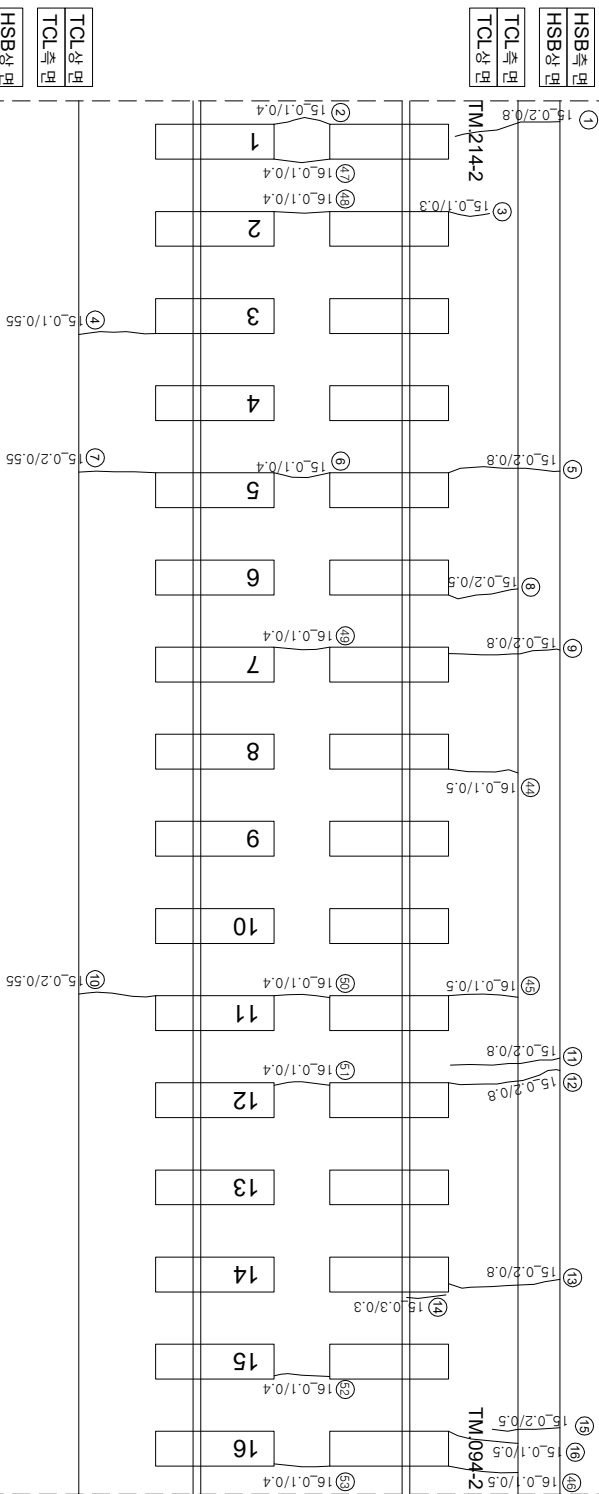
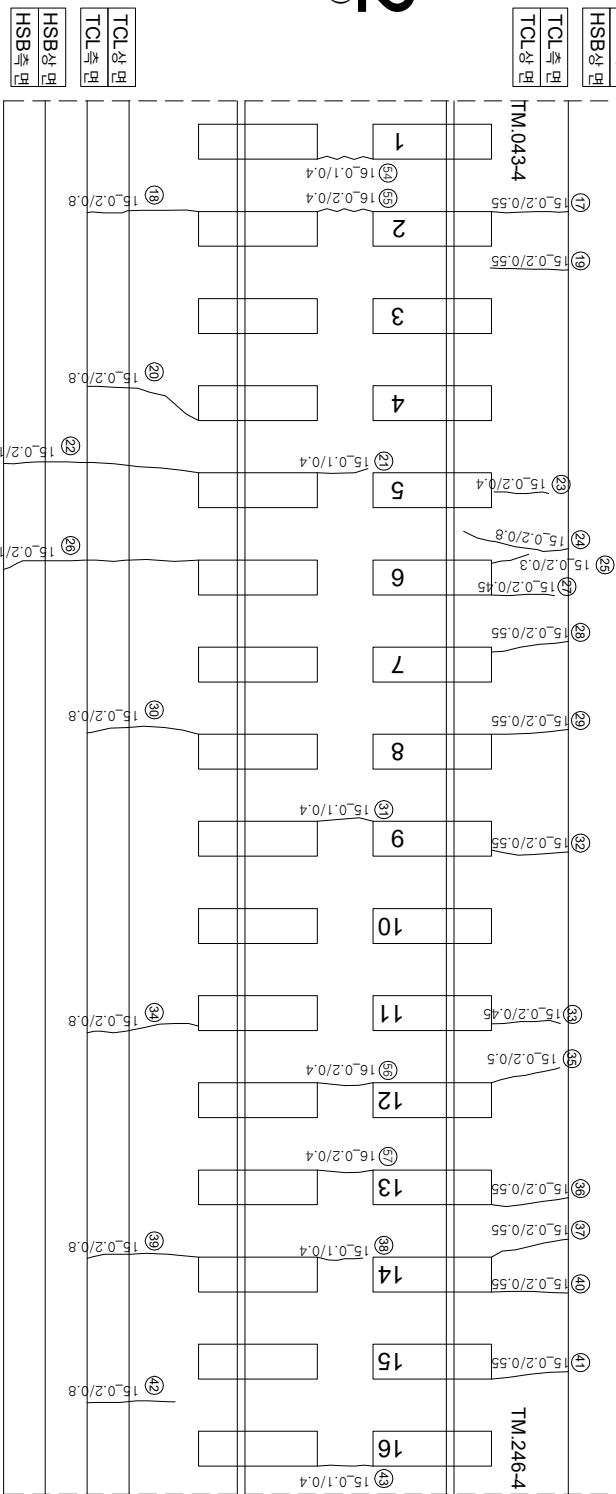
| 연번 | 순상 | 폭 | 연장 | 비고 | 연번 | 순상 | 폭 | 연장 | 비고 |
| 1 | 균열 | 0.1 mm | 0.8 m | | 56 | 균열 | 0.2 mm | 0.4 m | |
| 2 | 균열 | 0.1 mm | 0.4 m | | 57 | 균열 | 0.2 mm | | |
| 14 | 경계부 균열 | 0.3 mm | 0.3 m | | 69 | | | | |
