한남고속선 서평교 - 토아노반 - 32(48.300~48.310km, L=10m)

| 시 | 행 | 사 | 영 | 역 | 영 | 영 | 역 | 사 | 인 | | 장 | 아 | 지 | 단 | | |
|---|---|---|---|---|---|---|---|---|---|---|---|---|---|---|---|---|
| KORAIL<br>KOREA RAILROAD | 한국철도공사 | 2017년도 호남고속선 오송-광주승정간 편크리트캐도 점경영역 | | | | | | (주)한국구조물안전연구원<br>(주)한국도로안전연구원<br>(재)한국건설품질연구원 | 이 | 박 | 영 | 간원강<br>김경기<br>윤석기 | 영 | 0220 (0.3m이하 : 흑색) | 점목도상문리 | |

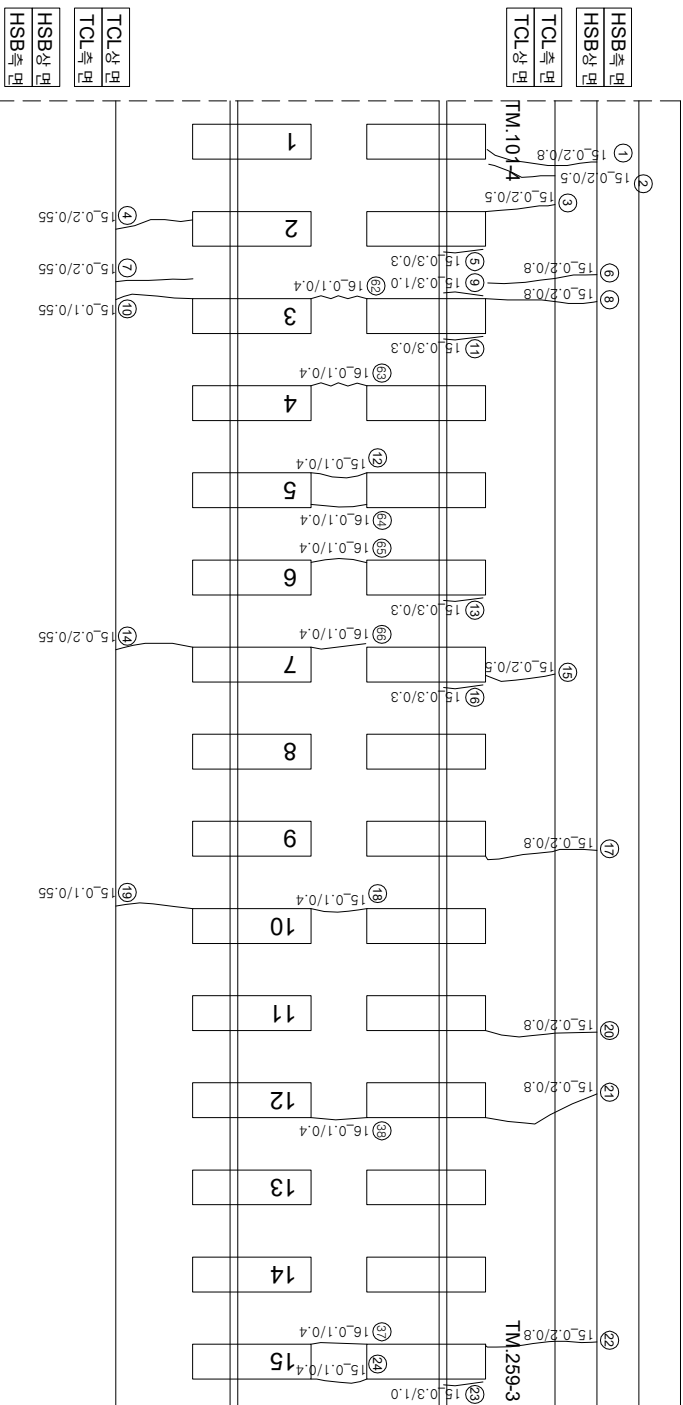
| 연번 | 순상 | 특 | 연장 | 비고 | 연번 | 순상 | 특 | 연장 | 비고 |
|---|---|---|---|---|---|---|---|---|---|
| 1 | 균열 0.2 | mm 0.8 | m | | 56 | 균열 0.2 | mm 0.5 | m | |
| 5 | 균열부 균열 0.3 | mm 0.3 | m | | 60 | 균열 0.1 | mm 0.55 | m | |
| 9 | 균열부 균열 0.3 | mm 1.0 | m | 같이줄가 | 64 | 균열 0.1 | mm 0.4 | m | |
| 23 | 균열부 균열 0.3 | mm 1.0 | m | 같이줄가 | 78 | | | | |
| 28 | 균열 0.2 | mm 1.5 | m | | 83 | | | | |
| 54 | 균열 0.2 | mm 1 | m | | 109 | | | | |
