호남고속선장구교\_p126(49.370~49.377km, S25-5)

| 시행 | 사명 | 영역 | 영역 | 시설 | 구간 | |
|---|---|---|---|---|---|---|
| KORAIL<br>KOREA RAILROAD | 한국철도공사 | 2017년도 호남고속선 오송-광주승강간 콘크리트케도 점검용역 | (주) 한국구조물안전연구원<br>(주) 한국도로안전연구원<br>(재) 한국건설품질연구원 | 이북영<br><br>김원강<br>김경기<br>윤석기 | 0.220 (0.3m이하 : 흑색) | 정문도상판리 |

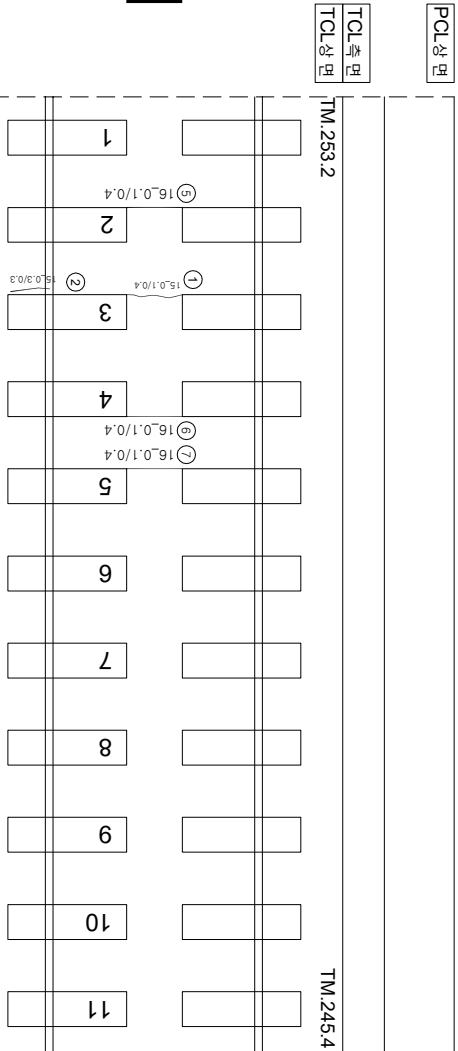
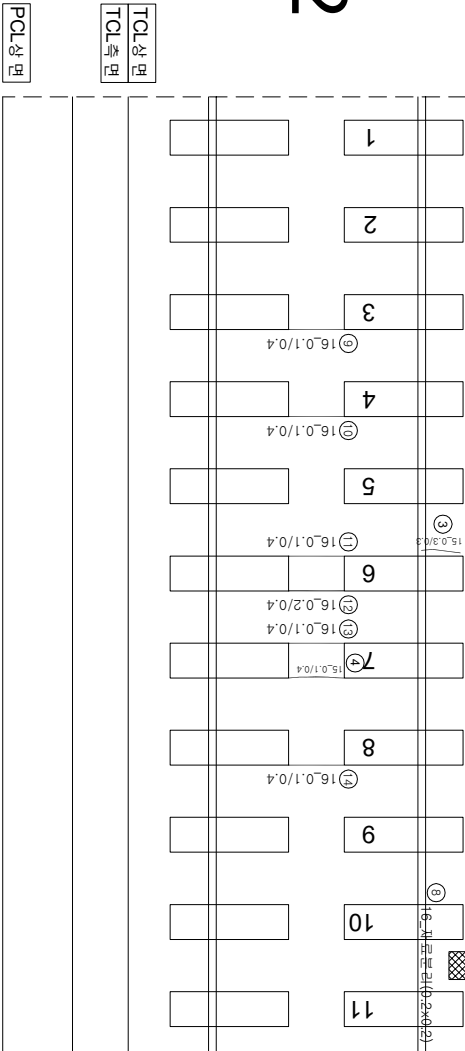
25 SPAN-5

| 연번 | 순상 | 폭 | 연장 | 비고 | 연번 | 순상 | 폭 | 연장 | 비고 |
|---|---|---|---|---|---|---|---|---|---|
| 1 | 균열 | 0.1 mm | 0.4 m | | 55 | | | | |
| 2 | 강제복 균열 | 0.3 mm | 0.3 m | | 56 | | | | |
| 3 | 강제복 균열 | 0.3 mm | 0.3 m | | 57 | | | | |
| 4 | 균열 | 0.1 mm | 0.4 m | | 58 | | | | |
| 5 | 균열 | 0.1 mm | 0.4 m | | 59 | | | | |
| 6 | 균열 | 0.1 mm | 0.4 m | | 60 | | | | |
| 7 | 균열 | 0.1 mm | 0.4 m | | 61 | | | | |
| 8 | 채표 분리 | 0.2 m | 0.2 m | | 62 | | | | |
| 9 | 균열 | 0.1 mm | 0.4 m | | 63 | | | | |
| 10 | 균열 | 0.1 mm | 0.4 m | | 64 | | | | |
| 11 | 균열 | 0.1 mm | 0.4 m | | 65 | | | | |
| 12 | 균열 | 0.2 mm | 0.4 m | | 66 | | | | |
| 13 | 균열 | 0.1 mm | 0.4 m | | 67 | | | | |
| 14 | 균열 | 0.1 mm | 0.4 m | | 68 | | | | |
| 31 | 균열 | | | | 85 | | | | |
| 32 | 균열 | | | | 86 | | | | |
| 33 | 균열 | 0.1 mm | 0.4 m | | 87 | | | | |
| 34 | 균열 | | | | 88 | | | | |
