한남고속선 장구교-137(49.447~49.454km, S28-1)

| 시행사 | 영역 | 영역 | 영역 | 사 | 이부영 | | 구분 | | | |
|---|---|---|---|---|---|---|---|---|---|---|
| KORAIL<br>KOREA RAILROAD<br>한국철도공사 | 2017년도 호남고속선 오송-광주승점간 콘크리트캐드 점검공역 | (주) 한국구조물안전연구원<br>(주) 한국국토안전연구원<br>(재) 한국건설품질연구원 | 이부영 | 김윤강<br>김경기<br>문적기 | 영원 | | 0220 (0.3m이하 : 흑석) | | 재료분리 | |

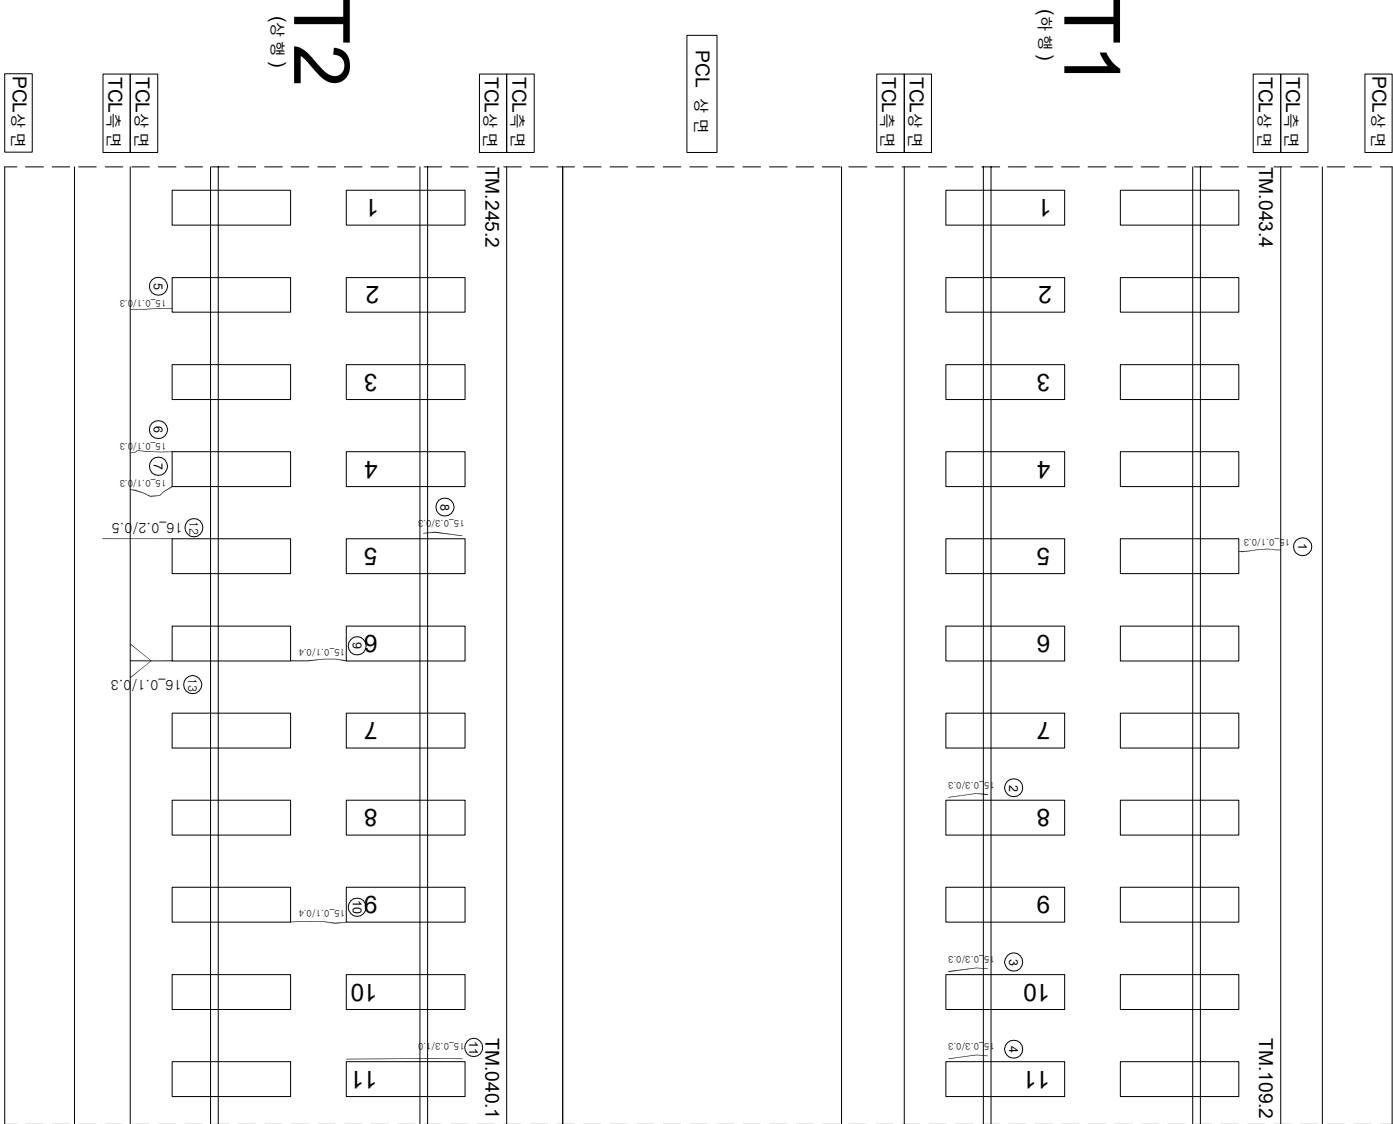
28 SPAN -1

| 연번 | 순상 | 폭 | 연장 | 비고 | 연번 | 순상 | 폭 | 연장 | 비고 |
|---|---|---|---|---|---|---|---|---|---|
| 1 | 균열 | 0.1 mm | 0.3 m | | 55 | | | | |
| 2 | 강재부 균열 | 0.3 mm | 0.3 m | | 56 | | | | |
| 3 | 강재부 균열 | 0.3 mm | 0.3 m | | 57 | | | | |
| 4 | 강재부 균열 | 0.3 mm | 0.3 m | | 58 | | | | |
| 5 | 균열 | 0.1 mm | 0.3 m | | 59 | | | | |
| 6 | 균열 | 0.1 mm | 0.3 m | | 60 | | | | |
| 7 | 균열 | 0.1 mm | 0.3 m | | 61 | | | | |
| 8 | 강재부 균열 | 0.3 mm | 0.3 m | | 62 | | | | |
| 9 | 균열 | 0.1 mm | 0.4 m | | 63 | | | | |
| 10 | 균열 | 0.1 mm | 0.4 m | | 64 | | | | |
| 11 | 강재부 균열 | 0.3 mm | 1.0 m | 같이줄기 | 65 | | | | |
| 12 | 균열 | 0.2 mm | 0.5 m | | 66 | | | | |
| 13 | 균열 | 0.1 mm | 0.3 m | | 67 | | | | |
