화남고속선장구교-175(49.713~49.720km, S35-4)

49K720  
35 SPAN - 4

| 시 | 행 사 | 영 역 | 영 역 | 영역 | 사 | 이 부 영 | | 구 분 | |
|---|---|---|---|---|---|---|---|---|---|
| KORAIL<br>KOREA RAILROAD | 한국철도공사 | 2017년도 호남고속선 오송-광주승정간 콘크리트캐드 점검공역 | (주) 한국구조물안전연구원<br>(주) 한국국토안전연구원<br>(재) 한국건설품질연구원 | 이 부 영 | 김 운 강<br>김 경 기<br>문 석 기 | 구 분 | 0220 (0.3m이하 : 철석) | 점목도상판리 | 재료판리 |

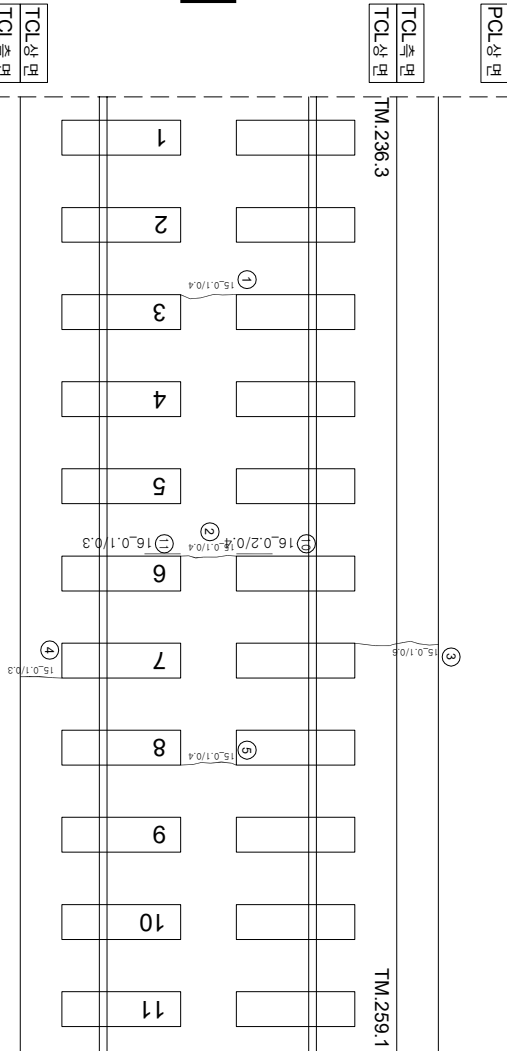
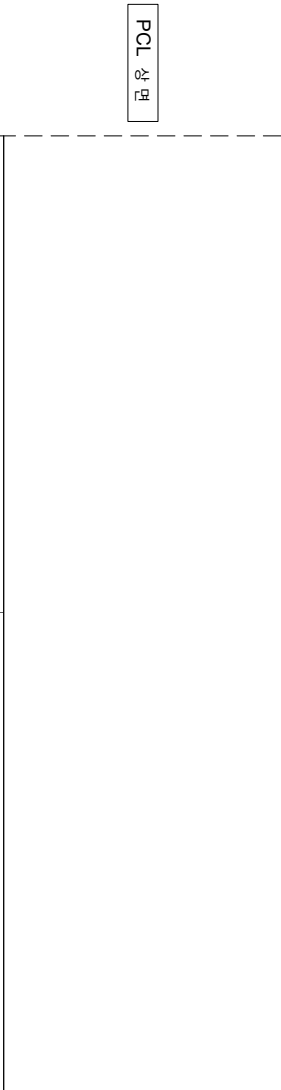
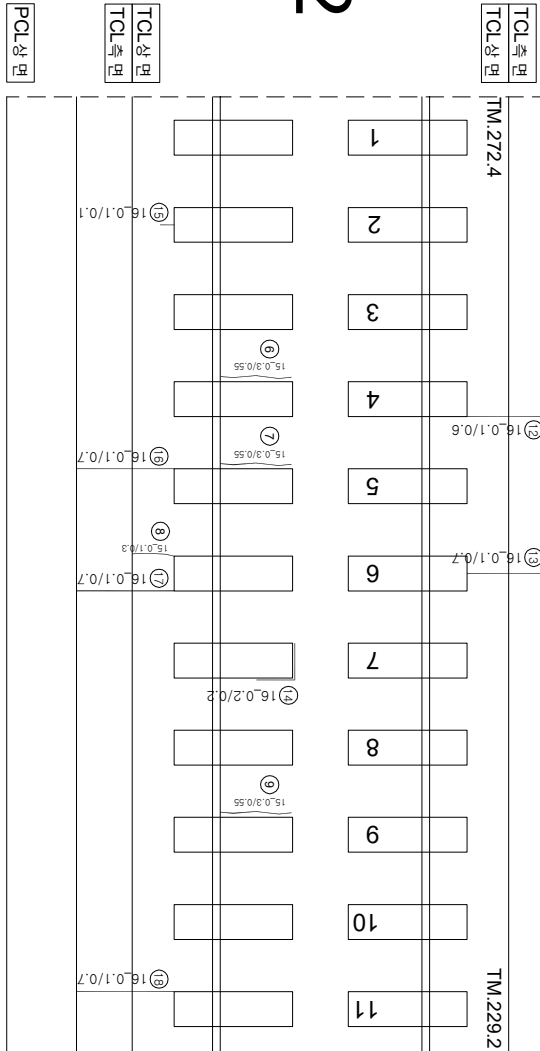
| 연번 | 순상 | 폭 | 연장 | 비고 | 연번 | 순상 | 폭 | 연장 | 비고 |
|---|---|---|---|---|---|---|---|---|---|
| 1 | 균열 | 0.1 mm | 0.4 m | | 55 | | | | |
| 2 | 균열 | 0.1 mm | 0.75 m | | 56 | | | | |
| 3 | 균열 | 0.1 mm | 0.3 m | | 57 | | | | |
| 4 | 균열 | 0.1 mm | 0.3 m | | 58 | | | | |
| 5 | 균열 | 0.1 mm | 0.4 m | | 59 | | | | |
| 6 | 경색부 균열 | 0.1 mm | 0.75 m | | 60 | | | | |
| 7 | 경색부 균열 | 0.1 mm | 0.7 m | | 61 | | | | |
| 8 | 균열 | 0.1 mm | 0.3 m | | 62 | | | | |
| 9 | 경색부 균열 | 0.3 mm | 0.3 m | | 63 | | | | |
| 10 | 경색부 균열 | 0.2 mm | 0.4 m | | 64 | | | | |
| 11 | 경색부 균열 | 0.1 mm | 0.3 m | | 65 | | | | |
| 12 | 균열 | 0.1 mm | 0.6 m | | 66 | | | | |
| 13 | 균열 | 0.1 mm | 0.7 m | | 67 | | | | |
| 14 | 경색부 균열 | 0.2 mm | 0.2 m | | 68 | | | | |
| 15 | 균열 | 0.1 mm | 0.1 m | | 69 | | | | |
| 16 | 균열 | 0.1 mm | 0.7 m | | 70 | | | | |
| 17 | 균열 | 0.1 mm | 0.7 m | | 71 | | | | |
| 18 | 균열 | 0.1 mm | 0.7 m | | 72 | | | | |
