# 호남고속선 장구교\_177(49.727~49.734km, S36-1)

P35  
49K727

49K734

36 SPAN - 1

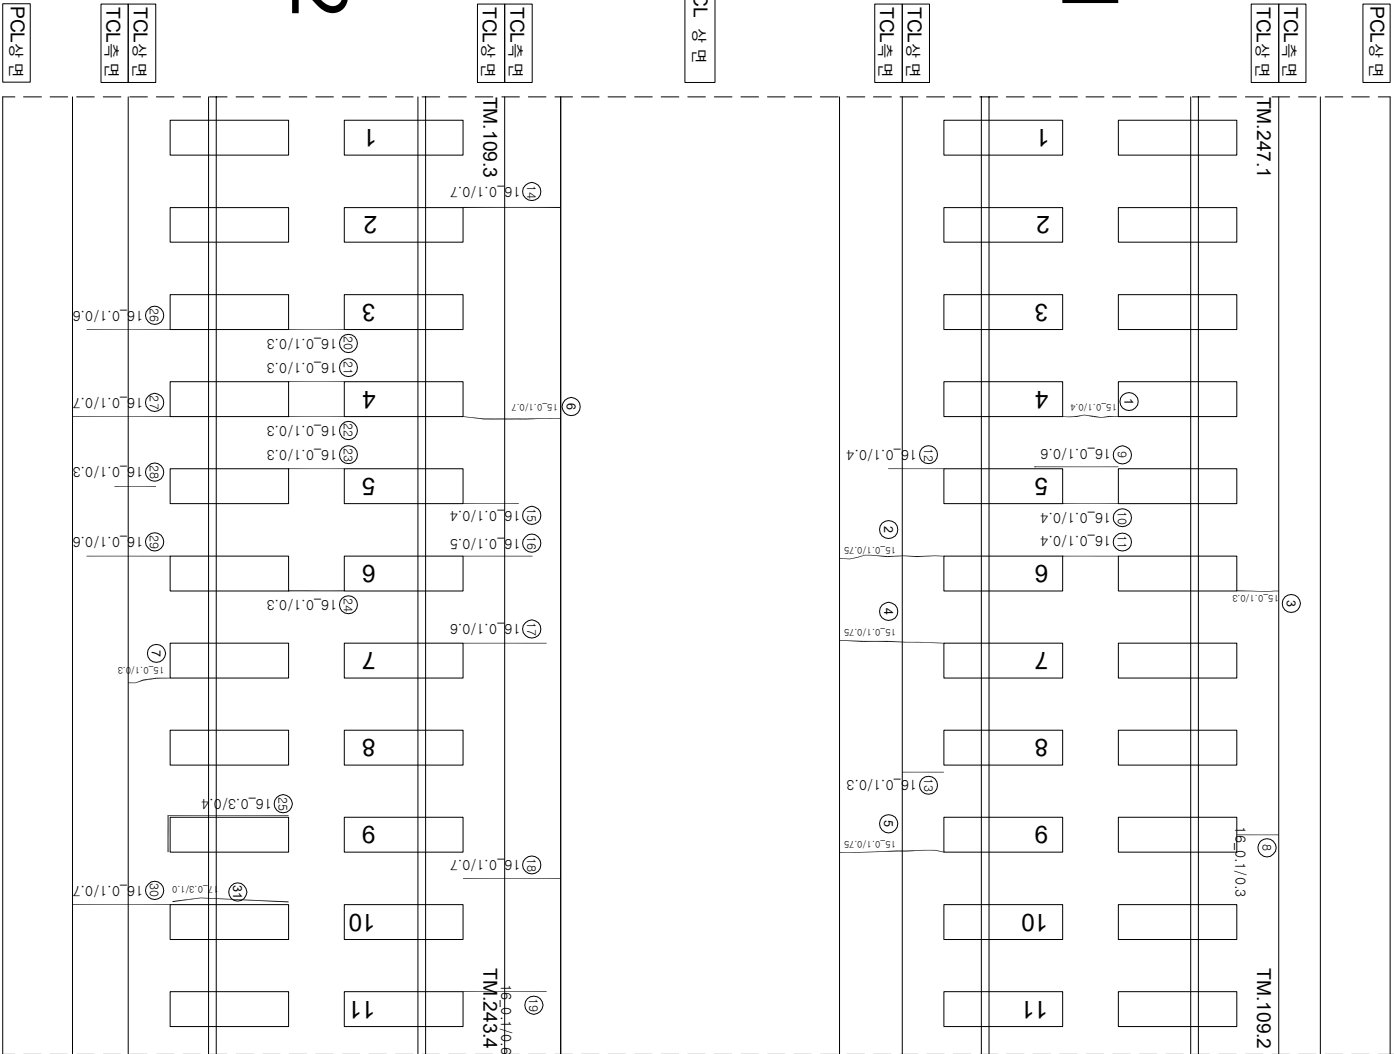
| 연번 | 순상 | 폭 | 연장 | 비고 | 연번 | 순상 | 폭 | 연장 | 비고 |
|---|---|---|---|---|---|---|---|---|---|
| 1 | 균열 | 0.1 mm | 0.4 m | | 55 | | | | |
| 2 | 균열 | 0.1 mm | 0.75 m | | 56 | | | | |
| 3 | 균열 | 0.1 mm | 0.3 m | | 57 | | | | |
| 4 | 균열 | 0.1 mm | 0.75 m | | 58 | | | | |
| 5 | 균열 | 0.1 mm | 0.75 m | | 59 | | | | |
| 6 | 균열 | 0.1 mm | 0.7 m | | 60 | | | | |
| 7 | 균열 | 0.1 mm | 0.3 m | | 61 | | | | |
| 8 | 균열 | 0.1 mm | 0.3 m | | 62 | | | | |
| 9 | 경계부 균열 | 0.1 mm | 0.6 m | | 63 | | | | |
| 10 | 균열 | 0.1 mm | 0.4 m | | 64 | | | | |
| 11 | 균열 | 0.1 mm | 0.4 m | | 65 | | | | |
| 12 | 균열 | 0.1 mm | 0.4 m | | 66 | | | | |
| 13 | 균열 | 0.1 mm | 0.3 m | | 67 | | | | |
| 14 | 균열 | 0.1 mm | 0.7 m | | 68 | | | | |
| 15 | 균열 | 0.1 mm | 0.4 m | | 69 | | | | |
| 16 | 균열 | 0.1 mm | 0.5 m | | 70 | | | | |
| 17 | 균열 | 0.1 mm | 0.6 m | | 71 | | | | |
| 18 | 균열 | 0.1 mm | 0.7 m | | 72 | | | | |
| 19 | 균열 | 0.1 mm | 0.6 m | | 73 | | | | |
| 20 | 균열 | 0.1 mm | 0.3 m | | 74 | | | | |
| 21 | 균열 | 0.1 mm | 0.3 m | | 75 | | | | |
| 22 | 균열 | 0.1 mm | 0.3 m | | 76 | | | | |
| 23 | 균열 | 0.1 mm | 0.3 m | | 77 | | | | |
| 24 | 균열 | 0.1 mm | 0.3 m | | 78 | | | | |
| 25 | 경계부 균열 | 0.3 mm | 0.4 m | | 79 | | | | |
| 26 | 균열 | 0.1 mm | 0.6 m | | 80 | | | | |
| 27 | 균열 | 0.1 mm | 0.7 m | | 81 | | | | |
| 28 | 균열 | 0.1 mm | 0.3 m | | 82 | | | | |
| 29 | 균열 | 0.1 mm | 0.6 m | | 83 | | | | |
| 30 | 균열 | 0.1 mm | 0.7 m | | 84 | | | | |
| 31 | 경계부 균열 | 0.3 mm | 1.0 m | 신구 | 85 | | | | |
