장구교\_토공노반\_104(51.350~51.360km, L=10m)

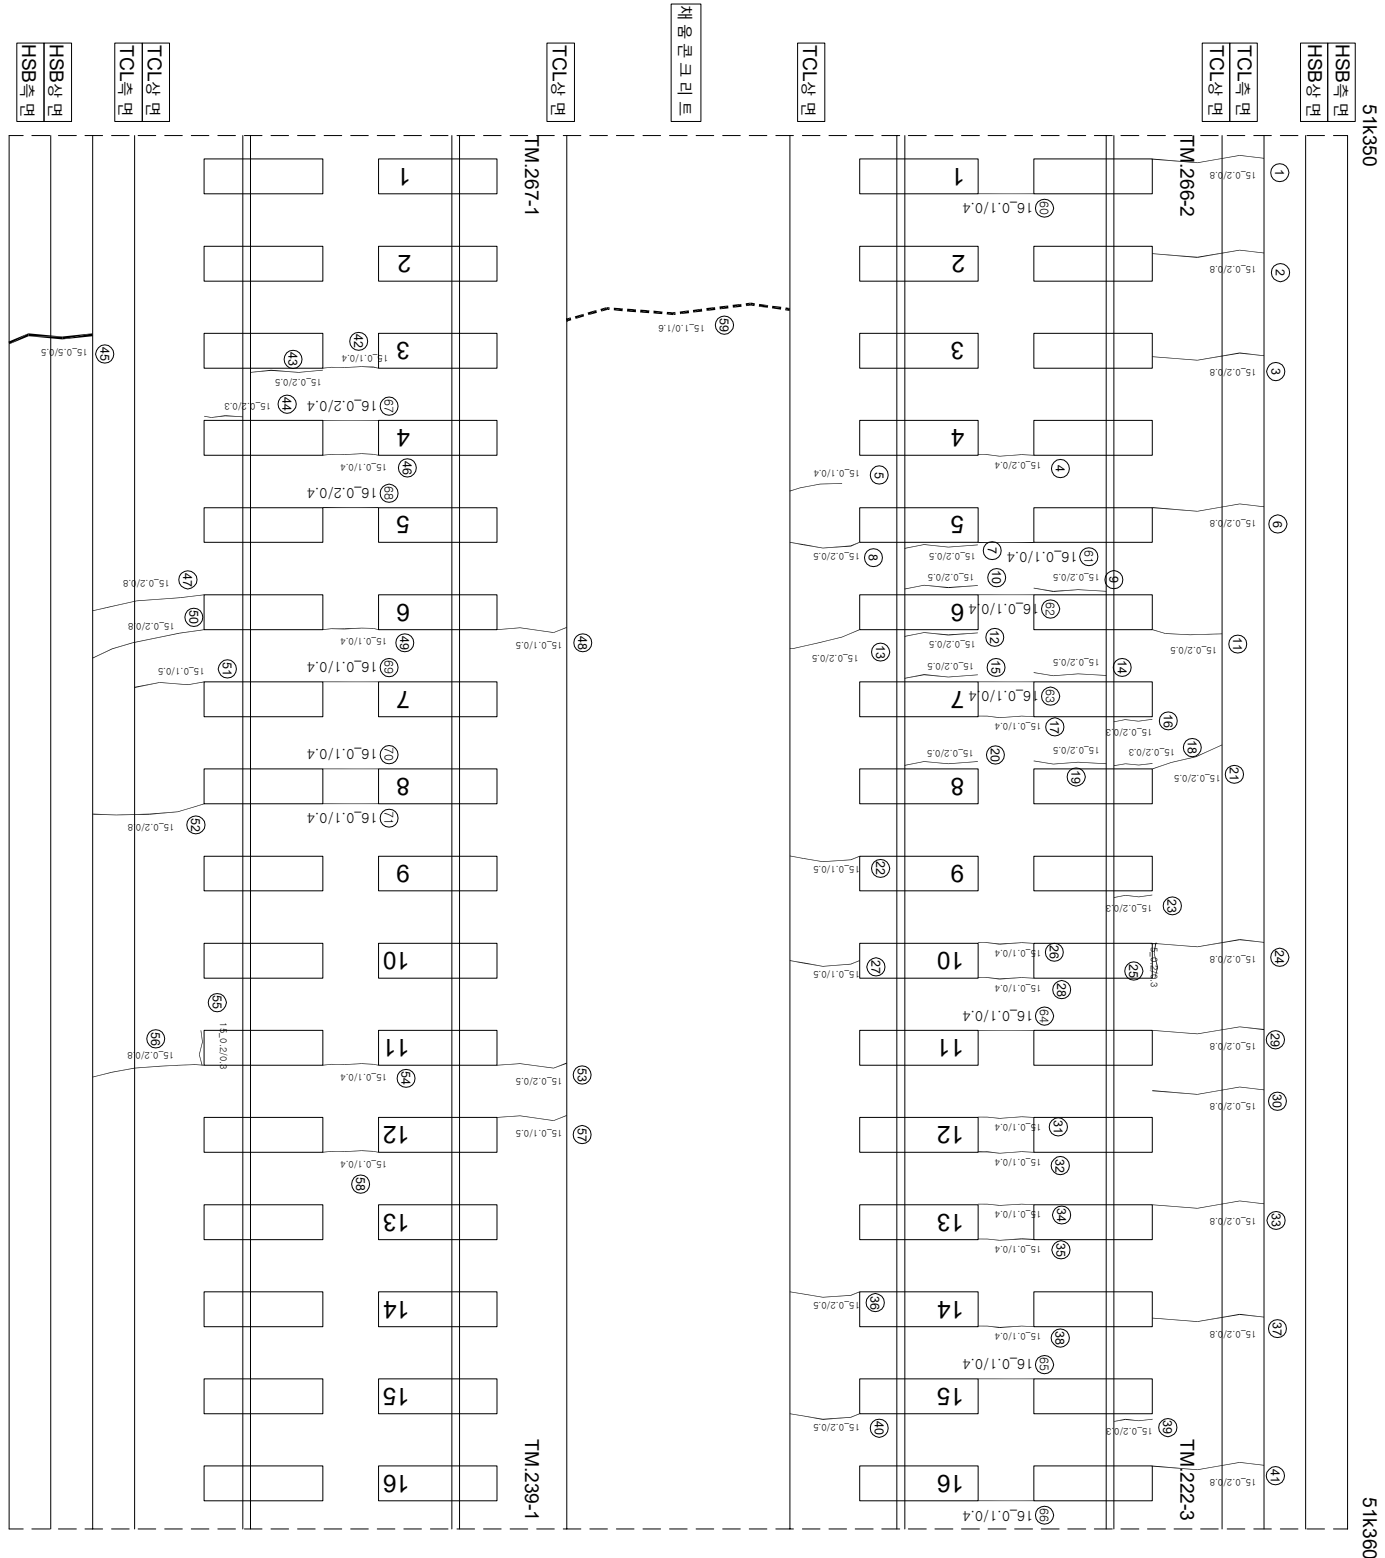
| 연번 | 순상 | 폭 | 연장 | 비고 | 연번 | 순상 | 폭 | 연장 | 비고 |
|---|---|---|---|---|---|---|---|---|---|
| 1 | 균열 | 0.2 mm | 0.8 m | | 55 | 경계부 균열 | 0.2 mm | 0.3 m | |
| 2 | 균열 | 0.2 mm | 0.8 m | | 56 | 균열 | 0.2 mm | 0.8 m | |
| 3 | 균열 | 0.2 mm | 0.8 m | | 57 | 균열 | 0.1 mm | 0.5 m | |
| 4 | 균열 | 0.2 mm | 0.4 m | | 58 | 균열 | 0.1 mm | 0.4 m | |
| 5 | 균열 | 0.1 mm | 0.4 m | | 59 | 균열 | 1.0 mm | 1.6 m | |
| 6 | 균열 | 0.2 mm | 0.8 m | | 60 | 균열 | 0.1 mm | 0.4 m | |
| 7 | 경계부 균열 | 0.2 mm | 0.5 m | | 61 | 균열 | 0.1 mm | 0.4 m | |
| 8 | 균열 | 0.2 mm | 0.5 m | | 62 | 균열 | 0.1 mm | 0.4 m | |
| 9 | 경계부 균열 | 0.2 mm | 0.5 m | | 63 | 균열 | 0.1 mm | 0.4 m | |
| 10 | 경계부 균열 | 0.2 mm | 0.5 m | | 64 | 균열 | 0.1 mm | 0.4 m | |
| 11 | 균열 | 0.2 mm | 0.5 m | | 65 | 균열 | 0.1 mm | 0.4 m | |
| 12 | 경계부 균열 | 0.2 mm | 0.5 m | | 66 | 균열 | 0.1 mm | 0.4 m | |
| 13 | 균열 | 0.2 mm | 0.5 m | | 67 | 균열 | 0.2 mm | 0.4 m | |
| 14 | 경계부 균열 | 0.2 mm | 0.5 m | | 68 | 균열 | 0.2 mm | 0.4 m | |
| 15 | 경계부 균열 | 0.2 mm | 0.5 m | | 69 | 균열 | 0.1 mm | 0.4 m | |
| 16 | 경계부 균열 | 0.2 mm | 0.3 m | | 70 | 균열 | 0.1 mm | 0.4 m | |
| 17 | 균열 | 0.1 mm | 0.4 m | | 71 | 균열 | 0.1 mm | 0.4 m | |
| 18 | 경계부 균열 | 0.2 mm | 0.3 m | | 72 | | | | |
| 19 | 경계부 균열 | 0.2 mm | 0.5 m | | 73 | | | | |
| 20 | 경계부 균열 | 0.2 mm | 0.5 m | | 74 | | | | |
| 21 | 균열 | 0.2 mm | 0.5 m | | 75 | | | | |
| 22 | 균열 | 0.1 mm | 0.5 m | | 76 | | | | |
| 23 | 경계부 균열 | 0.2 mm | 0.3 m | | 77 | | | | |
| 24 | 균열 | 0.2 mm | 0.8 m | | 78 | | | | |
| 25 | 경계부 균열 | 0.2 mm | 0.3 m | | 79 | | | | |
| 26 | 균열 | 0.1 mm | 0.4 m | | 80 | | | | |
| 27 | 균열 | 0.1 mm | 0.5 m | | 81 | | | | |
| 28 | 균열 | 0.1 mm | 0.4 m | | 82 | | | | |
| 29 | 균열 | 0.2 mm | 0.8 m | | 83 | | | | |
| 30 | 균열 | 0.2 mm | 0.8 m | | 84 | | | | |
| 31 | 균열 | 0.1 mm | 0.4 m | | 85 | | | | |
| 32 | 균열 | 0.1 mm | 0.4 m | | 86 | | | | |
| 33 | 균열 | 0.2 mm | 0.8 m | | 87 | | | | |
| 34 | 균열 | 0.1 mm | 0.4 m | | 88 | | | | |
| 35 | 균열 | 0.1 mm | 0.4 m | | 89 | | | | |
| 36 | 균열 | 0.2 mm | 0.5 m | | 90 | | | | |
| 37 | 균열 | 0.2 mm | 0.8 m | | 91 | | | | |
| 38 | 균열 | 0.1 mm | 0.4 m | | 92 | | | | |
| 39 | 경계부 균열 | 0.2 mm | 0.3 m | | 93 | | | | |
| 40 | 균열 | 0.2 mm | 0.5 m | | 94 | | | | |
| 41 | 균열 | 0.2 mm | 0.8 m | | 95 | | | | |
| 42 | 균열 | 0.1 mm | 0.4 m | | 96 | | | | |
| 43 | 경계부 균열 | 0.2 mm | 0.5 m | | 97 | | | | |
| 44 | 경계부 균열 | 0.2 mm | 0.3 m | | 98 | | | | |
| 45 | 균열 | 0.5 mm | 0.5 m | | 99 | | | | |
| 46 | 균열 | 0.1 mm | 0.4 m | | 100 | | | | |
| 47 | 균열 | 0.2 mm | 0.8 m | | 101 | | | | |
| 48 | 균열 | 0.1 mm | 0.5 m | | 102 | | | | |
| 49 | 균열 | 0.1 mm | 0.4 m | | 103 | | | | |
| 50 | 균열 | 0.2 mm | 0.8 m | | 104 | | | | |
| 51 | 균열 | 0.1 mm | 0.5 m | | 105 | | | | |
| 52 | 균열 | 0.2 mm | 0.8 m | | 106 | | | | |
| 53 | 균열 | 0.2 mm | 0.5 m | | 107 | | | | |
| 54 | 균열 | 0.1 mm | 0.4 m | | 108 | | | | |
