한남고속선 오강교 - 토아노반 - 13(51.880~51.890km, L=10m)

| 시 | 행 사 | 영 역 | 영 역 | 영 역 | 사 | 과 | | 장 | 아 | 지 | 단 | | |
|---|---|---|---|---|---|---|---|---|---|---|---|---|---|
| KORAIL<br>KOREA RAILROAD | 한국철도공사 | 2017년도 호남고속선 | 오송-광주승정간 콘크리트케도 점검공역 | (주) 한국구조물안전연구원<br>(주) 한국국토안전연구원<br>(재) 한국건설품질연구원 | 이 복 영 | 김 원 강<br>김 경 기<br>문 은 석 | 영 연 | | 0220 (0.3mm이하 : 흑색) | | 한목도상판리 | | 재료분리 |

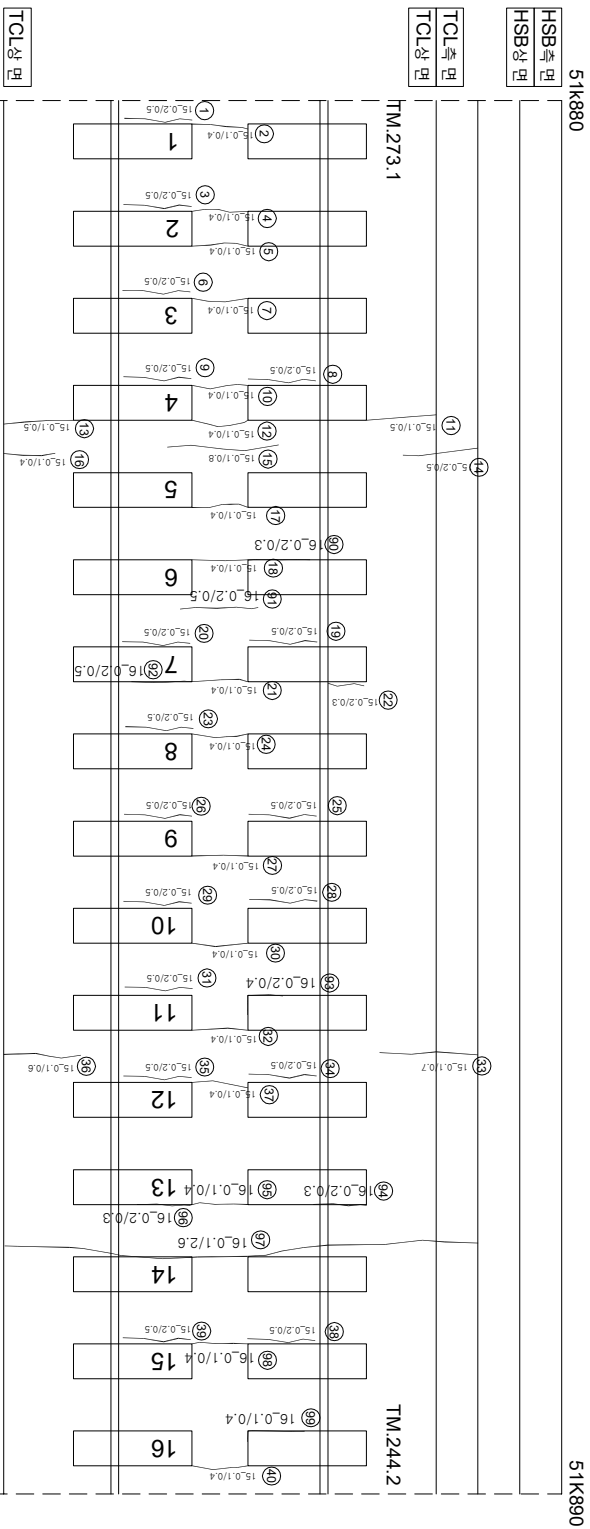
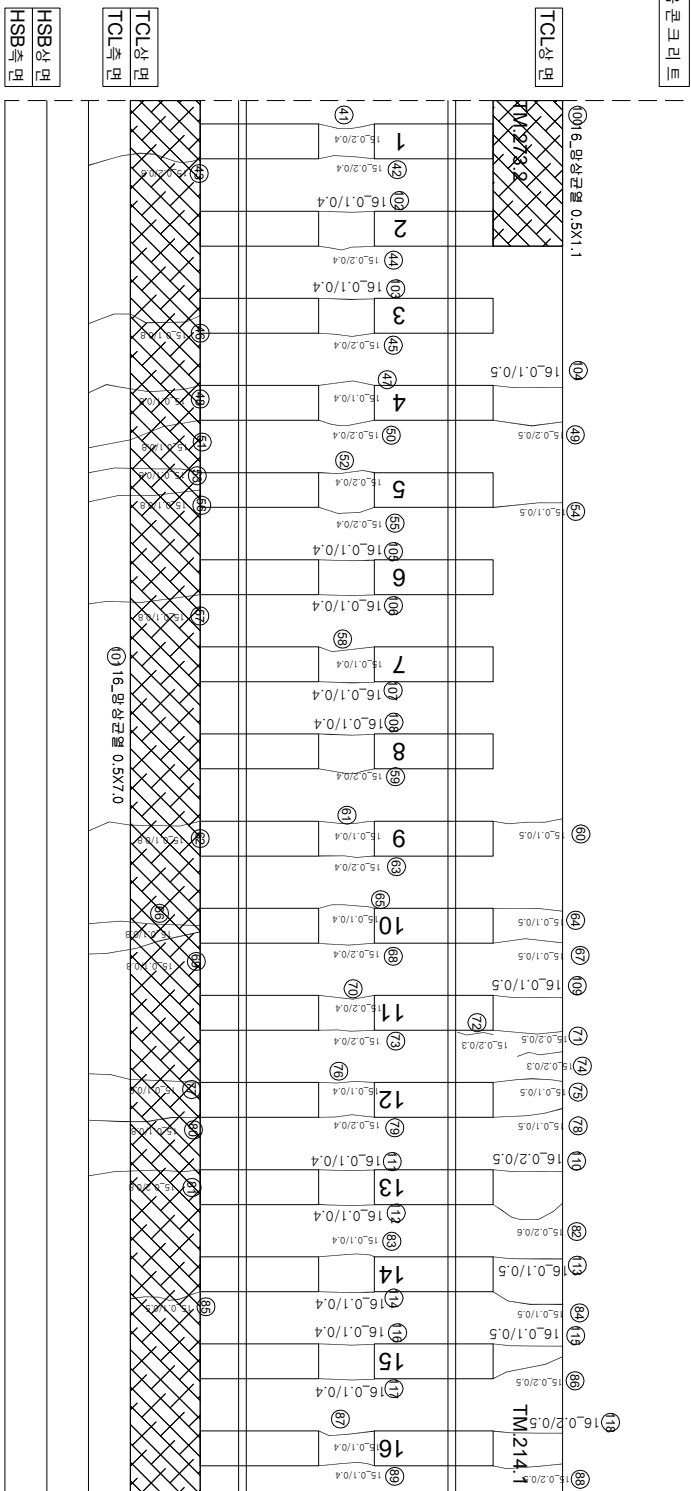
**T2**  
**(0<sub>+</sub>, 0<sub>max</sub>)**

| 연번 | 순상 | 목 | 연장 | 비고 | 연번 | 순상 | 목 | 연장 | 비고 |
|---|---|---|---|---|---|---|---|---|---|
| 1 | 강제부 균열 | 0.2 mm | 0.5 m | | 64 | 균열 | 0.2 mm | 0.4 m | |
| 2 | 균열 | 0.1 mm | 0.4 m | | 65 | 균열 | 0.1 mm | 0.5 m | |
| 3 | 강제부 균열 | 0.2 mm | 0.5 m | | 66 | 균열 | 0.1 mm | 0.4 m | |
| 4 | 균열 | 0.1 mm | 0.4 m | | 67 | 균열 | 0.1 mm | 0.8 m | |
| 5 | 강제부 균열 | 0.2 mm | 0.5 m | | 68 | 균열 | 0.2 mm | 0.5 m | |
| 6 | 강제부 균열 | 0.2 mm | 0.5 m | | 69 | 균열 | 0.1 mm | 0.8 m | |
| 7 | 균열 | 0.1 mm | 0.4 m | | 70 | 균열 | 0.2 mm | 0.4 m | |
| 8 | 강제부 균열 | 0.2 mm | 0.5 m | | 71 | 균열 | 0.2 mm | 0.5 m | |
| 9 | 강제부 균열 | 0.2 mm | 0.5 m | | 72 | 강제부 균열 | 0.2 mm | 0.3 m | |
| 10 | 균열 | 0.1 mm | 0.4 m | | 73 | 균열 | 0.2 mm | 0.4 m | |
| 11 | 균열 | 0.1 mm | 0.5 m | | 74 | 균열 | 0.2 mm | 0.3 m | |
| 12 | 균열 | 0.1 mm | 0.4 m | | 75 | 균열 | 0.1 mm | 0.5 m | |
| 13 | 균열 | 0.1 mm | 0.5 m | | 76 | 균열 | 0.1 mm | 0.4 m | |
| 14 | 균열 | 0.2 mm | 0.5 m | | 77 | 균열 | 0.1 mm | 0.8 m | |
| 15 | 균열 | 0.1 mm | 0.8 m | | 78 | 균열 | 0.1 mm | 0.5 m | |
| 16 | 균열 | 0.1 mm | 0.4 m | | 79 | 균열 | 0.2 mm | 0.4 m | |
| 17 | 균열 | 0.1 mm | 0.4 m | | 80 | 균열 | 0.1 mm | 0.8 m | |
| 18 | 균열 | 0.1 mm | 0.4 m | | 81 | 균열 | 0.2 mm | 0.8 m | |
| 19 | 강제부 균열 | 0.2 mm | 0.5 m | | 82 | 균열 | 0.2 mm | 0.6 m | |
| 20 | 강제부 균열 | 0.2 mm | 0.5 m | | 83 | 균열 | 0.1 mm | 0.4 m | |
| 21 | 균열 | 0.1 mm | 0.4 m | | 84 | 균열 | 0.1 mm | 0.5 m | |
| 22 | 강제부 균열 | 0.2 mm | 0.3 m | | 85 | 균열 | 0.1 mm | 0.5 m | |
| 23 | 강제부 균열 | 0.2 mm | 0.5 m | | 86 | 균열 | 0.2 mm | 0.5 m | |
| 24 | 균열 | 0.1 mm | 0.4 m | | 87 | 균열 | 0.1 mm | 0.4 m | |
| 25 | 강제부 균열 | 0.2 mm | 0.5 m | | 88 | 균열 | 0.2 mm | 0.5 m | |
| 26 | 강제부 균열 | 0.2 mm | 0.5 m | | 89 | 균열 | 0.1 mm | 0.4 m | |
| 27 | 균열 | 0.1 mm | 0.4 m | | 90 | 강제부 균열 | 0.2 mm | 0.3 m | |
| 28 | 강제부 균열 | 0.2 mm | 0.5 m | | 91 | 균열 | 0.2 mm | 0.5 m | |
| 29 | 강제부 균열 | 0.2 mm | 0.5 m | | 92 | 강제부 균열 | 0.2 mm | 0.5 m | |
| 30 | 균열 | 0.1 mm | 0.4 m | | 93 | 강제부 균열 | 0.2 mm | 0.4 m | |
| 31 | 강제부 균열 | 0.2 mm | 0.5 m | | 94 | 강제부 균열 | 0.1 mm | 0.4 m | |
| 32 | 균열 | 0.1 mm | 0.4 m | | 95 | 균열 | 0.1 mm | 0.4 m | |
| 33 | 균열 | 0.1 mm | 0.7 m | | 96 | 강제부 균열 | 0.2 mm | 0.3 m | |
| 34 | 강제부 균열 | 0.2 mm | 0.5 m | | 97 | 균열 | 0.1 mm | 2.6 m | |
| 35 | 강제부 균열 | 0.2 mm | 0.5 m | | 98 | 균열 | 0.1 mm | 0.4 m | |
| 36 | 균열 | 0.1 mm | 0.6 m | | 99 | 강제부 균열 | 0.1 mm | 0.4 m | |
| 37 | 균열 | 0.1 mm | 0.4 m | | 100 | 형상 균열 | 0.5 m | 1.1 m | |
| 38 | 강제부 균열 | 0.2 mm | 0.5 m | | 101 | 형상 균열 | 0.5 m | 7.0 m | |
| 39 | 강제부 균열 | 0.2 mm | 0.5 m | | 102 | 균열 | 0.1 mm | 0.4 m | |
| 40 | 균열 | 0.1 mm | 0.4 m | | 103 | 균열 | 0.1 mm | 0.4 m | |
| 41 | 균열 | 0.2 mm | 0.4 m | | 104 | 균열 | 0.1 mm | 0.5 m | |
| 42 | 균열 | 0.2 mm | 0.4 m | | 105 | 균열 | 0.1 mm | 0.4 m | |
| 43 | 균열 | 0.2 mm | 0.8 m | | 106 | 균열 | 0.1 mm | 0.4 m | |
| 44 | 균열 | 0.2 mm | 0.4 m | | 107 | 균열 | 0.1 mm | 0.4 m | |
| 45 | 균열 | 0.2 mm | 0.8 m | | 108 | 균열 | 0.1 mm | 0.4 m | |
| 46 | 균열 | 0.1 mm | 0.4 m | | 109 | 균열 | 0.1 mm | 0.5 m | |
| 47 | 균열 | 0.1 mm | 0.4 m | | 110 | 균열 | 0.2 mm | 0.5 m | |
| 48 | 균열 | 0.1 mm | 0.8 m | | 111 | 균열 | 0.1 mm | 0.4 m | |
| 49 | 균열 | 0.2 mm | 0.5 m | | 112 | 균열 | 0.1 mm | 0.4 m | |
| 50 | 균열 | 0.2 mm | 0.4 m | | 113 | 균열 | 0.1 mm | 0.5 m | |
| 51 | 균열 | 0.1 mm | 0.8 m | | 114 | 균열 | 0.1 mm | 0.4 m | |
| 52 | 균열 | 0.2 mm | 0.8 m | | 115 | 균열 | 0.1 mm | 0.5 m | |
| 53 | 균열 | 0.1 mm | 0.8 m | | 116 | 균열 | 0.1 mm | 0.4 m | |
| 54 | 균열 | 0.1 mm | 0.5 m | | 117 | 균열 | 0.1 mm | 0.4 m | |
| 55 | 균열 | 0.2 mm | 0.4 m | | 118 | 균열 | 0.2 mm | 0.5 m | |
| 56 | 균열 | 0.1 mm | 0.8 m | | | | | | |
| 57 | 균열 | 0.1 mm | 0.8 m | | | | | | |
| 58 | 균열 | 0.1 mm | 0.4 m | | | | | | |
| 59 | 균열 | 0.2 mm | 0.4 m | | | | | | |
| 60 | 균열 | 0.1 mm | 0.5 m | | | | | | |
| 61 | 균열 | 0.1 mm | 0.4 m | | | | | | |
| 62 | 균열 | 0.1 mm | 0.8 m | | | | | | |
