화남고속선 신당교 - 109 (52.750~52.757km, S22-1)

| 시 | 행 | 사 | 종 | 역 | 명 | 종 | 역 | 사 | 간 | | | | |
|---|---|---|---|---|---|---|---|---|---|---|---|---|---|
| KORAIL<br>KOREA RAILROAD | | 한국철도공사 | 2017년도 | 후남고속선 | 오송-광주승강장 | 판곡리트캐드 | 점검용역 | (주) 한국구조물안전연구원<br>(주) 한국도로안전연구원<br>(제) 한국건설품질연구원 | 이북영 | 각 안 강<br>김 경 기<br>윤 석 기 | 평면 | | |

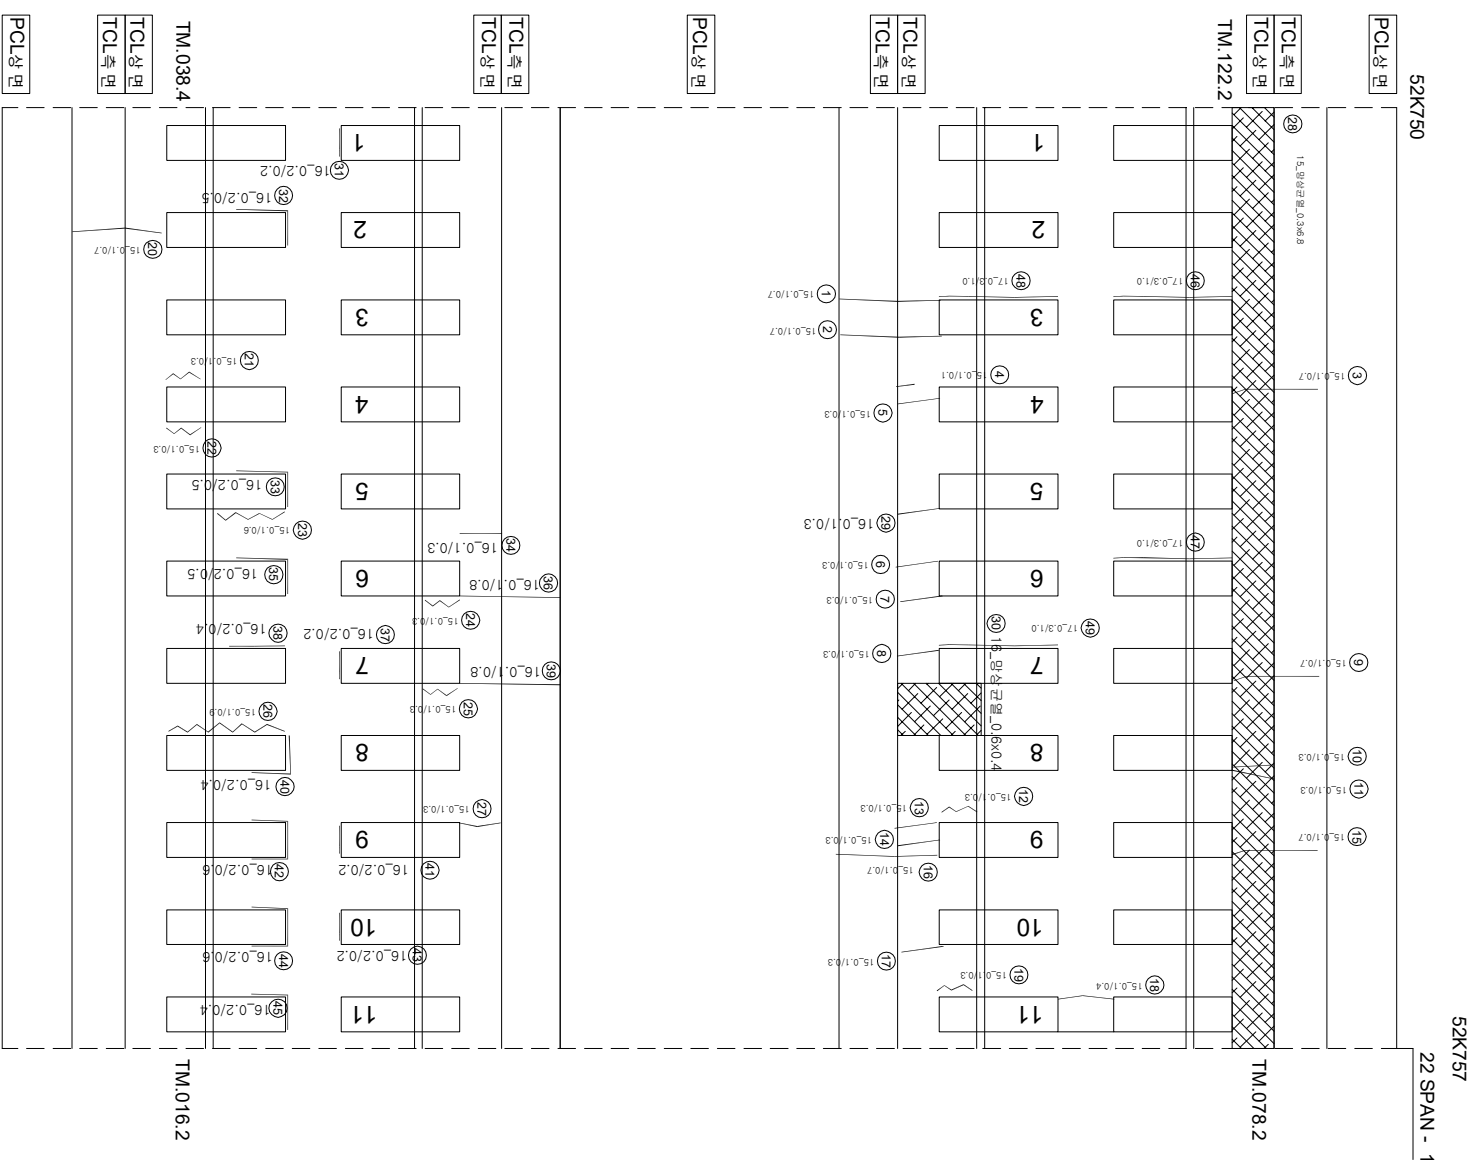
| 연번 | 순상 | 폭 | 연청 | 비고 | 연번 | 순상 | 폭 | 연청 | 비고 |
|---|---|---|---|---|---|---|---|---|---|
| 1 | 균열 | 0.1 mm | 0.7 m | | 55 | | | | |
| 28 | 균열 | 0.3 mm | 6.8 m | | 82 | | | | |
| 30 | 균열 | 0.6 mm | 0.4 m | | 84 | | | | |
| 46 | 균열 | 0.3 mm | 1.0 m | 신규 | 100 | | | | |
| 47 | 균열 | 0.3 mm | 1.0 m | 신규 | 101 | | | | |
| 48 | 균열 | 0.3 mm | 1.0 m | 신규 | 102 | | | | |
| 49 | 균열 | 0.3 mm | 1.0 m | 신규 | 103 | | | | |
