호남고속선 정지고가\_88(57.500~57.507km, S14-1)

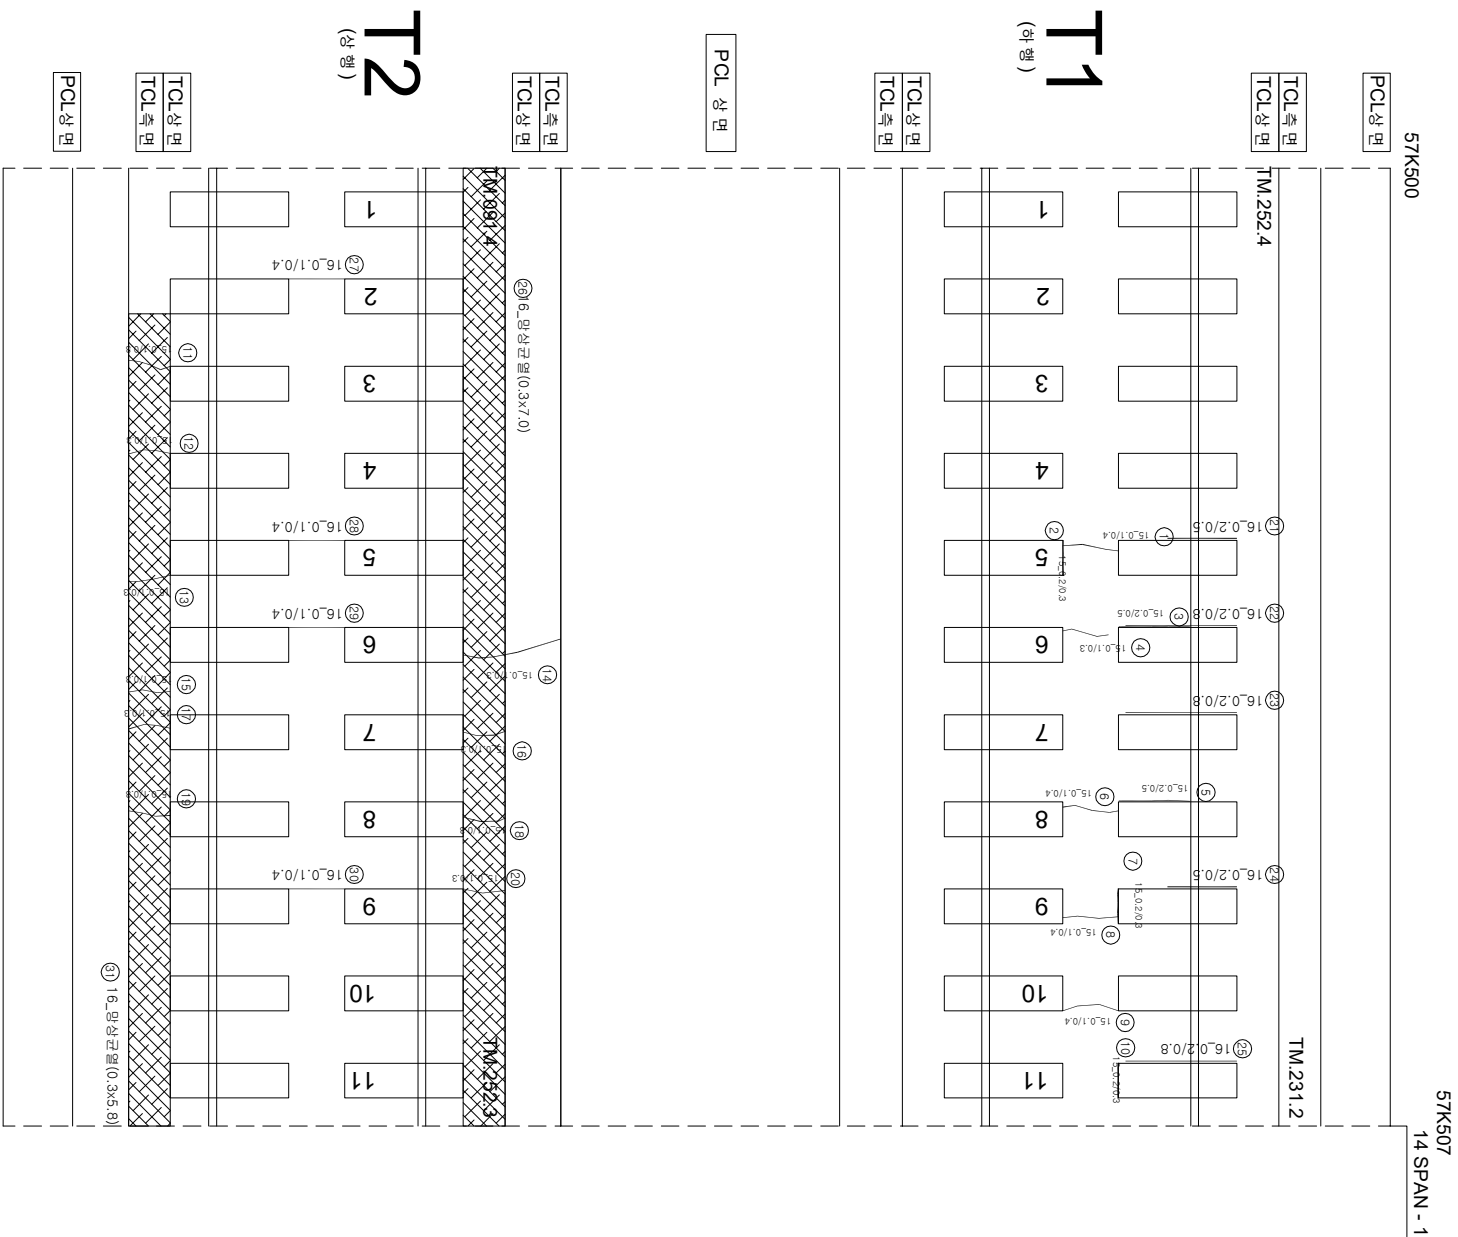
| 연번 | 순상 | 폭 | 연장 | 비고 | 연번 | 순상 | 폭 | 연장 | 비고 |
|---|---|---|---|---|---|---|---|---|---|
| 1 | 균열 | 0.1 mm | 0.4 m | | 55 | | | | |
| 2 | 강재부 균열 | 0.2 mm | 0.3 m | | 56 | | | | |
| 3 | 강재부 균열 | 0.2 mm | 0.5 m | | 57 | | | | |
| 4 | 균열 | 0.1 mm | 0.3 m | | 58 | | | | |
| 5 | 강재부 균열 | 0.2 mm | 0.5 m | | 59 | | | | |
| 6 | 균열 | 0.1 mm | 0.4 m | | 60 | | | | |
| 7 | 강재부 균열 | 0.2 mm | 0.3 m | | 61 | | | | |
| 8 | 균열 | 0.1 mm | 0.4 m | | 62 | | | | |
| 9 | 균열 | 0.1 mm | 0.4 m | | 63 | | | | |
| 10 | 강재부 균열 | 0.2 mm | 0.3 m | | 64 | | | | |
| 11 | 균열 | 0.1 mm | 0.3 m | | 65 | | | | |
| 12 | 균열 | 0.1 mm | 0.3 m | | 66 | | | | |
| 13 | 균열 | 0.1 mm | 0.3 m | | 67 | | | | |
| 14 | 균열 | 0.1 mm | 0.3 m | | 68 | | | | |
| 15 | 균열 | 0.1 mm | 0.3 m | | 69 | | | | |
| 16 | 균열 | 0.1 mm | 0.3 m | | 70 | | | | |
| 17 | 균열 | 0.1 mm | 0.3 m | | 71 | | | | |
| 18 | 균열 | 0.1 mm | 0.3 m | | 72 | | | | |
| 19 | 균열 | 0.1 mm | 0.3 m | | 73 | | | | |
| 20 | 균열 | 0.1 mm | 0.3 m | | 74 | | | | |
| 21 | 강재부 균열 | 0.2 mm | 0.5 m | | 75 | | | | |
| 22 | 강재부 균열 | 0.2 mm | 0.8 m | | 76 | | | | |
| 23 | 강재부 균열 | 0.2 mm | 0.8 m | | 77 | | | | |
| 24 | 강재부 균열 | 0.2 mm | 0.5 m | | 78 | | | | |
| 25 | 강재부 균열 | 0.2 mm | 0.8 m | | 79 | | | | |
| 26 | 만상균열 | 0.3 m | 7.0 m | | 80 | | | | |
| 27 | 균열 | 0.1 mm | 0.4 m | | 81 | | | | |
| 28 | 균열 | 0.1 mm | 0.4 m | | 82 | | | | |
| 29 | 균열 | 0.1 mm | 0.4 m | | 83 | | | | |
| 30 | 균열 | 0.1 mm | 0.4 m | | 84 | | | | |
| 31 | 만상균열 | 0.3 m | 5.8 m | | 85 | | | | |
