호남고속선 정지 고가\_585(60.989~60.996km, S113-3)

| 2017년도 호남고속선 오송-광주승정간 콘크리트케도 점검용역<br>(주)한국구조물안전연구원<br>(주)한국도로안전연구원<br>(재)한국건설품질연구원 | | | | | | | | | | | |

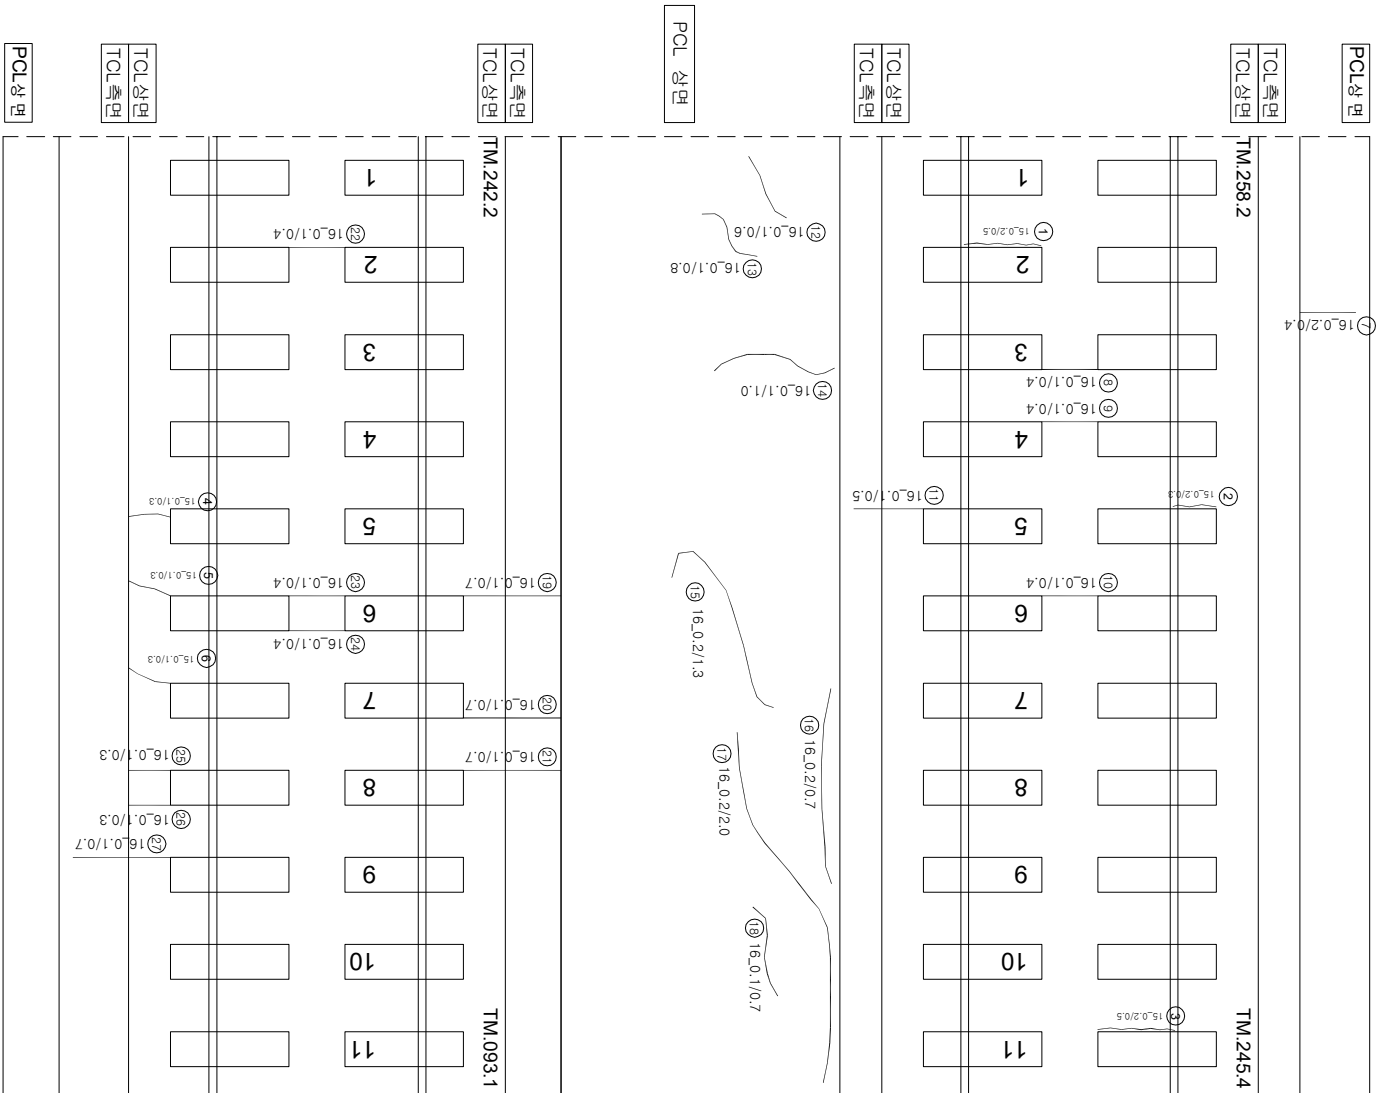
60K996  
113 SPAN-3

| 번호 | 산상 | 폭 | 연장 | 비고 | 번호 | 산상 | 폭 | 연장 | 비고 |
|---|---|---|---|---|---|---|---|---|---|
| 1 | 경계부 군열 | 0.2 mm | 0.5 m | | 55 | | | | |
| 2 | 경계부 군열 | 0.2 mm | 0.3 m | | 56 | | | | |
| 3 | 경계부 군열 | 0.2 mm | 0.5 m | | 57 | | | | |
| 4 | 군열 | 0.1 mm | 0.3 m | | 58 | | | | |
| 7 | 군열 | 0.2 mm | 0.4 m | | 61 | | | | |
| 13 | 군열 | 0.1 mm | 0.8 m | | 67 | | | | |
| 15 | 군열 | 0.2 mm | 1.3 m | | 69 | | | | |
| 17 | 군열 | 0.2 mm | 2.0 m | | 71 | | | | |
