호남고속선 정지코가\_641(61.380~61.387km, S123-3)

123 SPAN - 3

| 시 | 행 사 | 용 역 명 | 용 역 사 | 이 복 영 | | 건 설 | | | | |
|---|---|---|---|---|---|---|---|---|---|---|
| KORAIL<br>KOREA RAILROAD | 한국철도공사 | 2017년도 호남고속선 오송~광주승정간 콘크리트케도 점검용역 | (직) 한국국토물안자연구원<br>(주) 한국국토안전연구원<br>(재) 한국건설품질연구원 | 이 복 영<br><br>간 윤 강<br>김 경 기<br>문 석 기 | 영 | 0.220 (0.3m이하 : 흑색) | | 천목도상본리 | | 자료본리 |

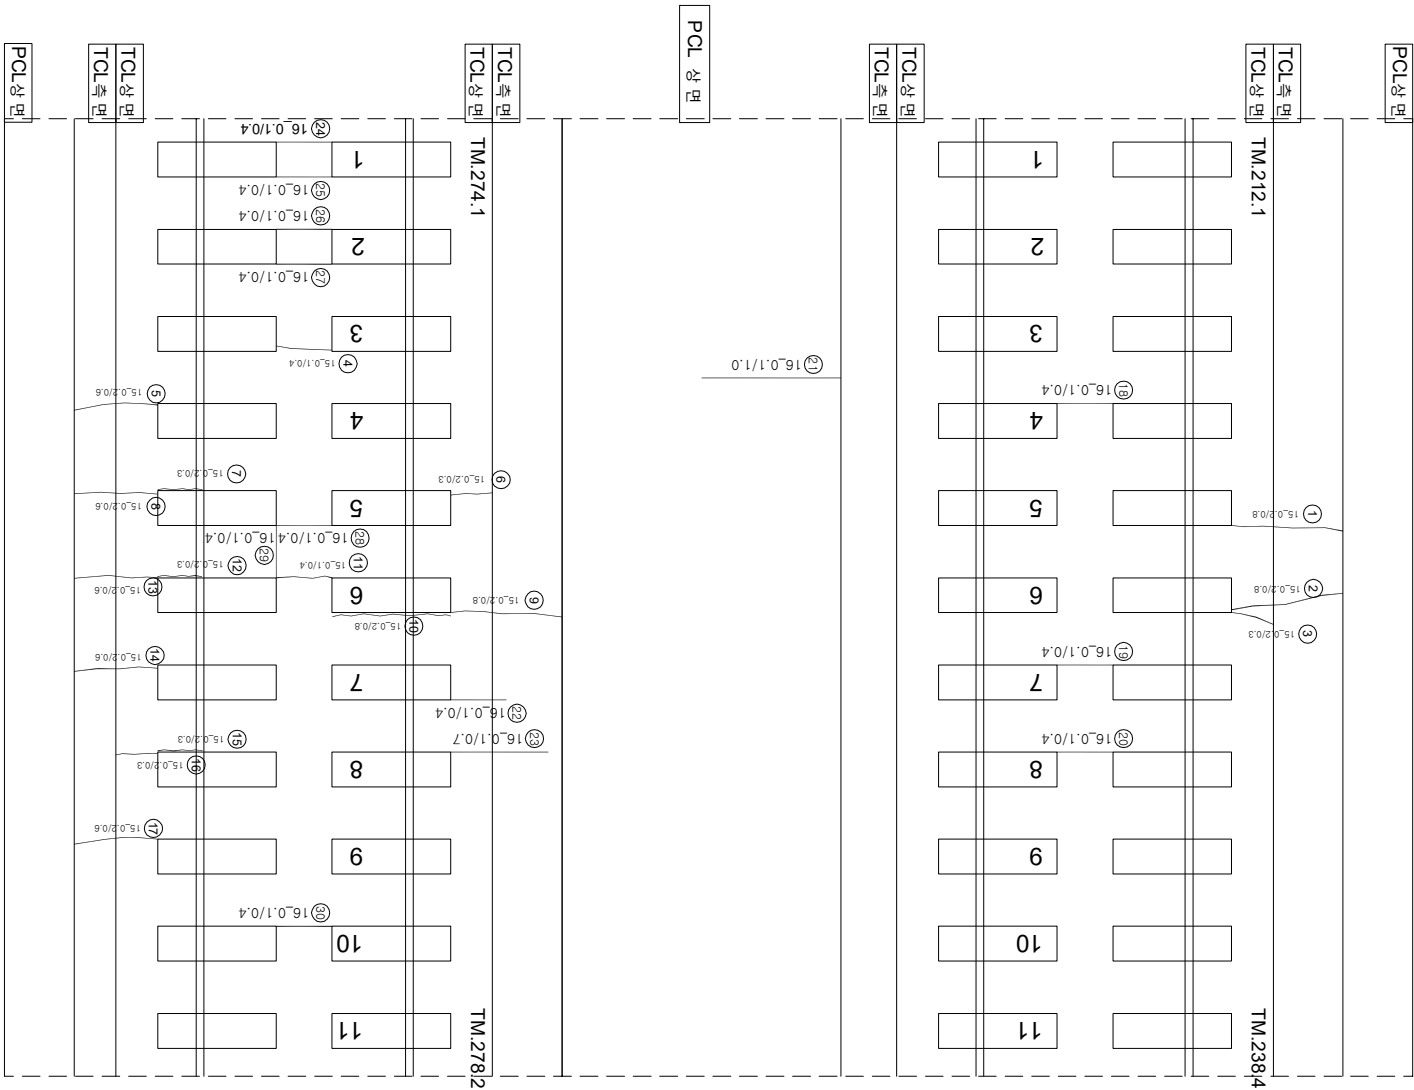
| 연번 | 순차 | 폭 | 연장 | 비고 | 연번 | 순차 | 폭 | 연장 | 비고 |
|---|---|---|---|---|---|---|---|---|---|
| 1 | 균열 | 0.2 mm | 0.8 m | | 55 | | | | |
| 2 | 균열 | 0.2 mm | 0.8 m | | 56 | | | | |
| 3 | 균열 | 0.2 mm | 0.3 m | | 57 | | | | |
| 4 | 균열 | 0.1 mm | 0.4 m | | 58 | | | | |
| 5 | 균열 | 0.2 mm | 0.6 m | | 59 | | | | |
| 6 | 균열 | 0.2 mm | 0.3 m | | 60 | | | | |
| 7 | 강재부 균열 | 0.2 mm | 0.3 m | | 61 | | | | |
| 8 | 균열 | 0.2 mm | 0.6 m | | 62 | | | | |
| 9 | 균열 | 0.2 mm | 0.8 m | | 63 | | | | |
| 10 | 강재부 균열 | 0.2 mm | 0.8 m | | 64 | | | | |
| 11 | 균열 | 0.1 mm | 0.4 m | | 65 | | | | |
| 12 | 강재부 균열 | 0.2 mm | 0.3 m | | 66 | | | | |
| 13 | 균열 | 0.2 mm | 0.6 m | | 67 | | | | |
| 14 | 균열 | 0.2 mm | 0.6 m | | 68 | | | | |
| 15 | 강재부 균열 | 0.2 mm | 0.3 m | | 69 | | | | |
| 16 | 균열 | 0.2 mm | 0.3 m | | 70 | | | | |
| 17 | 균열 | 0.2 mm | 0.6 m | | 71 | | | | |
| 18 | 균열 | 0.1 mm | 0.4 m | | 72 | | | | |
| 19 | 균열 | 0.1 mm | 0.4 m | | 73 | | | | |
| 20 | 균열 | 0.1 mm | 0.4 m | | 74 | | | | |
| 21 | 균열 | 0.1 mm | 1.0 m | | 75 | | | | |
| 22 | 균열 | 0.1 mm | 0.4 m | | 76 | | | | |
| 23 | 균열 | 0.1 mm | 0.7 m | | 77 | | | | |
| 24 | 균열 | 0.1 mm | 0.4 m | | 78 | | | | |
| 25 | 균열 | 0.1 mm | 0.4 m | | 79 | | | | |
| 26 | 균열 | 0.1 mm | 0.4 m | | 80 | | | | |
| 27 | 균열 | 0.1 mm | 0.4 m | | 81 | | | | |
| 28 | 균열 | 0.1 mm | 0.4 m | | 82 | | | | |
| 29 | 균열 | 0.1 mm | 0.4 m | | 83 | | | | |
| 30 | 균열 | 0.1 mm | 0.4 m | | 84 | | | | |
