호남고속선 정지코가\_732(62.019~62.026km, S138-1)

62K026  
138 SPAN - 1

| 시 | 행 | 사 | 공 | 여 | 공 | 여 | 사 | 단 | | 정 |
|---|---|---|---|---|---|---|---|---|---|---|
| | | | 2017년도 호남고속선 오송-광주승정간 콘크리트케도 점검용역 | | | | | | | |

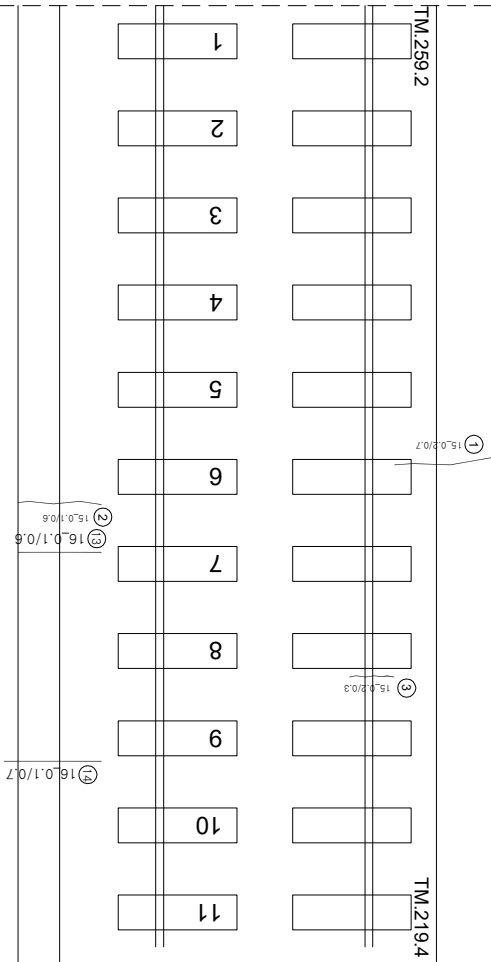
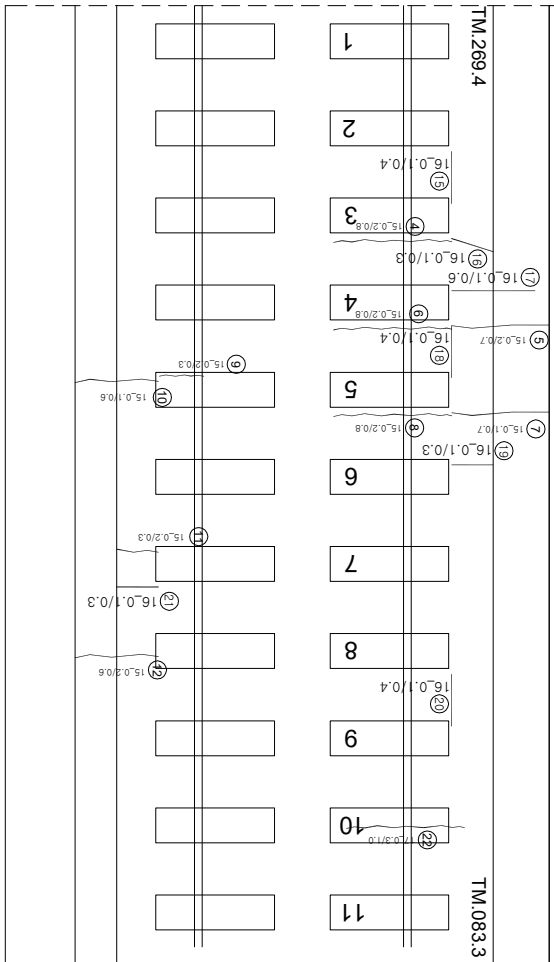
| 연번 | 산상 | 폭 | 연장 | 비고 | 연번 | 산상 | 폭 | 연장 | 비고 |
|---|---|---|---|---|---|---|---|---|---|
| 1 | 균열 | 0.2 mm | 0.7 m | | 55 | | | | |
| 2 | 균열 | 0.1 mm | 0.6 m | | 56 | | | | |
| 3 | 균열 | 0.2 mm | 0.3 m | | 57 | | | | |
| 4 | 장계부 균열 | 0.2 mm | 0.8 m | | 58 | | | | |
| 5 | 균열 | 0.2 mm | 0.7 m | | 59 | | | | |
| 6 | 장계부 균열 | 0.2 mm | 0.8 m | | 60 | | | | |
| 7 | 균열 | 0.1 mm | 0.7 m | | 61 | | | | |
| 8 | 장계부 균열 | 0.2 mm | 0.8 m | | 62 | | | | |
| 9 | 장계부 균열 | 0.2 mm | 0.3 m | | 63 | | | | |
| 10 | 균열 | 0.1 mm | 0.6 m | | 64 | | | | |
| 11 | 균열 | 0.2 mm | 0.3 m | | 65 | | | | |
| 12 | 균열 | 0.2 mm | 0.6 m | | 66 | | | | |
| 13 | 균열 | 0.1 mm | 0.6 m | | 67 | | | | |
| 14 | 균열 | 0.1 mm | 0.7 m | | 68 | | | | |
| 15 | 균열 | 0.1 mm | 0.4 m | | 69 | | | | |
| 16 | 균열 | 0.1 mm | 0.3 m | | 70 | | | | |
| 17 | 균열 | 0.1 mm | 0.6 m | | 71 | | | | |
| 18 | 균열 | 0.1 mm | 0.4 m | | 72 | | | | |
| 19 | 균열 | 0.1 mm | 0.3 m | | 73 | | | | |
| 20 | 균열 | 0.1 mm | 0.4 m | | 74 | | | | |
| 21 | 균열 | 0.1 mm | 0.3 m | | 75 | | | | |
| 22 | 균열 | 0.3 mm | 1.0 m | 신규 | 76 | | | | |
