호남고속선 정지고가 407(59.733~59.740km, S77-5)

| 시 | 행 | 사 | 용 | 역 | 명 | 용 | 역 | 사 | 구간 | |
|---|---|---|---|---|---|---|---|---|---|---|
| KORAIL | | 한국철도공사 | 2017년도 하부고속선 오송-광주승정간 콘크리트케도 점검용역 | (주) 한국구조물안전연구원<br>(주) 한라토목안전연구원<br>(제) 한국건설품질연구원 | 이 복 영 | 각 안 강<br>김 경 기<br>윤 석 기 | | 원목노상판리 | | 재로판리 |

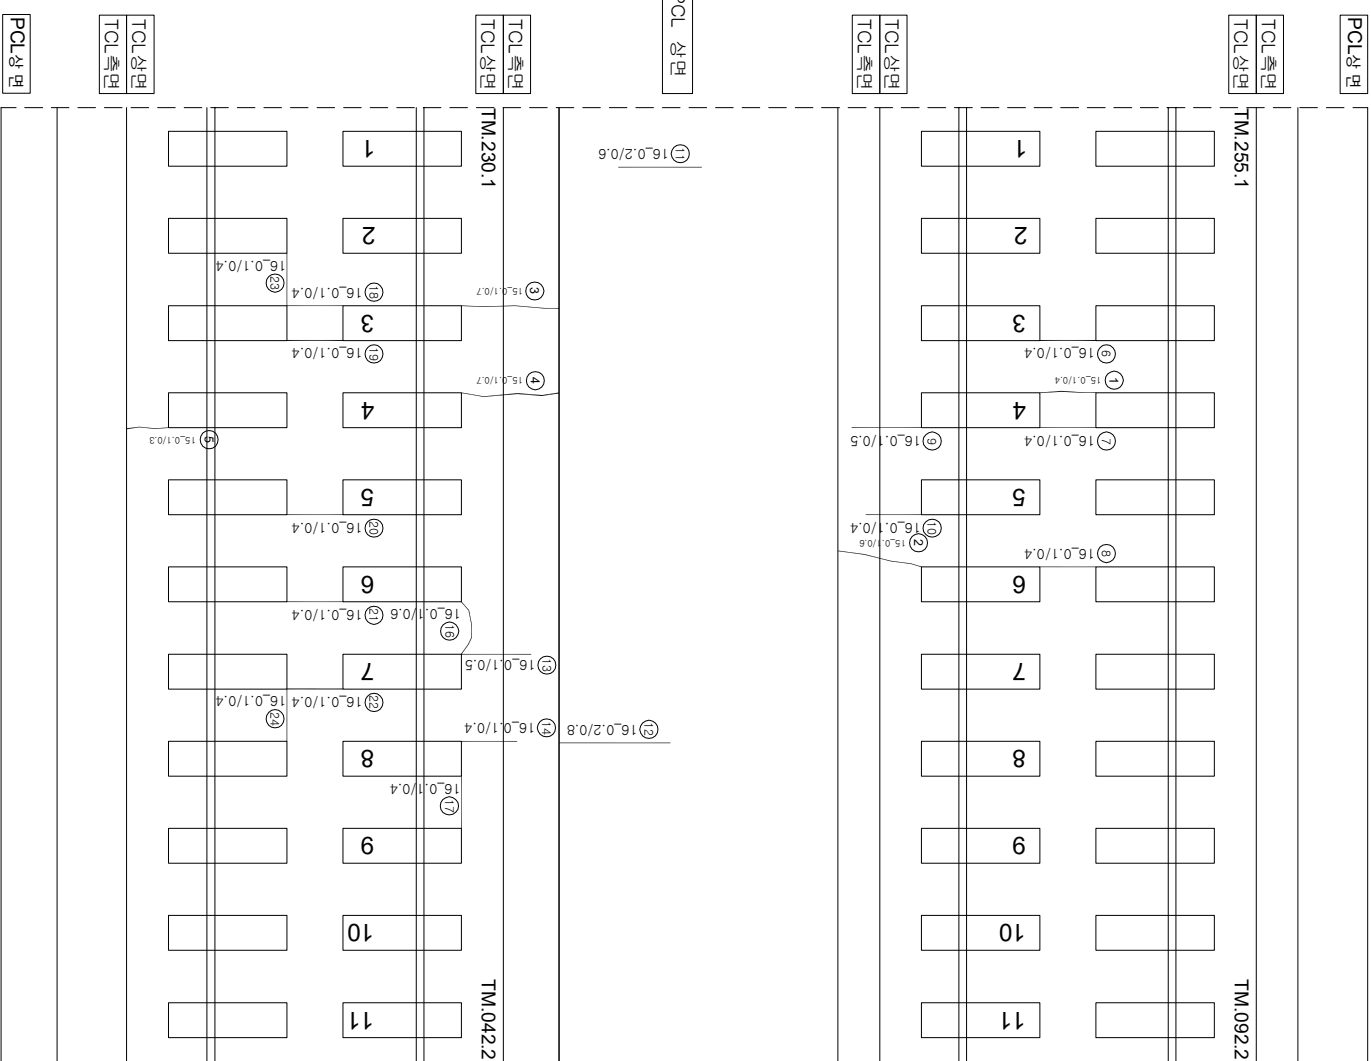
PCL상면

| 연번 | 순상 | 폭 | 연장 | 비고 | 연번 | 순상 | 폭 | 연장 | 비고 |
|---|---|---|---|---|---|---|---|---|---|
| 1 | 균열 | 0.1 mm | 0.4 m | | 55 | | | | |
| 2 | 균열 | 0.1 mm | 0.6 m | | 56 | | | | |
| 3 | 균열 | 0.1 mm | 0.7 m | | 57 | | | | |
| 4 | 균열 | 0.1 mm | 0.7 m | | 58 | | | | |
| 5 | 균열 | 0.1 mm | 0.3 m | | 59 | | | | |
| 6 | 균열 | 0.1 mm | 0.4 m | | 60 | | | | |
| 7 | 균열 | 0.1 mm | 0.4 m | | 61 | | | | |
| 8 | 균열 | 0.1 mm | 0.4 m | | 62 | | | | |
| 9 | 균열 | 0.1 mm | 0.5 m | | 63 | | | | |
| 10 | 균열 | 0.1 mm | 0.4 m | | 64 | | | | |
| 11 | 균열 | 0.2 mm | 0.6 m | | 65 | | | | |
| 12 | 균열 | 0.2 mm | 0.8 m | | 66 | | | | |
| 13 | 균열 | 0.1 mm | 0.5 m | | 67 | | | | |
| 14 | 균열 | 0.1 mm | 0.4 m | | 68 | | | | |
| 15 | 균열 | 0.1 mm | 0.6 m | | 69 | | | | |
| 16 | 균열 | 0.1 mm | 0.4 m | | 70 | | | | |
| 17 | 균열 | 0.1 mm | 0.4 m | | 71 | | | | |
| 18 | 균열 | 0.1 mm | 0.4 m | | 72 | | | | |
| 19 | 균열 | 0.1 mm | 0.4 m | | 73 | | | | |
| 20 | 균열 | 0.1 mm | 0.4 m | | 74 | | | | |
| 21 | 균열 | 0.1 mm | 0.4 m | | 75 | | | | |
| 22 | 균열 | 0.1 mm | 0.4 m | | 76 | | | | |
| 23 | 균열 | 0.1 mm | 0.4 m | | 77 | | | | |
| 24 | 균열 | 0.1 mm | 0.4 m | | 78 | | | | |
