호남고속선 정지코가\_866(62.950~62.956km, S164-2)

164 SPAN - 2

| 시 | 행 사 | 용 역 명 | 용 역 사 | 이 복 영 | | 건 설 | | | | |
|---|---|---|---|---|---|---|---|---|---|---|
| KORAIL<br>KOREA RAILROAD | 한국철도공사 | 2017년도 호남고속선 오송~광주승정간 콘크리트케도 점검용역 | (직) 한국국토물안자연구원<br>(주) 한국국토안전연구원<br>(재) 한국건설품질연구원 | 이 복 영<br><br>간 윤 강<br>김 경 기<br>문 석 기 | 영 | 0.220 (0.3m이하 : 흑색) | | 천목도상본리 | | 자료본리 |

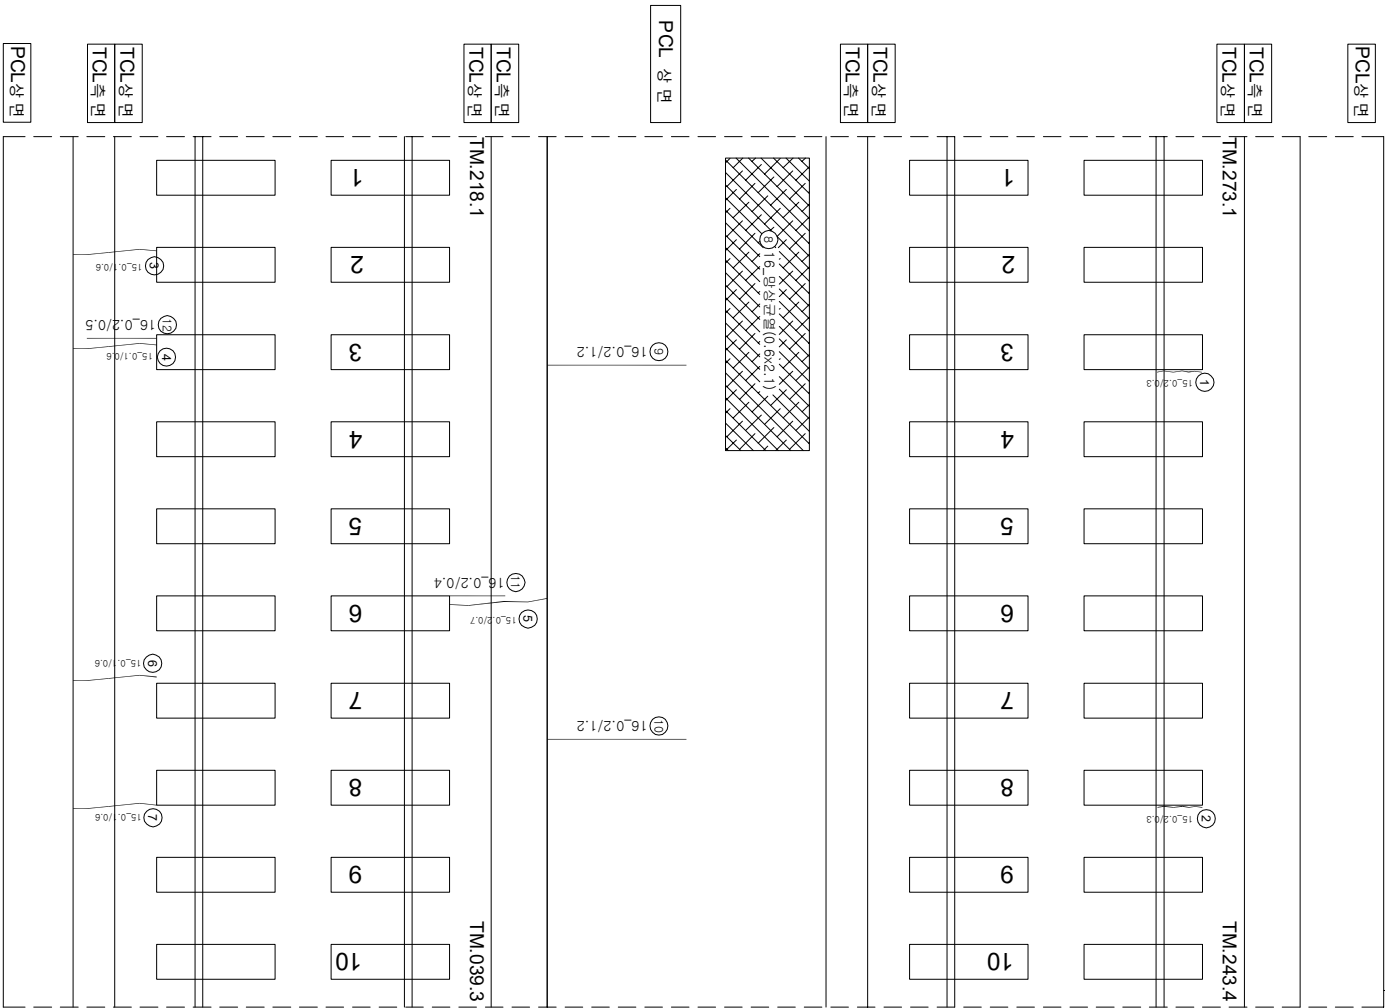
| 연번 | 손상 | 폭 | 연장 | 비고 | 연번 | 손상 | 폭 | 연장 | 비고 |
|---|---|---|---|---|---|---|---|---|---|
| 1 | 경계부 균열 | 0.2 mm | 0.3 m | | 55 | | | | |
| 2 | 경계부 균열 | 0.2 mm | 0.3 m | | 56 | | | | |
| 3 | 균열 | 0.1 mm | 0.6 m | | 57 | | | | |
| 4 | 균열 | 0.1 mm | 0.6 m | | 58 | | | | |
| 5 | 균열 | 0.2 mm | 0.7 m | | 59 | | | | |
| 6 | 균열 | 0.1 mm | 0.6 m | | 60 | | | | |
| 7 | 균열 | 0.1 mm | 0.6 m | | 61 | | | | |
| 8 | 방상 균열 | 0.6 m | 2.1 m | | 62 | | | | |
| 9 | 균열 | 0.2 mm | 1.2 m | | 63 | | | | |
| 10 | 균열 | 0.2 mm | 1.2 m | | 64 | | | | |
| 11 | 균열 | 0.2 mm | 0.4 m | | 65 | | | | |
| 12 | 균열 | 0.2 mm | 0.5 m | | 66 | | | | |
