호남고속선 정지 고가\_872(62.986~62.992km, S165-3)

165 SPAN - 3

| 시 | 행 | 사 | 공 | 여 | 공 | 여 | 사 | 단 | | 정 |
|---|---|---|---|---|---|---|---|---|---|---|
| <b>한국철도공사</b><br>KOREA RAILROAD | | | | | | | | | | |
| 2017년도 호남고속선 오송-광주순정간 콘크리트케도 점검용역 | | | | | | | | | | |

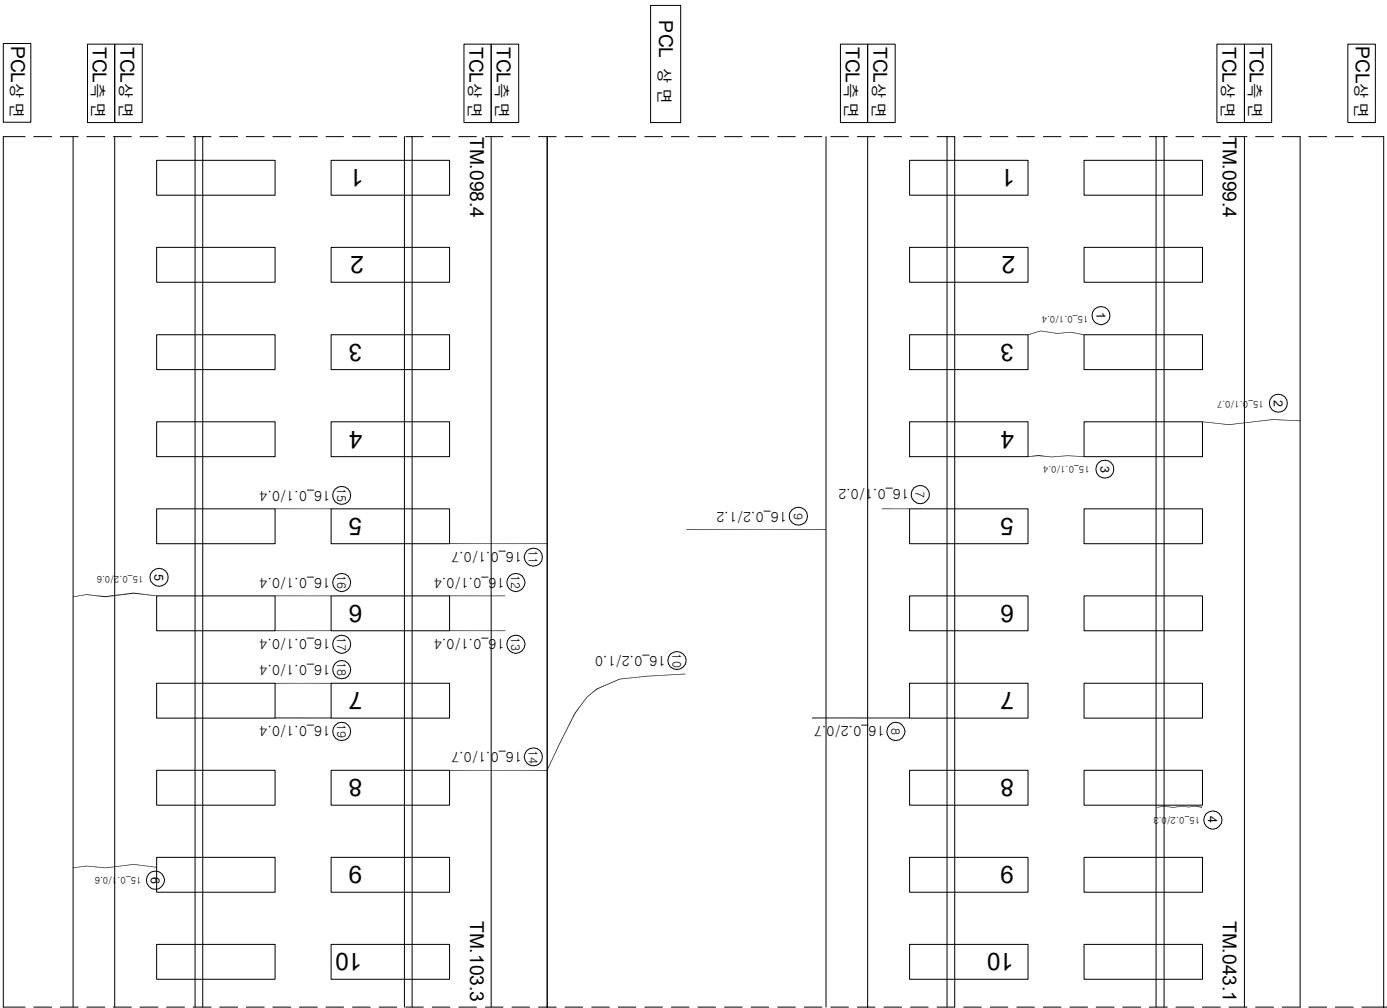
| 연번 | 손상 | 폭 | 연장 | 비고 | 연번 | 손상 | 폭 | 연장 | 비고 |
|---|---|---|---|---|---|---|---|---|---|
| 1 | 균열 | 0.1 mm | 0.4 m | | 55 | | | | |
| 2 | 균열 | 0.1 mm | 0.7 m | | 56 | | | | |
| 3 | 균열 | 0.1 mm | 0.4 m | | 57 | | | | |
| 4 | 경계부-균열 | 0.2 mm | 0.3 m | | 58 | | | | |
| 5 | 균열 | 0.2 mm | 0.6 m | | 59 | | | | |
| 6 | 균열 | 0.1 mm | 0.6 m | | 60 | | | | |
| 7 | 균열 | 0.1 mm | 0.2 m | | 61 | | | | |
| 8 | 균열 | 0.2 mm | 0.7 m | | 62 | | | | |
| 9 | 균열 | 0.2 mm | 1.2 m | | 63 | | | | |
| 10 | 균열 | 0.2 mm | 1.0 m | | 64 | | | | |
| 11 | 균열 | 0.1 mm | 0.7 m | | 65 | | | | |
| 12 | 균열 | 0.1 mm | 0.4 m | | 66 | | | | |
| 13 | 균열 | 0.1 mm | 0.4 m | | 67 | | | | |
| 14 | 균열 | 0.1 mm | 0.7 m | | 68 | | | | |
| 15 | 균열 | 0.1 mm | 0.4 m | | 69 | | | | |
| 16 | 균열 | 0.1 mm | 0.4 m | | 70 | | | | |
| 17 | 균열 | 0.1 mm | 0.4 m | | 71 | | | | |
| 18 | 균열 | 0.1 mm | 0.4 m | | 72 | | | | |
| 19 | 균열 | 0.1 mm | 0.4 m | | 73 | | | | |
