호남고속선 정지고가\_959(63.578~63.585km, S182-5)

| 시 | 행 | 사 | 영 | 여 | 명 | 영 | 여 | 사 | 단 | | |
|---|---|---|---|---|---|---|---|---|---|---|---|
| 2017년도 호남고속선 오송-광주승정간 콘크리트케도 점검용역 | | | | | | | | | | | |

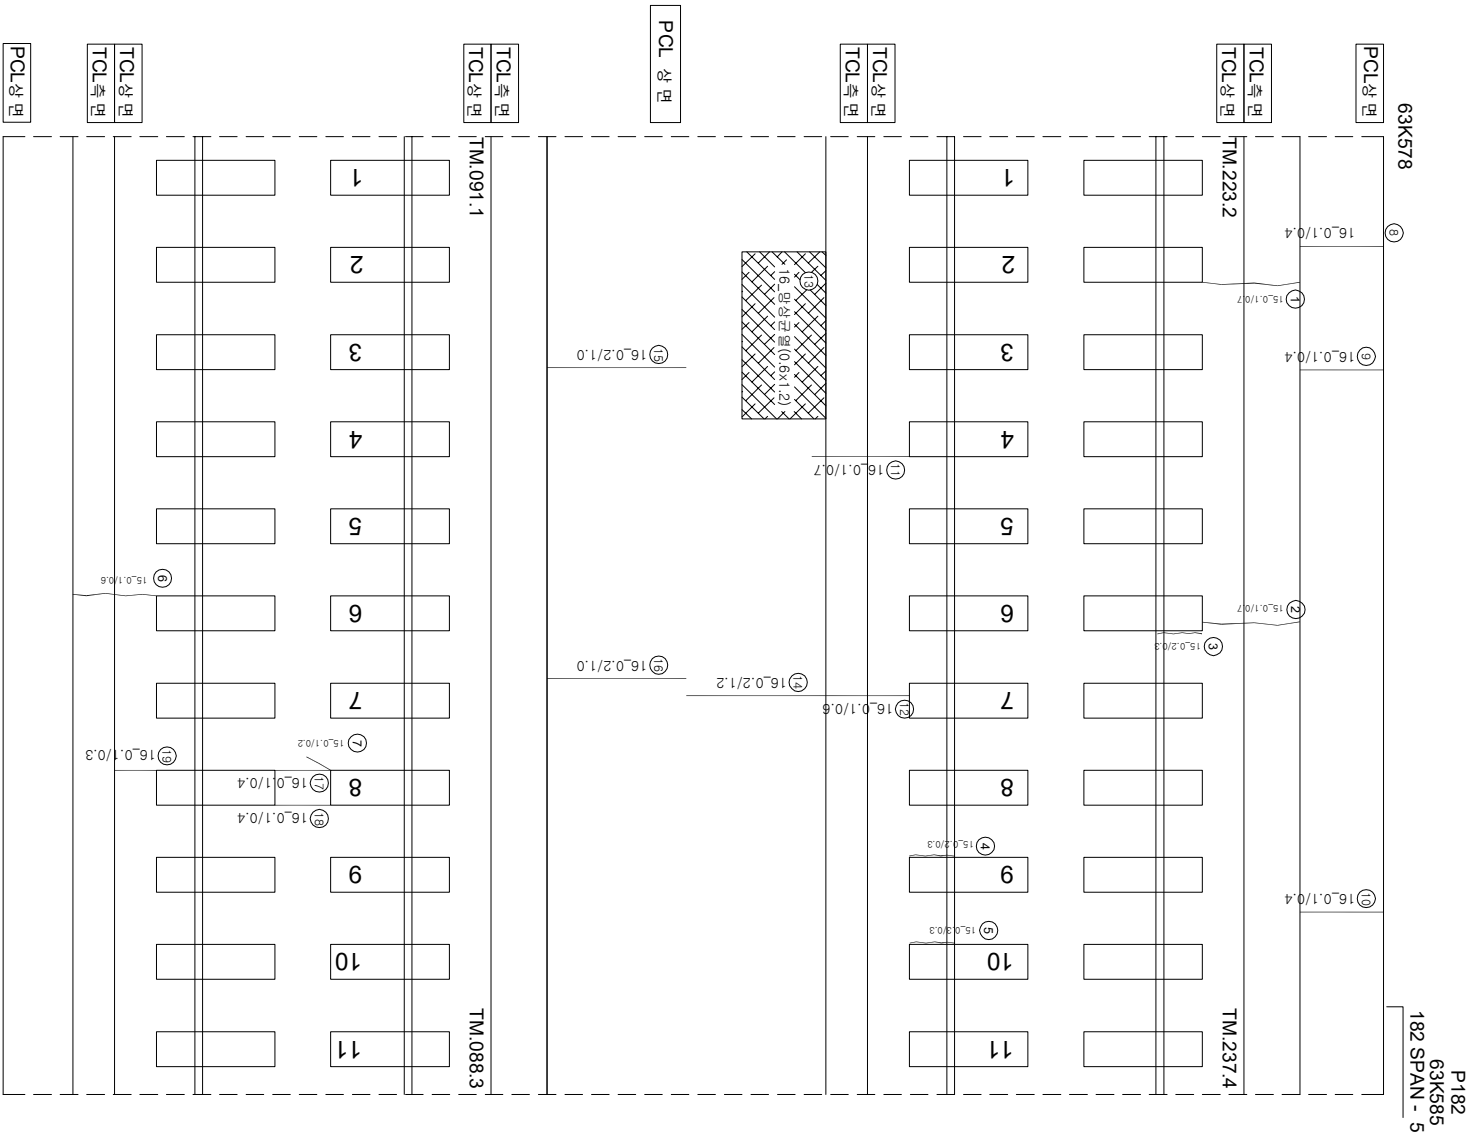
| 연번 | 순상 | 폭 | 연장 | 비고 | 연번 | 순상 | 폭 | 연장 | 비고 |
|---|---|---|---|---|---|---|---|---|---|
| 1 | 균열 | 0.1 mm | 0.7 m | | 55 | | | | |
| 2 | 균열 | 0.1 mm | 0.7 m | | 56 | | | | |
| 3 | 강재부 균열 | 0.2 mm | 0.3 m | | 57 | | | | |
| 4 | 강재부 균열 | 0.2 mm | 0.3 m | | 58 | | | | |
| 5 | 강재부 균열 | 0.3 mm | 0.3 m | | 59 | | | | |
| 6 | 균열 | 0.1 mm | 0.6 m | | 60 | | | | |
| 7 | 균열 | 0.1 mm | 0.2 m | | 61 | | | | |
| 8 | 균열 | 0.1 mm | 0.4 m | | 62 | | | | |
| 9 | 균열 | 0.1 mm | 0.4 m | | 63 | | | | |
| 10 | 균열 | 0.1 mm | 0.4 m | | 64 | | | | |
| 11 | 균열 | 0.1 mm | 0.7 m | | 65 | | | | |
| 12 | 균열 | 0.1 mm | 0.6 m | | 66 | | | | |
| 13 | 방산균열 | 0.6 m | 1.2 m | | 67 | | | | |
| 14 | 균열 | 0.2 mm | 1.2 m | | 68 | | | | |
| 15 | 균열 | 0.2 mm | 1.0 m | | 69 | | | | |
| 16 | 균열 | 0.2 mm | 1.0 m | | 70 | | | | |
| 17 | 균열 | 0.1 mm | 0.4 m | | 71 | | | | |
| 18 | 균열 | 0.1 mm | 0.4 m | | 72 | | | | |
| 19 | 균열 | 0.1 mm | 0.3 m | | 73 | | | | |
