호남고속선 신작교-38(66.737~66.744km, S8-2)

8 SPAN - 2

| 시행처 | 영역 | 영역 | 영역 | 영역 | 구간 | | |
|---|---|---|---|---|---|---|---|
| <br><b>KORAIL</b><br>KOREA RAILROAD<br><b>한국철도공사</b> | 2017년도 호남고속선 오송~광주승정간 콘크리트케도 점검구역 | (주) 한국구조물안전연구원<br>(주) 한국도로안전연구원<br>(재) 한국건설품질연구원 | <b>이북영</b> | 김윤강<br>김정기<br>원석기 | 구간 | | |

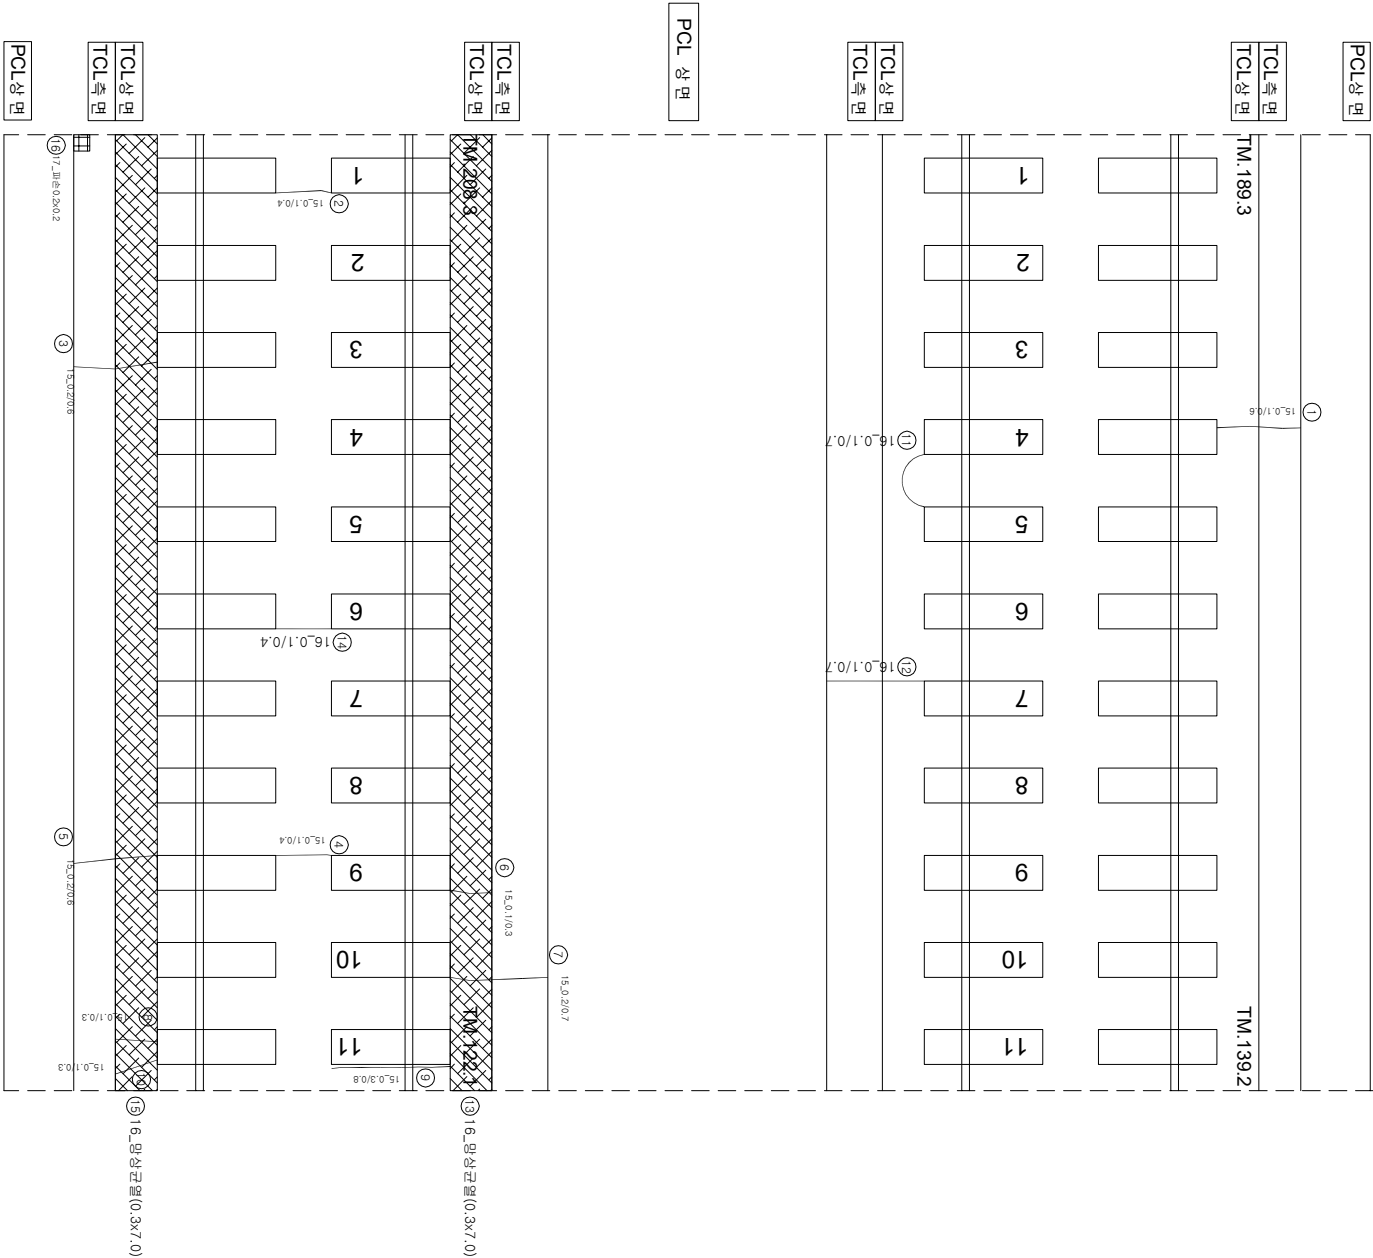
| 연번 | 순상 | 폭 | 연장 | 비고 | 연번 | 순상 | 폭 | 연장 | 비고 |
|---|---|---|---|---|---|---|---|---|---|
| 1 | 균열 | 0.1 mm | 0.6 m | | 55 | | | | |
| 2 | 균열 | 0.1 mm | 0.4 m | | 56 | | | | |
| 3 | 균열 | 0.2 mm | 0.6 m | | 57 | | | | |
| 4 | 균열 | 0.1 mm | 0.4 m | | 58 | | | | |
| 5 | 균열 | 0.2 mm | 0.6 m | | 59 | | | | |
| 6 | 균열 | 0.1 mm | 0.3 m | | 60 | | | | |
| 7 | 균열 | 0.2 mm | 0.7 m | | 61 | | | | |
| 8 | 균열 | 0.1 mm | 0.3 m | | 62 | | | | |
| 9 | 경계부 균열 | 0.3 mm | 0.8 m | | 63 | | | | |
| 10 | 균열 | 0.1 mm | 0.3 m | | 64 | | | | |
| 11 | 균열 | 0.1 mm | 0.7 m | | 65 | | | | |
| 12 | 균열 | 0.1 mm | 0.7 m | | 66 | | | | |
| 13 | 영상균열 | 0.3 m | 7.0 m | | 67 | | | | |
| 14 | 균열 | 0.1 mm | 0.4 m | | 68 | | | | |
| 15 | 영상균열 | 0.3 m | 7.0 m | | 69 | | | | |
| 16 | 파손 | 0.2 m | 0.2 m | 신구 | 70 | | | | |
