호남고속선 신작교-180(67.731~67.738km, S36-4)

36 SPAN - 4

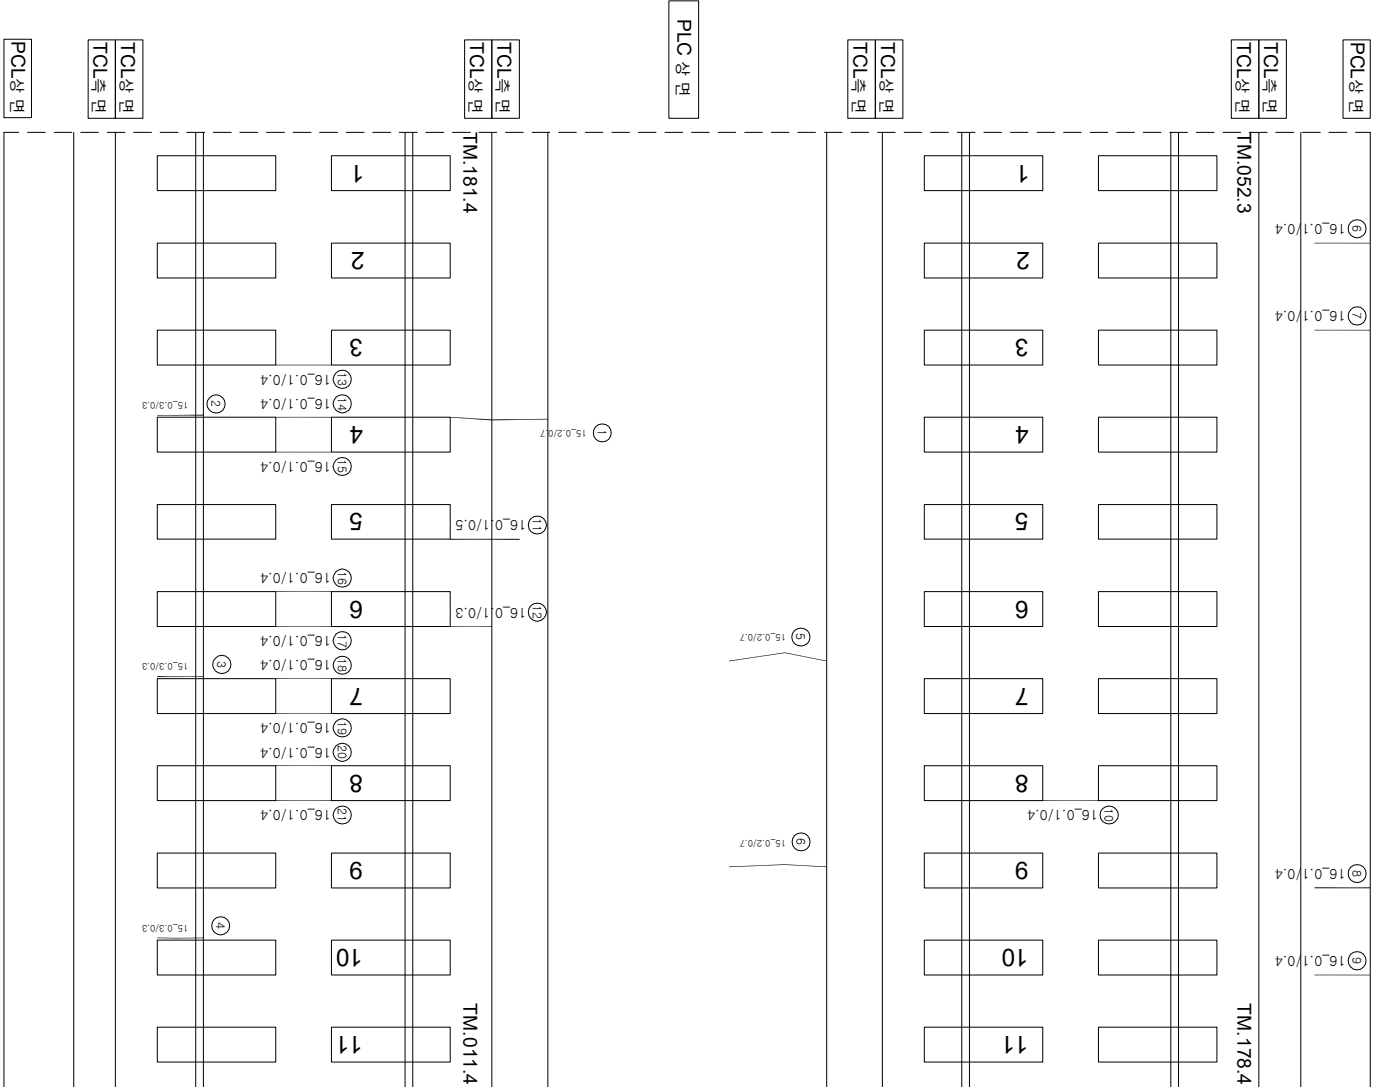
| 연번 | 순상 | 폭 | 연장 | 비고 | 연번 | 순상 | 폭 | 연장 | 비고 |
|---|---|---|---|---|---|---|---|---|---|
| 1 | 균열 | 0.2 mm | 0.7 m | | 55 | | | | |
| 2 | 장계부 균열 | 0.3 mm | 0.3 m | | 56 | | | | |
| 3 | 장계부 균열 | 0.3 mm | 0.3 m | | 57 | | | | |
| 4 | 장계부 균열 | 0.2 mm | 0.7 m | | 58 | | | | |
| 5 | 균열 | 0.2 mm | 0.7 m | | 59 | | | | |
| 6 | 균열 | 0.1 mm | 0.4 m | | 60 | | | | |
| 7 | 균열 | 0.1 mm | 0.4 m | | 61 | | | | |
| 8 | 균열 | 0.1 mm | 0.4 m | | 62 | | | | |
| 9 | 균열 | 0.1 mm | 0.4 m | | 63 | | | | |
| 10 | 균열 | 0.1 mm | 0.4 m | | 64 | | | | |
| 11 | 균열 | 0.1 mm | 0.5 m | | 65 | | | | |
| 12 | 균열 | 0.1 mm | 0.3 m | | 66 | | | | |
| 13 | 균열 | 0.1 mm | 0.4 m | | 67 | | | | |
| 14 | 균열 | 0.1 mm | 0.4 m | | 68 | | | | |
| 15 | 균열 | 0.1 mm | 0.4 m | | 69 | | | | |
| 16 | 균열 | 0.1 mm | 0.4 m | | 70 | | | | |
| 17 | 균열 | 0.1 mm | 0.4 m | | 71 | | | | |
| 18 | 균열 | 0.1 mm | 0.4 m | | 72 | | | | |
| 19 | 균열 | 0.1 mm | 0.4 m | | 73 | | | | |
| 20 | 균열 | 0.1 mm | 0.4 m | | 74 | | | | |
| 21 | 균열 | 0.1 mm | 0.4 m | | 75 | | | | |
