한남고속선 1차 노선 - 144(69.810~69.820km, L=10m)

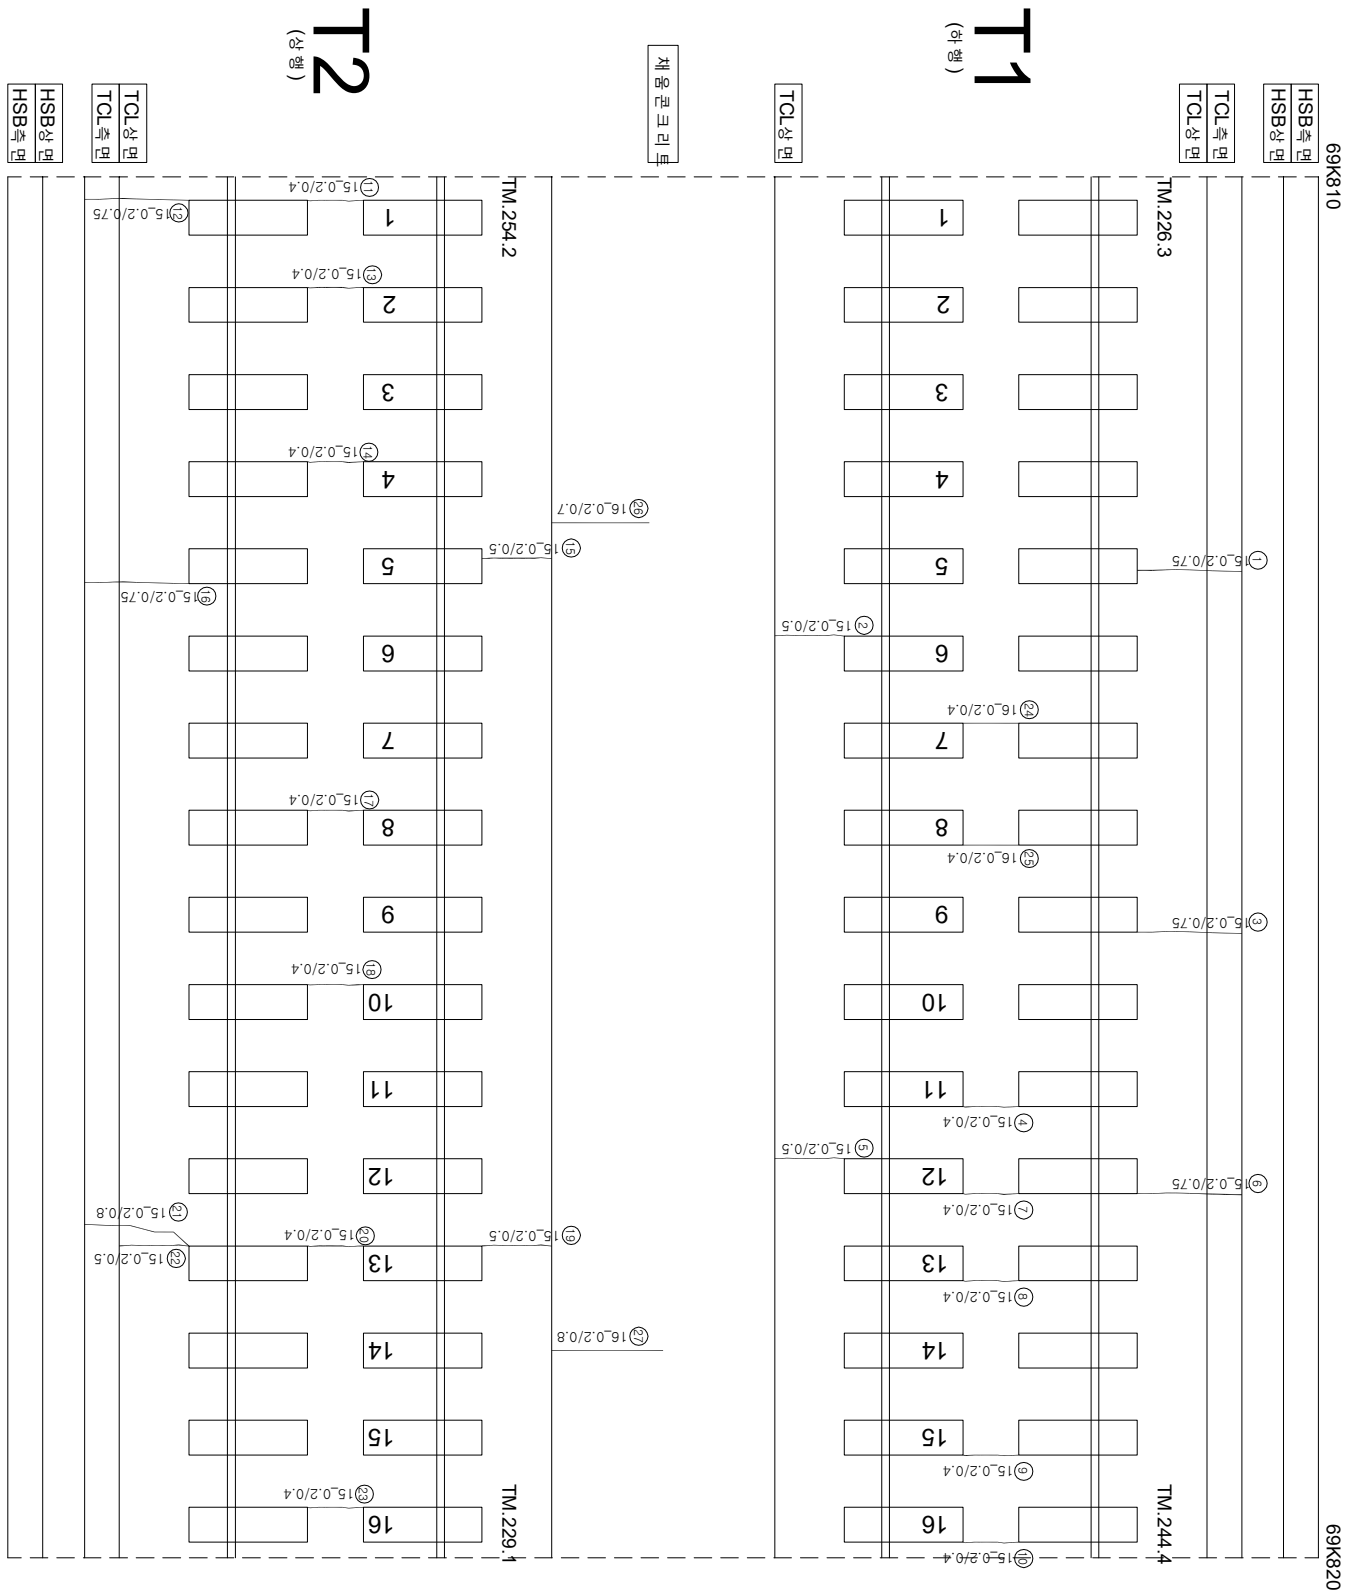
| 연번 | 순상 | 폭 | 연장 | 비고 | 연번 | 순상 | 폭 | 연장 | 비고 |
|---|---|---|---|---|---|---|---|---|---|
| 1 | 균열 | 0.2 mm | 0.8 m | | 55 | | | | |
| 2 | 균열 | 0.2 mm | 0.5 m | | 56 | | | | |
| 3 | 균열 | 0.2 mm | 0.8 m | | 57 | | | | |
| 4 | 균열 | 0.2 mm | 0.4 m | | 58 | | | | |
| 5 | 균열 | 0.2 mm | 0.5 m | | 59 | | | | |
| 6 | 균열 | 0.2 mm | 0.8 m | | 60 | | | | |
| 7 | 균열 | 0.2 mm | 0.4 m | | 61 | | | | |
| 8 | 균열 | 0.2 mm | 0.4 m | | 62 | | | | |
| 9 | 균열 | 0.2 mm | 0.4 m | | 63 | | | | |
| 10 | 균열 | 0.2 mm | 0.4 m | | 64 | | | | |
| 11 | 균열 | 0.2 mm | 0.4 m | | 65 | | | | |
| 12 | 균열 | 0.2 mm | 0.8 m | | 66 | | | | |
| 13 | 균열 | 0.2 mm | 0.4 m | | 67 | | | | |
| 14 | 균열 | 0.2 mm | 0.4 m | | 68 | | | | |
| 15 | 균열 | 0.2 mm | 0.5 m | | 69 | | | | |
| 16 | 균열 | 0.2 mm | 0.8 m | | 70 | | | | |
| 17 | 균열 | 0.2 mm | 0.4 m | | 71 | | | | |
| 18 | 균열 | 0.2 mm | 0.4 m | | 72 | | | | |
| 19 | 균열 | 0.2 mm | 0.5 m | | 73 | | | | |
| 20 | 균열 | 0.2 mm | 0.4 m | | 74 | | | | |
| 21 | 균열 | 0.2 mm | 0.8 m | | 75 | | | | |
| 22 | 균열 | 0.2 mm | 0.5 m | | 76 | | | | |
| 23 | 균열 | 0.2 mm | 0.4 m | | 77 | | | | |
| 24 | 균열 | 0.2 mm | 0.4 m | | 78 | | | | |
| 25 | 균열 | 0.2 mm | 0.4 m | | 79 | | | | |
| 26 | 균열 | 0.2 mm | 0.7 m | | 80 | | | | |
| 27 | 균열 | 0.2 mm | 0.8 m | | 81 | | | | |
