한남고속선 여왕코-토아노반-29(70.870~70.880km, L=10m)

| 시 | 행 | 사 | 영 | 역 | 명 | 영 | 역 | 사 | 과 | | 장 | 아 | 지 | 단 | | | | | | | | | | | | | | | |
|---|---|---|---|---|---|---|---|---|---|---|---|---|---|---|---|---|---|---|---|---|---|---|---|---|---|---|---|---|---|
| <br><b>KORAIL</b><br>KOREA RAILROAD | 한국철도공사 | 한국의소리<br>Korea Rail Road | 2017년도 호남고속선 오송-광주승정간 콘크리트케도 점검공역 | | | (주) 한국구조물안전연구원<br>(주) 한국도로안전연구원<br>(재) 한국건설품질연구원 | 이 부영 | 김원강<br>김경기<br>문은석 | 영 | | 0220 (0.3m이하 : 흑색) | | 차로분리 | | | | | | | | | | | | | | | | |

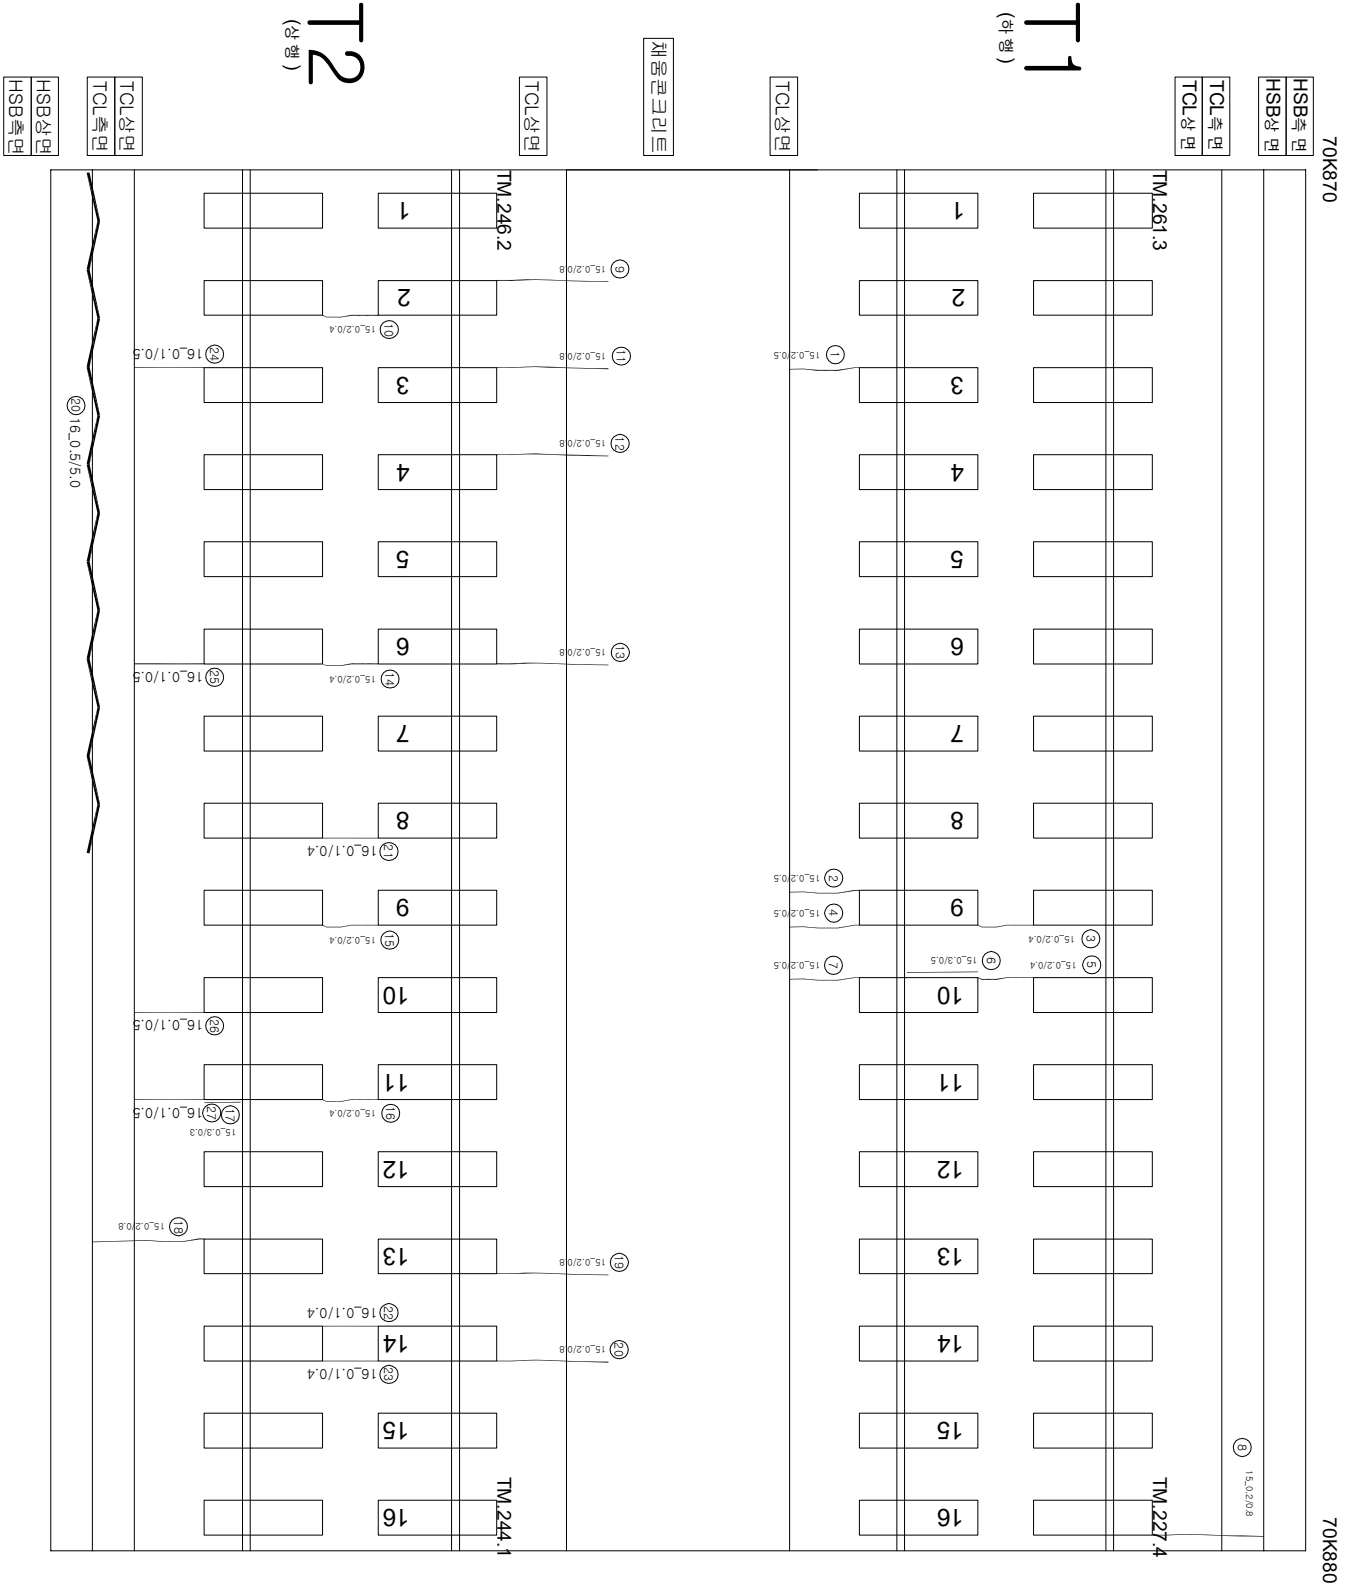
| 연번 | 순차 | 목 | 연장 | 비고 | 연번 | 순차 | 목 | 연장 | 비고 |
|---|---|---|---|---|---|---|---|---|---|
| 1 | 균열 | 0.2 mm | 0.5 m | | 55 | | | | |
| 2 | 균열 | 0.2 mm | 0.5 m | | 56 | | | | |
| 3 | 균열 | 0.2 mm | 0.4 m | | 57 | | | | |
| 4 | 균열 | 0.2 mm | 0.5 m | | 58 | | | | |
| 5 | 균열 | 0.2 mm | 0.4 m | | 59 | | | | |
| 6 | 강재부 균열 | 0.3 mm | 0.5 m | | 60 | | | | |
| 7 | 균열 | 0.2 mm | 0.5 m | | 61 | | | | |
| 8 | 균열 | 0.2 mm | 0.8 m | | 62 | | | | |
| 9 | 균열 | 0.2 mm | 0.4 m | | 63 | | | | |
| 10 | 균열 | 0.2 mm | 0.8 m | | 64 | | | | |
| 11 | 균열 | 0.2 mm | 0.8 m | | 65 | | | | |
| 12 | 균열 | 0.2 mm | 0.8 m | | 66 | | | | |
| 13 | 균열 | 0.2 mm | 0.4 m | | 67 | | | | |
| 14 | 균열 | 0.2 mm | 0.4 m | | 68 | | | | |
| 15 | 균열 | 0.2 mm | 0.4 m | | 69 | | | | |
| 16 | 균열 | 0.3 mm | 0.3 m | | 70 | | | | |
| 17 | 강재부 균열 | 0.2 mm | 0.8 m | | 71 | | | | |
| 18 | 균열 | 0.2 mm | 0.8 m | | 72 | | | | |
| 19 | 균열 | 0.2 mm | 0.8 m | | 73 | | | | |
| 20 | 충돌타 | 0.5 mm | 5.0 m | | 74 | | | | |
| 21 | 균열 | 0.1 mm | 0.4 m | | 75 | | | | |
| 22 | 균열 | 0.1 mm | 0.4 m | | 76 | | | | |
| 23 | 균열 | 0.1 mm | 0.4 m | | 77 | | | | |
| 24 | 균열 | 0.1 mm | 0.5 m | | 78 | | | | |
| 25 | 균열 | 0.1 mm | 0.5 m | | 79 | | | | |
| 26 | 균열 | 0.1 mm | 0.5 m | | 80 | | | | |
| 27 | 균열 | 0.1 mm | 0.5 m | | 81 | | | | |
