호남고속선 죽산교\_61(73.535~73.542km, S12-5)

| 시 | 행 사 | 영 역 | 영 역 | 영 역 | 사 | 인 지 | | 구 간 | | | | |
|---|---|---|---|---|---|---|---|---|---|---|---|---|
| KORAIL<br>KOREA RAILROAD | 한국철도공사 | 2017년도 호남고속선 오송-광주승정간 콘크리트케도 점검공역 | (주) 한국구조물안전연구원<br>(주) 한국도로안전연구원<br>(재) 한국건설품질연구원 | 이 박 영 | 강 완 강<br>김 경 기<br>윤 석 기 | 영 역 | | 0220 (0.3m이하 : 흑색) | | 점목 도상본리 | | 재료본리 |

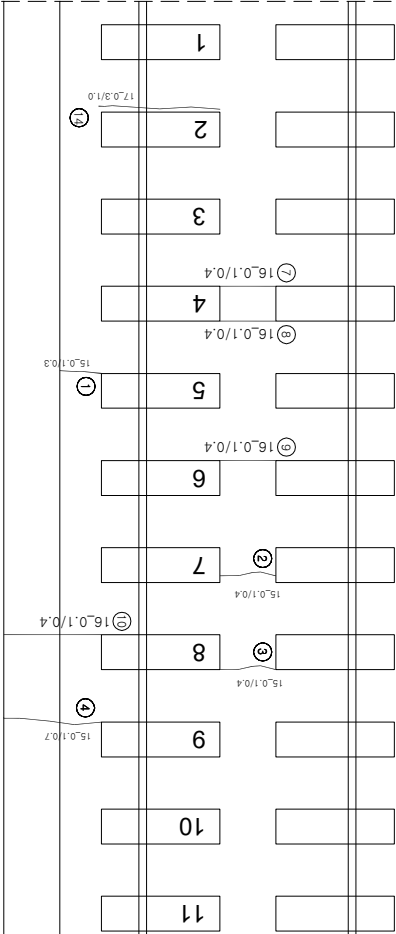
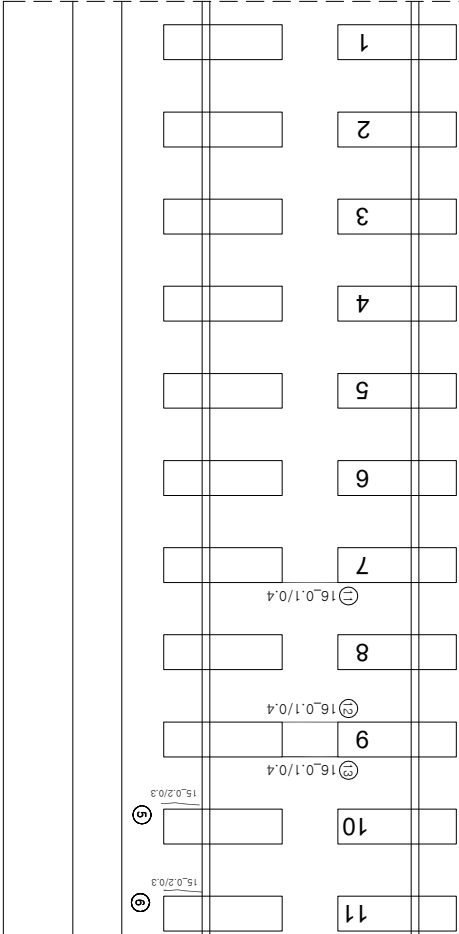
| 연번 | 순번 | 종 | 연장 | 비고 | 연번 | 순번 | 종 | 연장 | 비고 |
|---|---|---|---|---|---|---|---|---|---|
| 1 | 군열 | 0.1 | mm | 0.3 | m | 55 | | | |
| 2 | 군열 | 0.1 | mm | 0.4 | m | 56 | | | |
| 3 | 군열 | 0.1 | mm | 0.4 | m | 57 | | | |
| 4 | 군열 | 0.1 | mm | 0.7 | m | 58 | | | |
| 5 | 장계부 군열 | 0.2 | mm | 0.3 | m | 59 | | | |
| 6 | 장계부 군열 | 0.2 | mm | 0.3 | m | 60 | | | |
| 7 | 군열 | 0.1 | mm | 0.4 | m | 61 | | | |
| 8 | 군열 | 0.1 | mm | 0.4 | m | 62 | | | |
| 9 | 군열 | 0.1 | mm | 0.4 | m | 63 | | | |
| 10 | 군열 | 0.1 | mm | 0.4 | m | 64 | | | |
| 11 | 군열 | 0.1 | mm | 0.4 | m | 65 | | | |
| 12 | 군열 | 0.1 | mm | 0.4 | m | 66 | | | |
| 13 | 군열 | 0.1 | mm | 0.4 | m | 67 | | | |
| 14 | 장계부 군열 | 0.3 | mm | 1.0 | m | 68 | | | |
