화남고속선 죽산교-201(74.475~74.482km, S40-5)

| 시 | 행 사 | 영역 | 영역 | 영역 | 사 | 과목 | | 단 | | | | |
|---|---|---|---|---|---|---|---|---|---|---|---|---|
| KORAIL<br>KOREA RAILROAD | 한국철도공사 | 2017년도 호남고속선 오송-광주승정간 콘크리트케도 점검공역 | (주) 한국구조물안전연구원<br>(주) 한국국토안전연구원<br>(재) 한국건설품질연구원 | 이 부영 | 김 원 강<br>김 경 기<br>문 윤 석 | 영역 | | 0220 (0.3mm이하 : 흑색) | | 점목도상판리 | | 재료판리 |

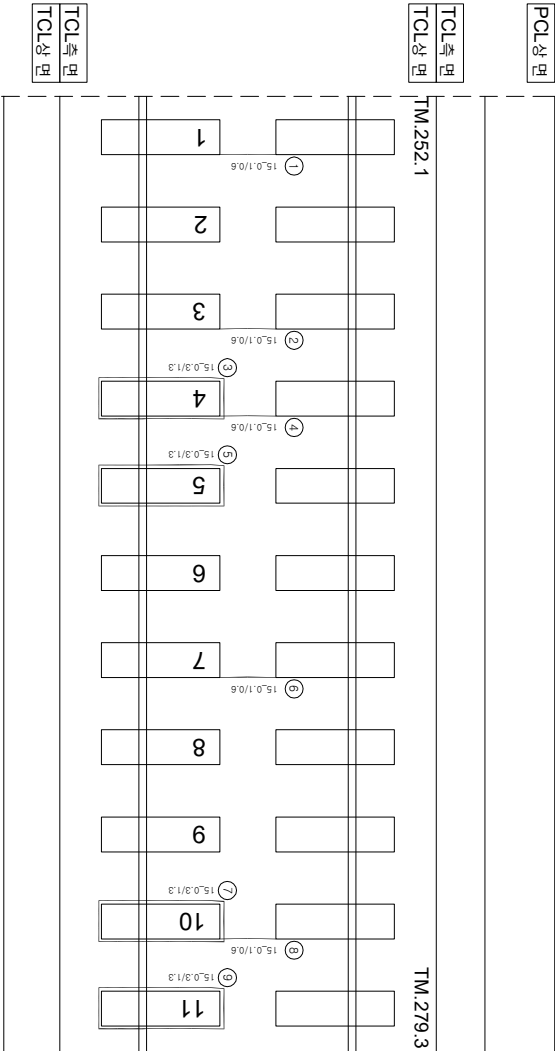
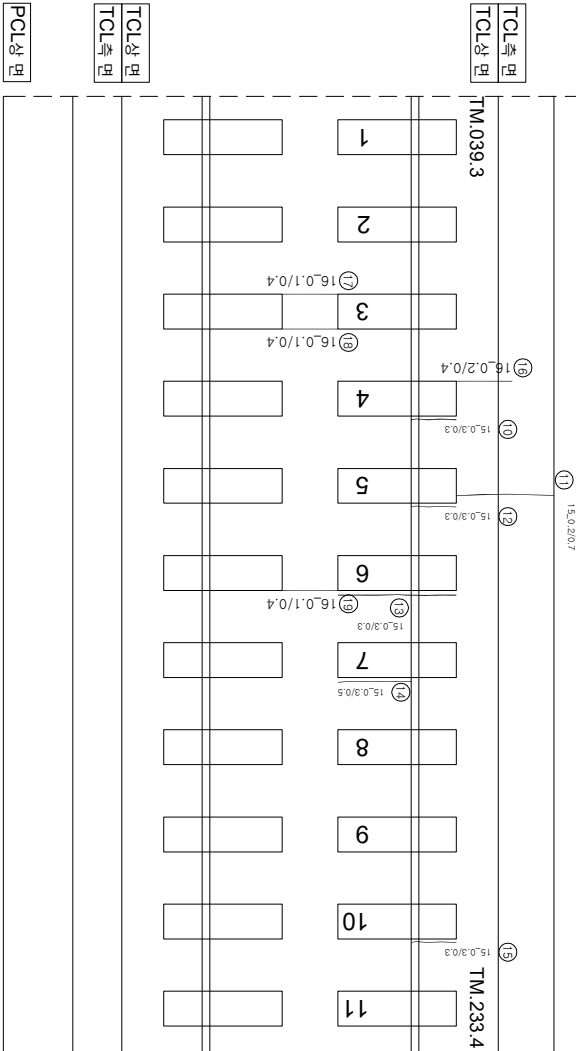
| 연번 | 순차 | 목 | 연장 | 비고 | 연번 | 순차 | 목 | 연장 | 비고 |
|---|---|---|---|---|---|---|---|---|---|
| 1 | 균열 | 0.1 mm | 0.6 m | | 55 | | | | |
| 2 | 균열 | 0.1 mm | 0.6 m | | 56 | | | | |
| 3 | 경계부 균열 | 0.3 mm | 1.3 m | | 57 | | | | |
| 4 | 균열 | 0.1 mm | 0.6 m | | 58 | | | | |
| 5 | 경계부 균열 | 0.3 mm | 1.3 m | | 59 | | | | |
| 6 | 균열 | 0.1 mm | 0.6 m | | 60 | | | | |
| 7 | 경계부 균열 | 0.3 mm | 1.3 m | | 61 | | | | |
| 8 | 균열 | 0.1 mm | 0.6 m | | 62 | | | | |
| 9 | 경계부 균열 | 0.3 mm | 1.3 m | | 63 | | | | |
| 10 | 경계부 균열 | 0.3 mm | 0.3 m | | 64 | | | | |
| 11 | 균열 | 0.2 mm | 0.7 m | | 65 | | | | |
| 12 | 경계부 균열 | 0.3 mm | 0.3 m | | 66 | | | | |
| 13 | 경계부 균열 | 0.3 mm | 0.3 m | | 67 | | | | |
| 14 | 경계부 균열 | 0.3 mm | 0.5 m | | 68 | | | | |
| 15 | 경계부 균열 | 0.3 mm | 0.3 m | | 69 | | | | |
| 16 | 균열 | 0.2 mm | 0.4 m | | 70 | | | | |
| 17 | 균열 | 0.1 mm | 0.4 m | | 71 | | | | |
| 18 | 균열 | 0.1 mm | 0.4 m | | 72 | | | | |
| 19 | 균열 | 0.1 mm | 0.4 m | | 73 | | | | |
