화남고속선 죽산교-222(74.614~74.620km, S45-1)

| 시 | 행 사 | 영 역 | 영 역 | 영역 | 사 | 과목 | | 단 | | | | | |
|---|---|---|---|---|---|---|---|---|---|---|---|---|---|
| <b>KORAIL</b><br>KOREA RAILROAD | 한국철도공사 | 2017년도 호남고속선 오송-광주승정간 콘크리트케도 점검공역 | (주) 한국구조물안전연구원<br>(주) 한국국토안전연구원<br>(재) 한국건설품질연구원 | 이 부영 | 김 원 강<br>김 경 기<br>문 윤 석 | 영역 | | 0.220 (0.3mm이하 : 흑색) | | 점도대상판리 | | 재료판리 | |

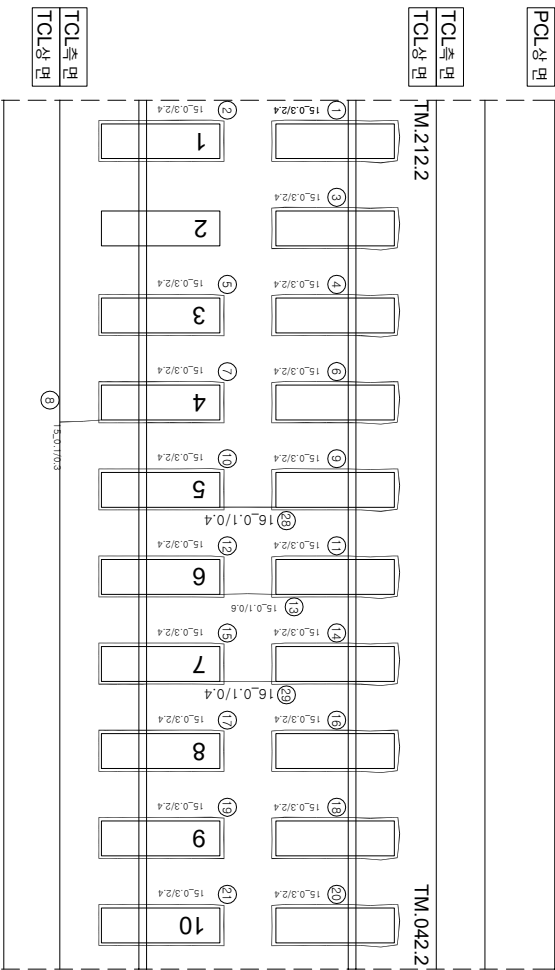
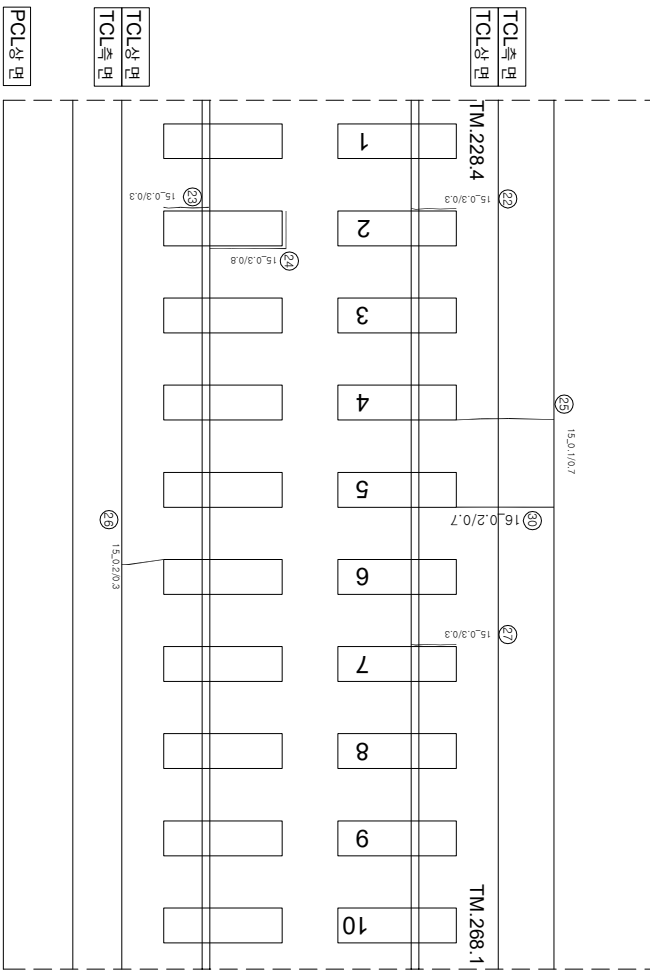
| 연번 | 순차 | 목 | 연장 | 비고 | 연번 | 순차 | 목 | 연장 | 비고 |
|---|---|---|---|---|---|---|---|---|---|
| 1 | 강제부 균열 | 0.3 mm | 2.4 m | | 56 | | | | |
| 2 | 강제부 균열 | 0.3 mm | 2.4 m | | 57 | | | | |
| 3 | 강제부 균열 | 0.3 mm | 2.4 m | | 57 | | | | |
| 4 | 강제부 균열 | 0.3 mm | 2.4 m | | 58 | | | | |
| 5 | 강제부 균열 | 0.3 mm | 2.4 m | | 59 | | | | |
| 6 | 강제부 균열 | 0.3 mm | 2.4 m | | 60 | | | | |
| 7 | 강제부 균열 | 0.3 mm | 2.4 m | | 61 | | | | |
| 8 | 균열 | 0.1 mm | 0.3 m | | 62 | | | | |
| 9 | 강제부 균열 | 0.3 mm | 2.4 m | | 63 | | | | |
| 10 | 강제부 균열 | 0.3 mm | 2.4 m | | 64 | | | | |
| 11 | 강제부 균열 | 0.3 mm | 2.4 m | | 65 | | | | |
| 12 | 강제부 균열 | 0.3 mm | 2.4 m | | 66 | | | | |
| 13 | 균열 | 0.1 mm | 0.6 m | | 67 | | | | |
| 14 | 강제부 균열 | 0.3 mm | 2.4 m | | 68 | | | | |
| 15 | 강제부 균열 | 0.3 mm | 2.4 m | | 69 | | | | |
| 16 | 강제부 균열 | 0.3 mm | 2.4 m | | 70 | | | | |
| 17 | 강제부 균열 | 0.3 mm | 2.4 m | | 71 | | | | |
| 18 | 강제부 균열 | 0.3 mm | 2.4 m | | 72 | | | | |
| 19 | 강제부 균열 | 0.3 mm | 2.4 m | | 73 | | | | |
| 20 | 강제부 균열 | 0.3 mm | 2.4 m | | 74 | | | | |
| 21 | 강제부 균열 | 0.3 mm | 2.4 m | | 75 | | | | |
| 22 | 강제부 균열 | 0.3 mm | 0.3 m | | 76 | | | | |
| 23 | 강제부 균열 | 0.3 mm | 0.3 m | | 77 | | | | |
| 24 | 강제부 균열 | 0.3 mm | 0.8 m | | 78 | | | | |
| 25 | 균열 | 0.1 mm | 0.7 m | | 79 | | | | |
| 26 | 균열 | 0.2 mm | 0.3 m | | 80 | | | | |
| 27 | 강제부 균열 | 0.3 mm | 0.3 m | | 81 | | | | |
| 28 | 균열 | 0.1 mm | 0.4 m | | 82 | | | | |
| 29 | 균열 | 0.1 mm | 0.4 m | | 83 | | | | |
| 30 | 균열 | 0.2 mm | 0.7 m | | 84 | | | | |
