한남고속선 죽산교\_233(74.681~74.688km, S47-2)

| 시 | 행 사 | 영 역 | 영 역 | 영역 | 사 | 과목 | | 단 | | | | | | | |
|---|---|---|---|---|---|---|---|---|---|---|---|---|---|---|---|
| KORAIL<br>KOREA RAILROAD | 한국철도공사 | 2017년도 호남고속선 오송-광주승정간 콘크리트케도 점검공역 | (주) 한국구조물안전연구원<br>(주) 한국국토안전연구원<br>(재) 한국건설품질연구원 | 이 부영 | 김 원 강<br>김 경 기<br>문 윤 석 | 영역 | | 0220 | (0.3mm이하 : 흑색) | | 참모대소방관리 | | 차료관리 | | |

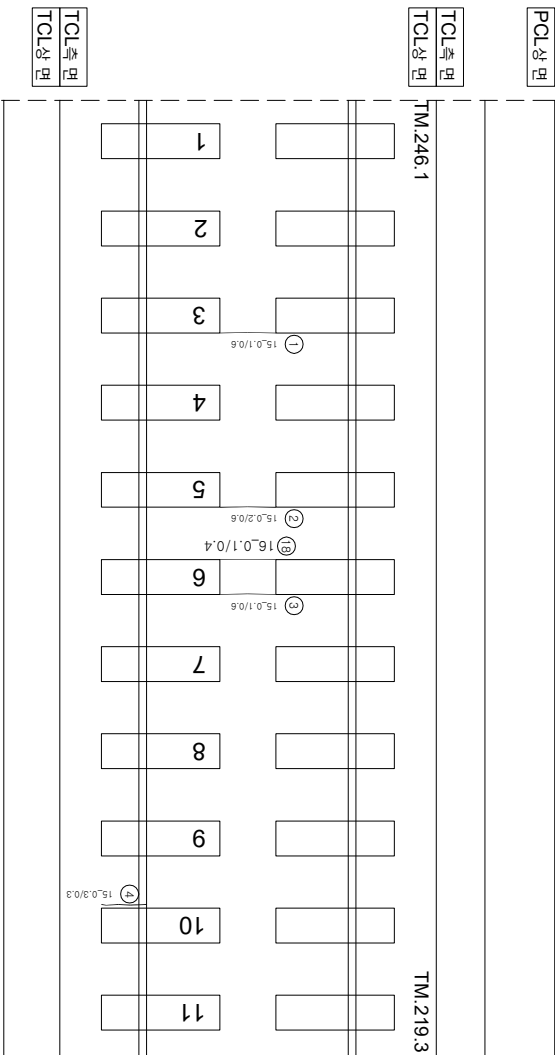
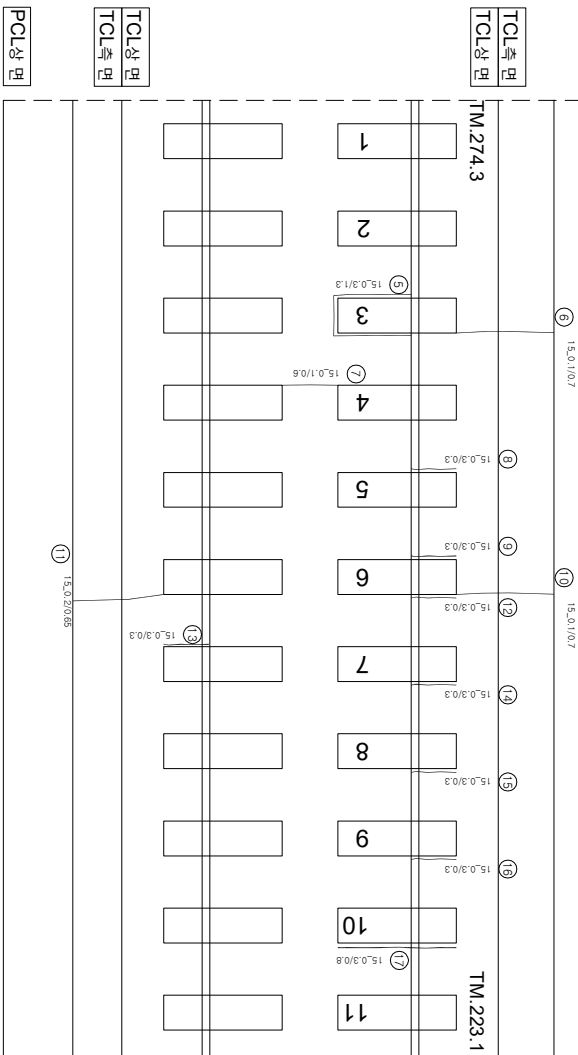
| 연번 | 산선 | 폭 | 연장 | 비고 | 연번 | 산선 | 폭 | 연장 | 비고 |
|---|---|---|---|---|---|---|---|---|---|
| 1 | 균열 | 0.1 | mm | 0.6 m | 55 | | | | |
| 2 | 균열 | 0.2 | mm | 0.6 m | 56 | | | | |
| 3 | 균열 | 0.1 | mm | 0.6 m | 57 | | | | |
| 4 | 균열부 균열 | 0.3 | mm | 0.3 m | 58 | | | | |
| 5 | 균열부 균열 | 0.3 | mm | 1.3 m | 59 | | | | |
| 6 | 균열 | 0.1 | mm | 0.7 m | 60 | | | | |
| 7 | 균열부 균열 | 0.1 | mm | 0.6 m | 61 | | | | |
| 8 | 균열부 균열 | 0.3 | mm | 0.3 m | 62 | | | | |
| 9 | 균열 | 0.1 | mm | 0.7 m | 63 | | | | |
| 10 | 균열 | 0.2 | mm | 0.65 m | 64 | | | | |
| 11 | 균열 | 0.2 | mm | 0.3 m | 65 | | | | |
| 12 | 균열부 균열 | 0.3 | mm | 0.3 m | 66 | | | | |
| 13 | 균열부 균열 | 0.3 | mm | 0.3 m | 67 | | | | |
| 14 | 균열부 균열 | 0.3 | mm | 0.3 m | 68 | | | | |
| 15 | 균열부 균열 | 0.3 | mm | 0.3 m | 69 | | | | |
| 16 | 균열부 균열 | 0.3 | mm | 0.3 m | 70 | | | | |
| 17 | 균열부 균열 | 0.3 | mm | 0.8 m | 71 | | | | |
| 18 | 균열 | 0.1 | mm | 0.4 m | 72 | | | | |
