호남고속선 죽산교\_315(75.241~75.248km, S63-4)

| 시 | 행 | 사 | 영 | 역 | 영 | 영 | 역 | 사 | 이 | | 영 | | | |
|---|---|---|---|---|---|---|---|---|---|---|---|---|---|---|
| KORAIL<br>KOREA RAILROAD | 한국철도공사 | 2017년도 호남고속선 오송-광주승정간 콘크리트케도 점검용역 | | | | | (주) 한국구조물안전연구원<br>(주) 한국도로안전연구원<br>(재) 한국건설품질연구원 | 이 복영 | 간 윤강<br>김 경 기<br>문 은 석 기 | 영 | | | | |

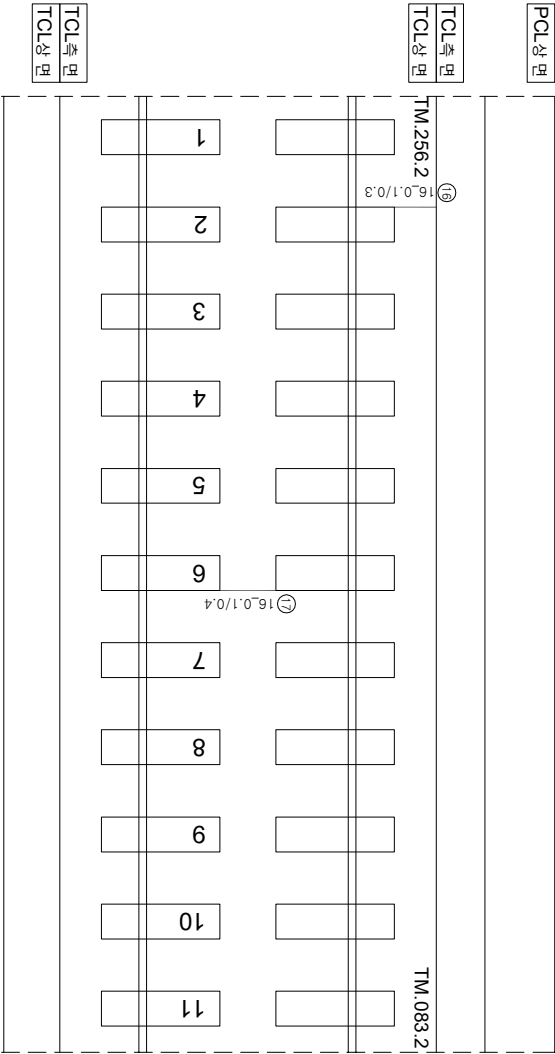
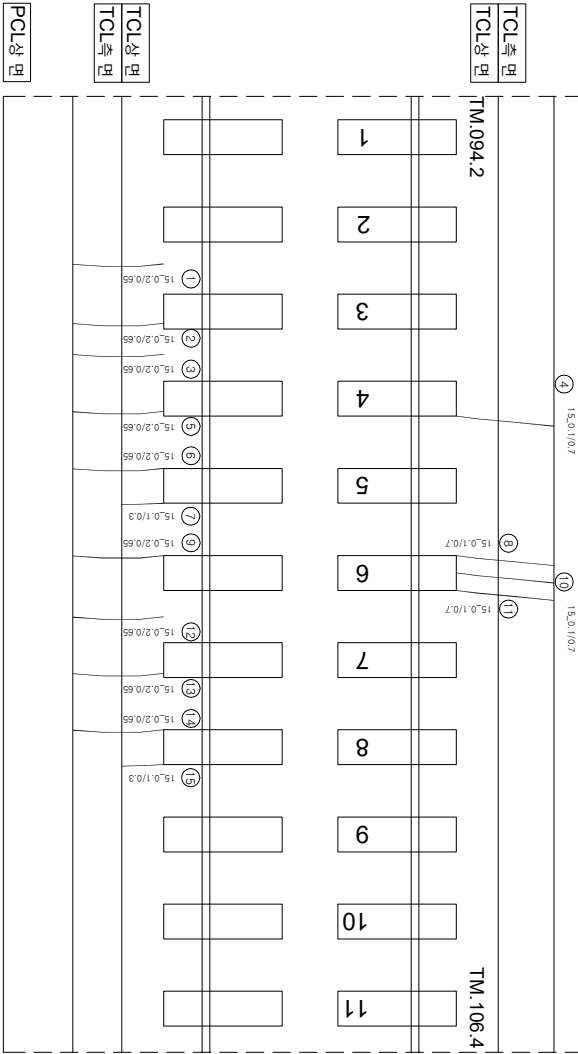
| 연번 | 산상 | 폭 | 연장 | 비고 | 연번 | 산상 | 폭 | 연장 | 비고 |
|---|---|---|---|---|---|---|---|---|---|
| 1 | 균열 | 0.2 mm | 0.65 m | | 55 | | | | |
| 2 | 균열 | 0.2 mm | 0.65 m | | 56 | | | | |
| 3 | 균열 | 0.2 mm | 0.65 m | | 57 | | | | |
| 4 | 균열 | 0.1 mm | 0.7 m | | 58 | | | | |
| 5 | 균열 | 0.2 mm | 0.65 m | | 59 | | | | |
| 6 | 균열 | 0.1 mm | 0.3 m | | 60 | | | | |
| 7 | 균열 | 0.1 mm | 0.7 m | | 61 | | | | |
| 8 | 균열 | 0.2 mm | 0.65 m | | 62 | | | | |
| 9 | 균열 | 0.1 mm | 0.7 m | | 63 | | | | |
| 10 | 균열 | 0.1 mm | 0.7 m | | 64 | | | | |
| 11 | 균열 | 0.2 mm | 0.65 m | | 65 | | | | |
| 12 | 균열 | 0.2 mm | 0.65 m | | 66 | | | | |
| 13 | 균열 | 0.2 mm | 0.65 m | | 67 | | | | |
| 14 | 균열 | 0.2 mm | 0.65 m | | 68 | | | | |
| 15 | 균열 | 0.1 mm | 0.3 m | | 69 | | | | |
| 16 | 균열 | 0.1 mm | 0.3 m | | 70 | | | | |
| 17 | 균열 | 0.1 mm | 0.4 m | | 71 | | | | |
