호남고속선 죽산교\_317(75.255~75.262km, S64-1)

| 시 | 행 사 | 영 역 | 영 역 | 공 공 사 | 관 령 지 | | 구 간 | | |
|---|---|---|---|---|---|---|---|---|---|
| KORAIL<br>KOREA RAILROAD | 한국철도공사 | 2017년도 호남고속선 오송-광주승정간 콘크리트케도 점검용역 | (주) 한국구조물안전연구원<br>(주) 한국국토안전연구원<br>(재) 한국건설품질연구원 | 이 부 영<br><br>김 원 강<br>김 경 기<br>문 은 석 | 관 령 지 | 영역 | 0.220 (0.3mm이하 : 흑색) | 한목대소방관리 | 차료관리 |

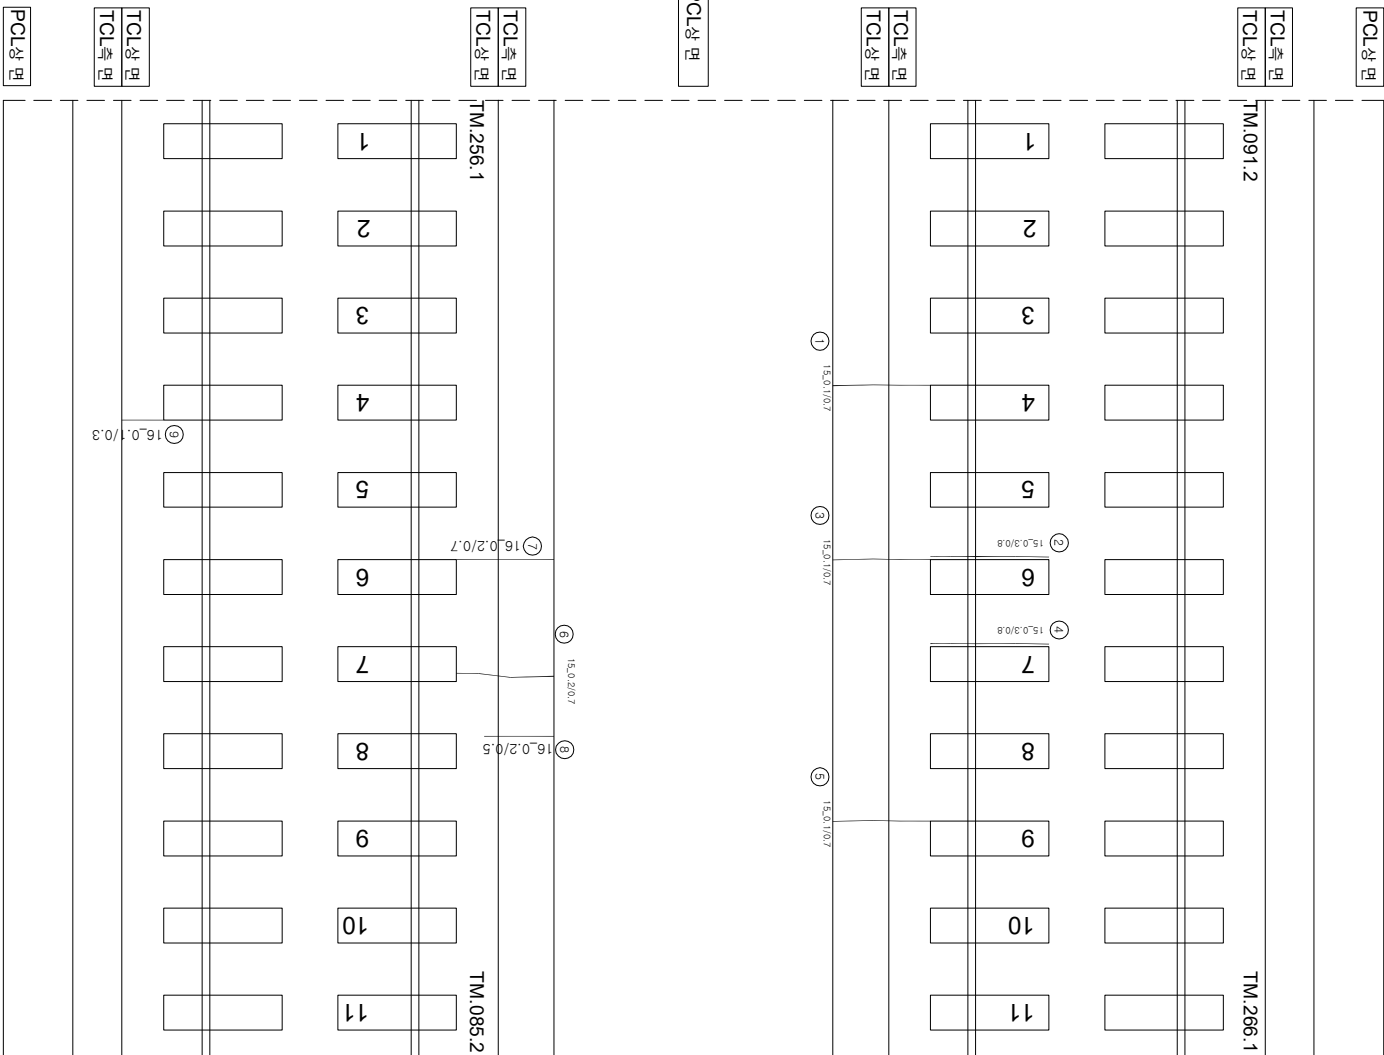
T2  
(0주  
0호)

| 순번 | 내선 | 복 | 연장 | 비고 | 순번 | 내선 | 복 | 연장 | 비고 |
|---|---|---|---|---|---|---|---|---|---|
| 1 | 내선 | 0.1 mm | 0.7 m | | 55 | | | | |
| 2 | 장계부, 내선 | 0.3 mm | 0.8 m | | 56 | | | | |
| 3 | 내선 | 0.1 mm | 0.7 m | | 57 | | | | |
| 4 | 장계부, 내선 | 0.3 mm | 0.8 m | | 58 | | | | |
| 5 | 내선 | 0.1 mm | 0.7 m | | 59 | | | | |
| 6 | 내선 | 0.2 mm | 0.7 m | | 60 | | | | |
| 7 | 내선 | 0.2 mm | 0.7 m | | 61 | | | | |
| 8 | 내선 | 0.2 mm | 0.5 m | | 62 | | | | |
| 9 | 내선 | 0.1 mm | 0.3 m | | 63 | | | | |
