호남고속선 죽산교\_323(75.297~75.304km, S65-2)

| 시 | 행 | 사 | 영 | 역 | 영 | 영 | 역 | 사 | 이 | | 영 | | | |
|---|---|---|---|---|---|---|---|---|---|---|---|---|---|---|
| KORAIL<br>KOREA RAILROAD | 한국철도공사 | 2017년도 호남고속선 오송-광주승정간 콘크리트케도 점검용역 | | | | | | (주) 한국구조물안전연구원<br>(주) 한국도로안전연구원<br>(재) 한국건설품질연구원 | 이 부영 | 간원강<br>김경기<br>문은석 | 영 | 0220 (0.3mm이하 : 흑색) | 점목도상판리 | 재료판리 |

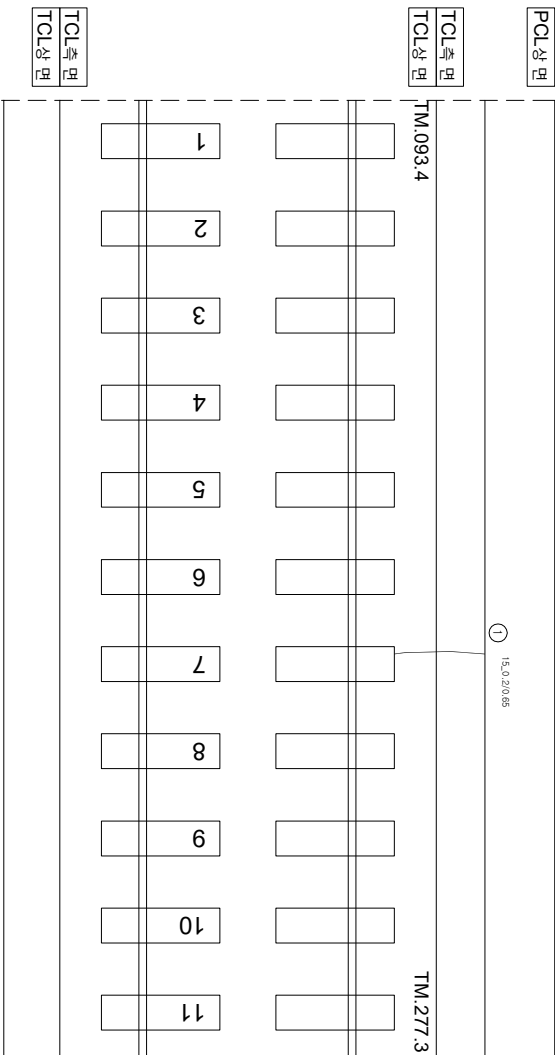
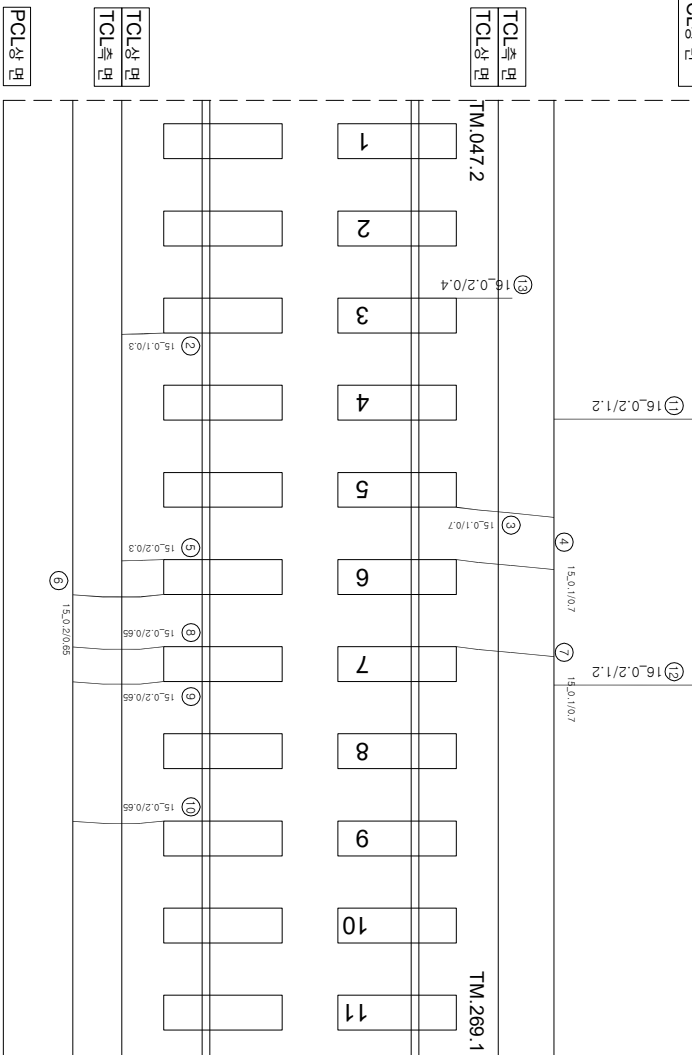
| 연번 | 순차 | 폭 | 연장 | 비고 | 연번 | 순차 | 폭 | 연장 | 비고 |
|---|---|---|---|---|---|---|---|---|---|
| 1 | 군열 | 0.2 mm | 0.65 m | | 55 | | | | |
| 2 | 군열 | 0.1 mm | 0.3 m | | 56 | | | | |
| 3 | 군열 | 0.1 mm | 0.7 m | | 57 | | | | |
| 4 | 군열 | 0.1 mm | 0.7 m | | 58 | | | | |
| 5 | 군열 | 0.2 mm | 0.3 m | | 59 | | | | |
| 6 | 군열 | 0.2 mm | 0.65 m | | 60 | | | | |
| 7 | 군열 | 0.1 mm | 0.7 m | | 61 | | | | |
| 8 | 군열 | 0.2 mm | 0.65 m | | 62 | | | | |
| 9 | 군열 | 0.2 mm | 0.65 m | | 63 | | | | |
| 10 | 군열 | 0.2 mm | 0.65 m | | 64 | | | | |
| 11 | 군열 | 0.2 mm | 1.2 m | | 65 | | | | |
| 12 | 군열 | 0.2 mm | 1.2 m | | 66 | | | | |
| 13 | 군열 | 0.2 mm | 0.4 m | | 67 | | | | |
