호남고속전주산업교\_324(75.304~75.311km, S65-3)

| 시 | 행 사 | 영 역 | 영 역 | 공 공 사 | 관 령 지 | | 구 간 | | |
|---|---|---|---|---|---|---|---|---|---|
| KORAIL<br>KOREA RAILROAD | 한국철도공사 | 2017년도 호남고속선 오송-광주승정간 콘크리트케도 점경용역 | (주) 한국구조물안전연구원<br>(주) 한국국토안전연구원<br>(재) 한국건설품질연구원 | 이 부 영<br>김 원 강<br>김 경 기<br>문 은 석 | 관 령 지 | 영 역 | 0.220 (0.3mm이하 : 흑색) | 한목대소방관리 | 차료관리 |

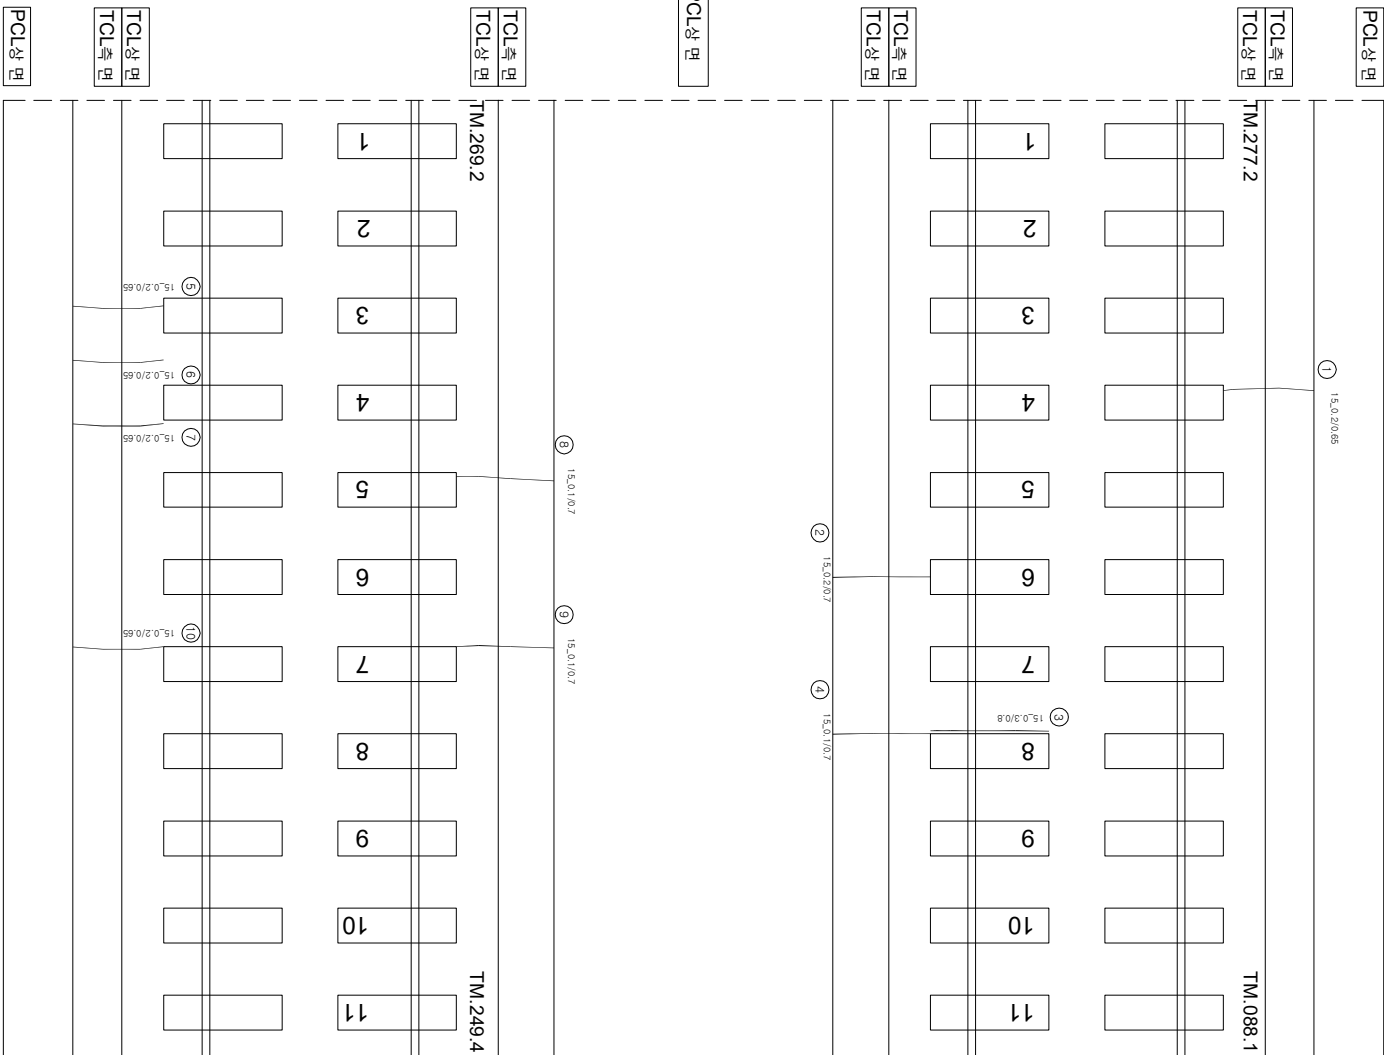
| 순번 | 내선 | 폭 | 연장 | 비고 | 순번 | 내선 | 폭 | 연장 | 비고 |
|---|---|---|---|---|---|---|---|---|---|
| 1 | 균열 | 0.2 mm | 0.65 m | | 55 | | | | |
| 2 | 균열 | 0.2 mm | 0.7 m | | 56 | | | | |
| 3 | 경계부 균열 | 0.3 mm | 0.8 m | | 57 | | | | |
| 4 | 균열 | 0.1 mm | 0.7 m | | 58 | | | | |
| 5 | 균열 | 0.2 mm | 0.65 m | | 59 | | | | |
| 6 | 균열 | 0.2 mm | 0.65 m | | 60 | | | | |
| 7 | 균열 | 0.2 mm | 0.65 m | | 61 | | | | |
| 8 | 균열 | 0.1 mm | 0.7 m | | 62 | | | | |
| 9 | 균열 | 0.1 mm | 0.7 m | | 63 | | | | |
| 10 | 균열 | 0.2 mm | 0.65 m | | 64 | | | | |
