호남고속선 죽산교\_325(75.311~75.318km, S65-4)

| 시 | 행 | 사 | 영 | 역 | 영 | 영 | 역 | 사 | 이 | | 영 | | | |
|---|---|---|---|---|---|---|---|---|---|---|---|---|---|---|
| KORAIL<br>KOREA RAILROAD | 한국철도공사 | 2017년도 호남고속선 오송-광주승정간 콘크리트케도 점검용역 | | | | | (주) 한국구조물안전연구원<br>(주) 한국도로안전연구원<br>(재) 한국건설품질연구원 | 이 복영 | 간 윤강<br>김 경 기<br>문 은 석 기 | 영 | | | | |

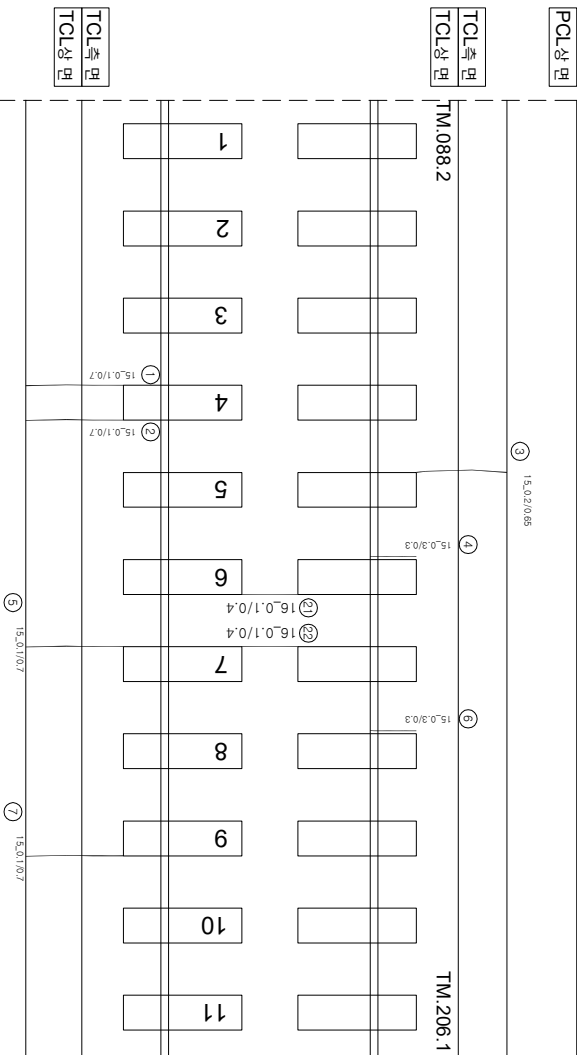
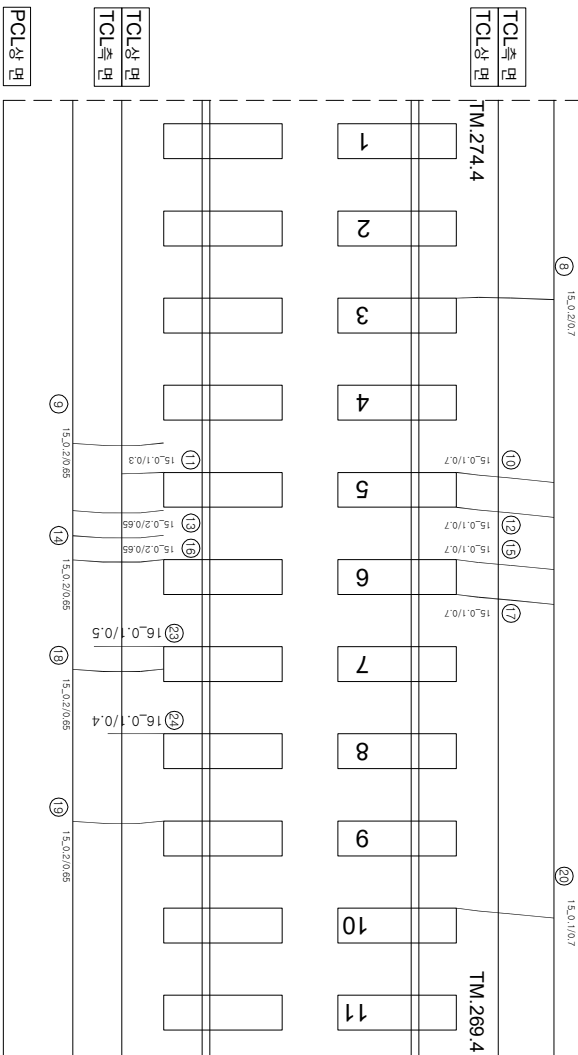
PCL상면

| 연번 | 산선 | 폭 | 연장 | 비고 | 연번 | 산선 | 폭 | 연장 | 비고 |
|---|---|---|---|---|---|---|---|---|---|
| 1 | 균열 | 0.1 mm | 0.7 m | | 55 | | | | |
| 2 | 균열 | 0.1 mm | 0.7 m | | 56 | | | | |
| 3 | 균열 | 0.2 mm | 0.65 m | | 57 | | | | |
| 4 | 강계부 균열 | 0.3 mm | 0.3 m | | 58 | | | | |
| 5 | 균열 | 0.1 mm | 0.7 m | | 59 | | | | |
| 6 | 강계부 균열 | 0.3 mm | 0.3 m | | 60 | | | | |
| 7 | 균열 | 0.1 mm | 0.7 m | | 61 | | | | |
| 8 | 균열 | 0.2 mm | 0.7 m | | 62 | | | | |
| 9 | 균열 | 0.2 mm | 0.65 m | | 63 | | | | |
| 10 | 균열 | 0.1 mm | 0.7 m | | 64 | | | | |
| 11 | 균열 | 0.1 mm | 0.3 m | | 65 | | | | |
| 12 | 균열 | 0.1 mm | 0.7 m | | 66 | | | | |
| 13 | 균열 | 0.2 mm | 0.65 m | | 67 | | | | |
| 14 | 균열 | 0.2 mm | 0.65 m | | 68 | | | | |
| 15 | 균열 | 0.1 mm | 0.7 m | | 69 | | | | |
| 16 | 균열 | 0.2 mm | 0.65 m | | 70 | | | | |
| 17 | 균열 | 0.1 mm | 0.7 m | | 71 | | | | |
| 18 | 균열 | 0.2 mm | 0.65 m | | 72 | | | | |
| 19 | 균열 | 0.2 mm | 0.65 m | | 73 | | | | |
| 20 | 균열 | 0.1 mm | 0.7 m | | 74 | | | | |
| 21 | 균열 | 0.1 mm | 0.4 m | | 75 | | | | |
| 22 | 균열 | 0.1 mm | 0.4 m | | 76 | | | | |
| 23 | 균열 | 0.1 mm | 0.5 m | | 77 | | | | |
| 24 | 균열 | 0.1 mm | 0.4 m | | 78 | | | | |
