호남고속선 죽산교\_310(75.206~75.213km, S62-4)

| 시 | 행 사 | 영 역 | 영 역 | 영 역 | 사 | 구 간 | | |
|---|---|---|---|---|---|---|---|---|
| <b>KORAIL</b><br><small>KOREA RAILROAD</small> | 한국철도공사 | 2017년도 호남고속선 오송-광주승정간 콘크리트케도 점검공역 | (주) 한국구조물안전연구원<br>(주) 한국국토안전연구원<br>(재) 한국건설품질연구원 | 이 박 영<br>김 경 기<br>윤 석 기 | 간 원 강<br>김 경 기<br>윤 석 기 | 0220 (0.3m이하 : 폭식) | 점목도상본리 | |

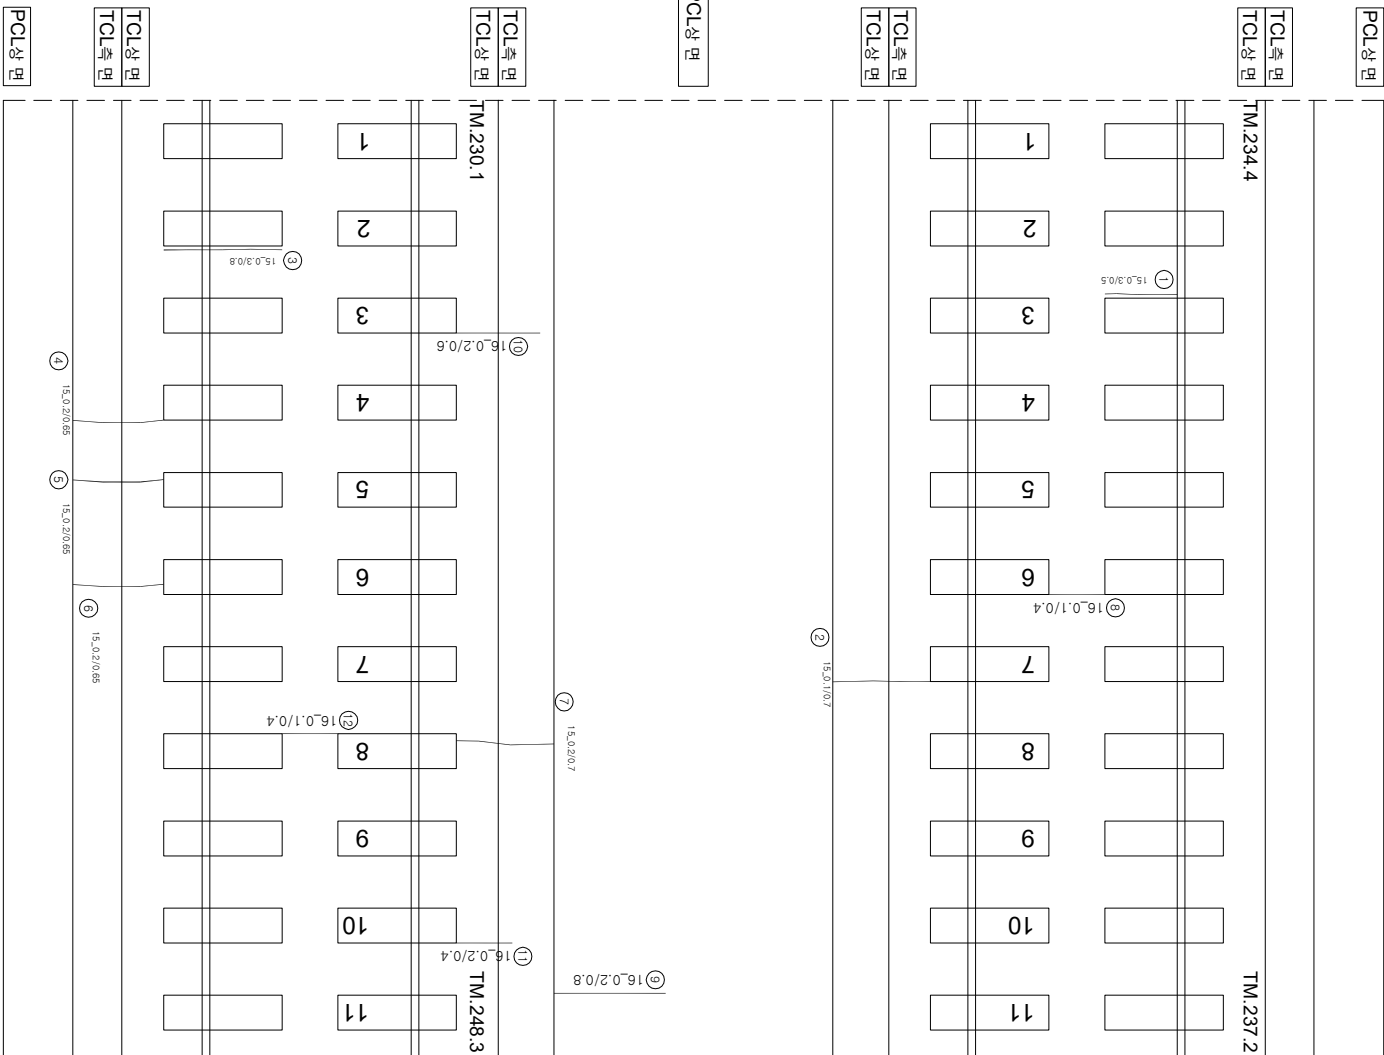
| 연번 | 순차 | 폭 | 연장 | 비고 | 연번 | 순차 | 폭 | 연장 | 비고 |
|---|---|---|---|---|---|---|---|---|---|
| 1 | 경계부 균열 | 0.3 | mm | 0.5 m | 55 | | | | |
| 2 | 균열 | 0.1 | mm | 0.7 m | 56 | | | | |
| 3 | 경계부 균열 | 0.3 | mm | 0.8 m | 57 | | | | |
| 4 | 균열 | 0.2 | mm | 0.65 m | 58 | | | | |
| 5 | 균열 | 0.2 | mm | 0.65 m | 59 | | | | |
| 6 | 균열 | 0.2 | mm | 0.65 m | 60 | | | | |
| 7 | 균열 | 0.2 | mm | 0.7 m | 61 | | | | |
| 8 | 균열 | 0.1 | mm | 0.4 m | 62 | | | | |
| 9 | 균열 | 0.2 | mm | 0.8 m | 63 | | | | |
| 10 | 균열 | 0.2 | mm | 0.6 m | 64 | | | | |
| 11 | 균열 | 0.2 | mm | 0.4 m | 65 | | | | |
| 12 | 균열 | 0.1 | mm | 0.4 m | 66 | | | | |
