호남고속선 중리교\_29 (75.895~75.902km, S6-3)

| 시 | 행 사 | 영 역 | 영 역 | 영 역 | 사 | 인 지 | | 단 | |
|---|---|---|---|---|---|---|---|---|---|
| | 한국철도공사 | 2017년도 호남고속선 오송-광주승정간 콘크리트케도 점검용역 | (주) 한국구조물안전연구원<br>(주) 한국국토안전연구원<br>(재) 한국건설품질연구원 | 이 박 영 | 강 완 강<br>김 경 기<br>윤 석 기 | 영역 | 0220 (0.3m이하 : 흑색) | 참목도상문리 | |

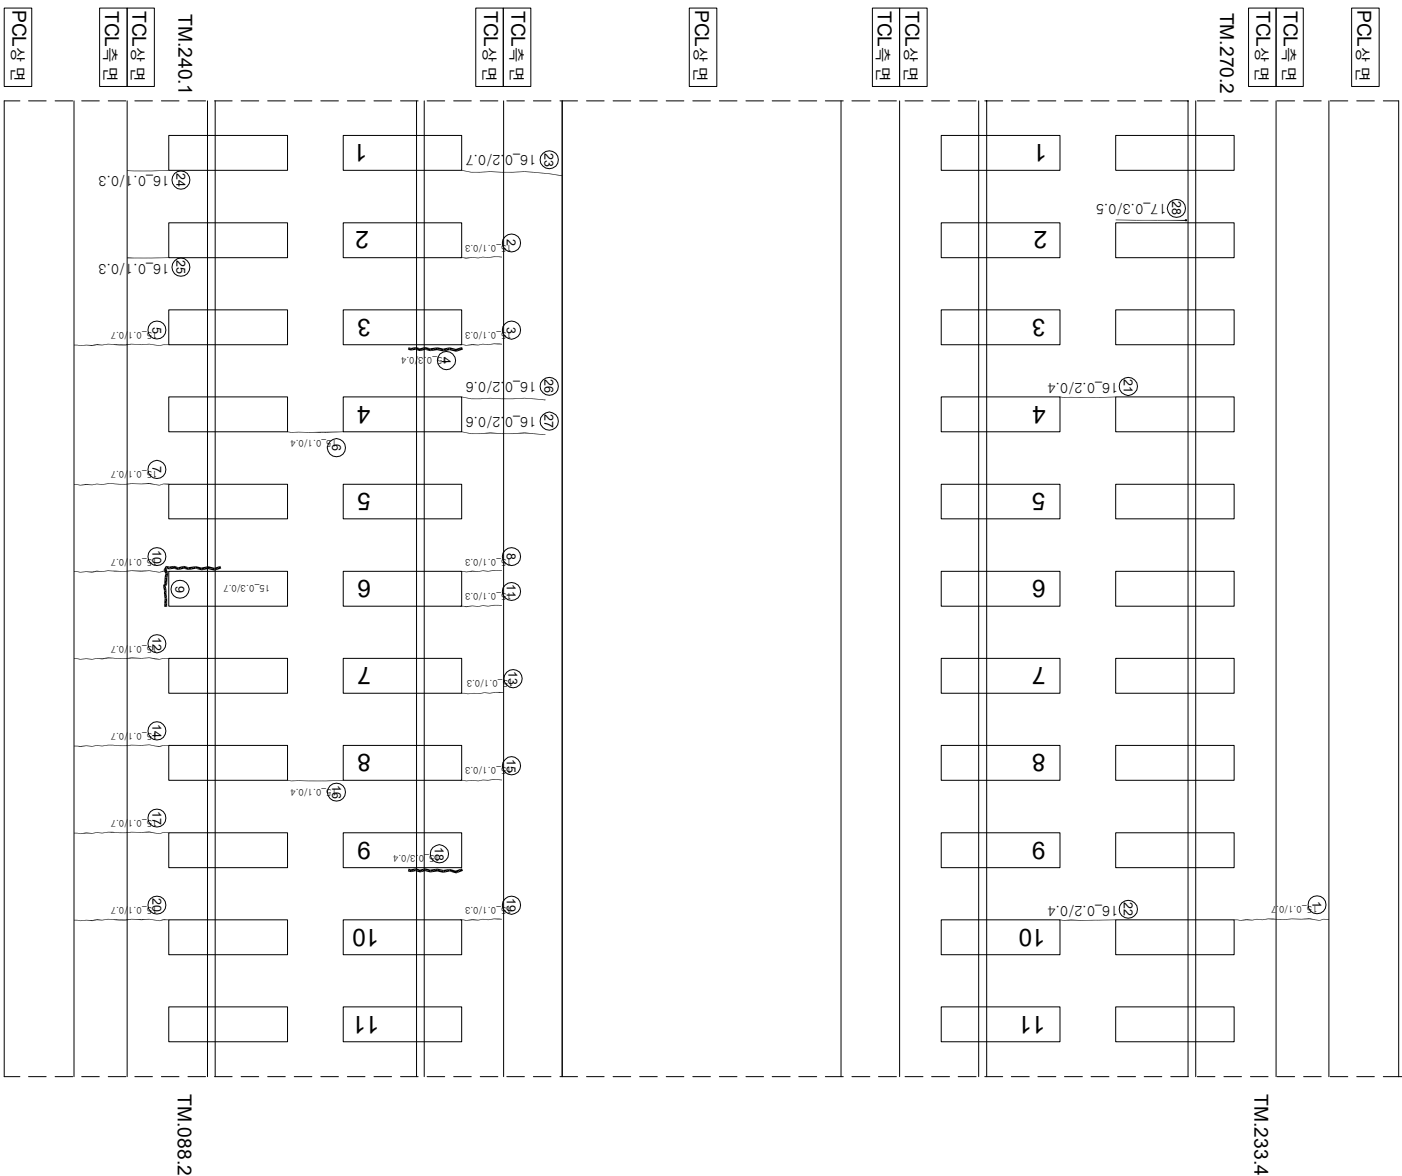
6 SPAN - 3

| 연번 | 순상 | 폭 | 연장 | 비고 | 연번 | 순상 | 폭 | 연장 | 비고 |
|---|---|---|---|---|---|---|---|---|---|
| 1 | 균열 | 0.1 mm | 0.7 m | | 55 | | | | |
| 2 | 균열 | 0.1 mm | 0.3 m | | 56 | | | | |
| 3 | 균열 | 0.1 mm | 0.3 m | | 57 | | | | |
| 4 | 경각부 균열 | 0.3 mm | 0.4 m | | 58 | | | | |
| 5 | 균열 | 0.1 mm | 0.7 m | | 59 | | | | |
| 6 | 균열 | 0.1 mm | 0.4 m | | 60 | | | | |
| 7 | 균열 | 0.1 mm | 0.7 m | | 61 | | | | |
| 8 | 균열 | 0.3 mm | 0.3 m | | 62 | | | | |
| 9 | 경각부 균열 | 0.3 mm | 0.7 m | | 63 | | | | |
| 10 | 균열 | 0.1 mm | 0.7 m | | 64 | | | | |
| 11 | 균열 | 0.1 mm | 0.3 m | | 65 | | | | |
| 12 | 균열 | 0.1 mm | 0.7 m | | 66 | | | | |
| 13 | 균열 | 0.1 mm | 0.3 m | | 67 | | | | |
| 14 | 균열 | 0.1 mm | 0.7 m | | 68 | | | | |
| 15 | 균열 | 0.1 mm | 0.3 m | | 69 | | | | |
| 16 | 균열 | 0.1 mm | 0.4 m | | 70 | | | | |
| 17 | 균열 | 0.1 mm | 0.7 m | | 71 | | | | |
| 18 | 경각부 균열 | 0.3 mm | 0.4 m | | 72 | | | | |
| 19 | 균열 | 0.1 mm | 0.3 m | | 73 | | | | |
| 20 | 균열 | 0.1 mm | 0.7 m | | 74 | | | | |
| 21 | 균열 | 0.2 mm | 0.4 m | | 75 | | | | |
| 22 | 균열 | 0.2 mm | 0.4 m | | 76 | | | | |
| 23 | 균열 | 0.2 mm | 0.7 m | | 77 | | | | |
| 24 | 균열 | 0.1 mm | 0.3 m | | 78 | | | | |
| 25 | 균열 | 0.1 mm | 0.3 m | | 79 | | | | |
| 26 | 균열 | 0.2 mm | 0.6 m | | 80 | | | | |
| 27 | 균열 | 0.2 mm | 0.6 m | | 81 | | | | |
| 28 | 경각부 균열 | 0.3 mm | 0.5 m | 신규 | 82 | | | | |
