화남고성선 동리 표-55 (76.077~76.084km, S11-4)

| 시 | 행 | 사 | 영 | 역 | 명 | 영 | 역 | 사 | 간 | | 영 |
|---|---|---|---|---|---|---|---|---|---|---|---|
| KORAIL<br>KOREA RAILROAD | 한국철도공사 | 2017년도 호남고속선 오송-광주선정가 콘크리트케도 점검영역 | (주) 한국구조물안전연구원<br>(주) 한국도로안전연구원<br>(재) 한국건설철도안전연구원 | 이<br>복<br>영 | 간<br>윤<br>경<br>김<br>경<br>기<br>윤<br>석<br>기 | 경<br>원 | 0.22% | (0.3%)이하 : 녹색 | | 천목도상봉리 | |

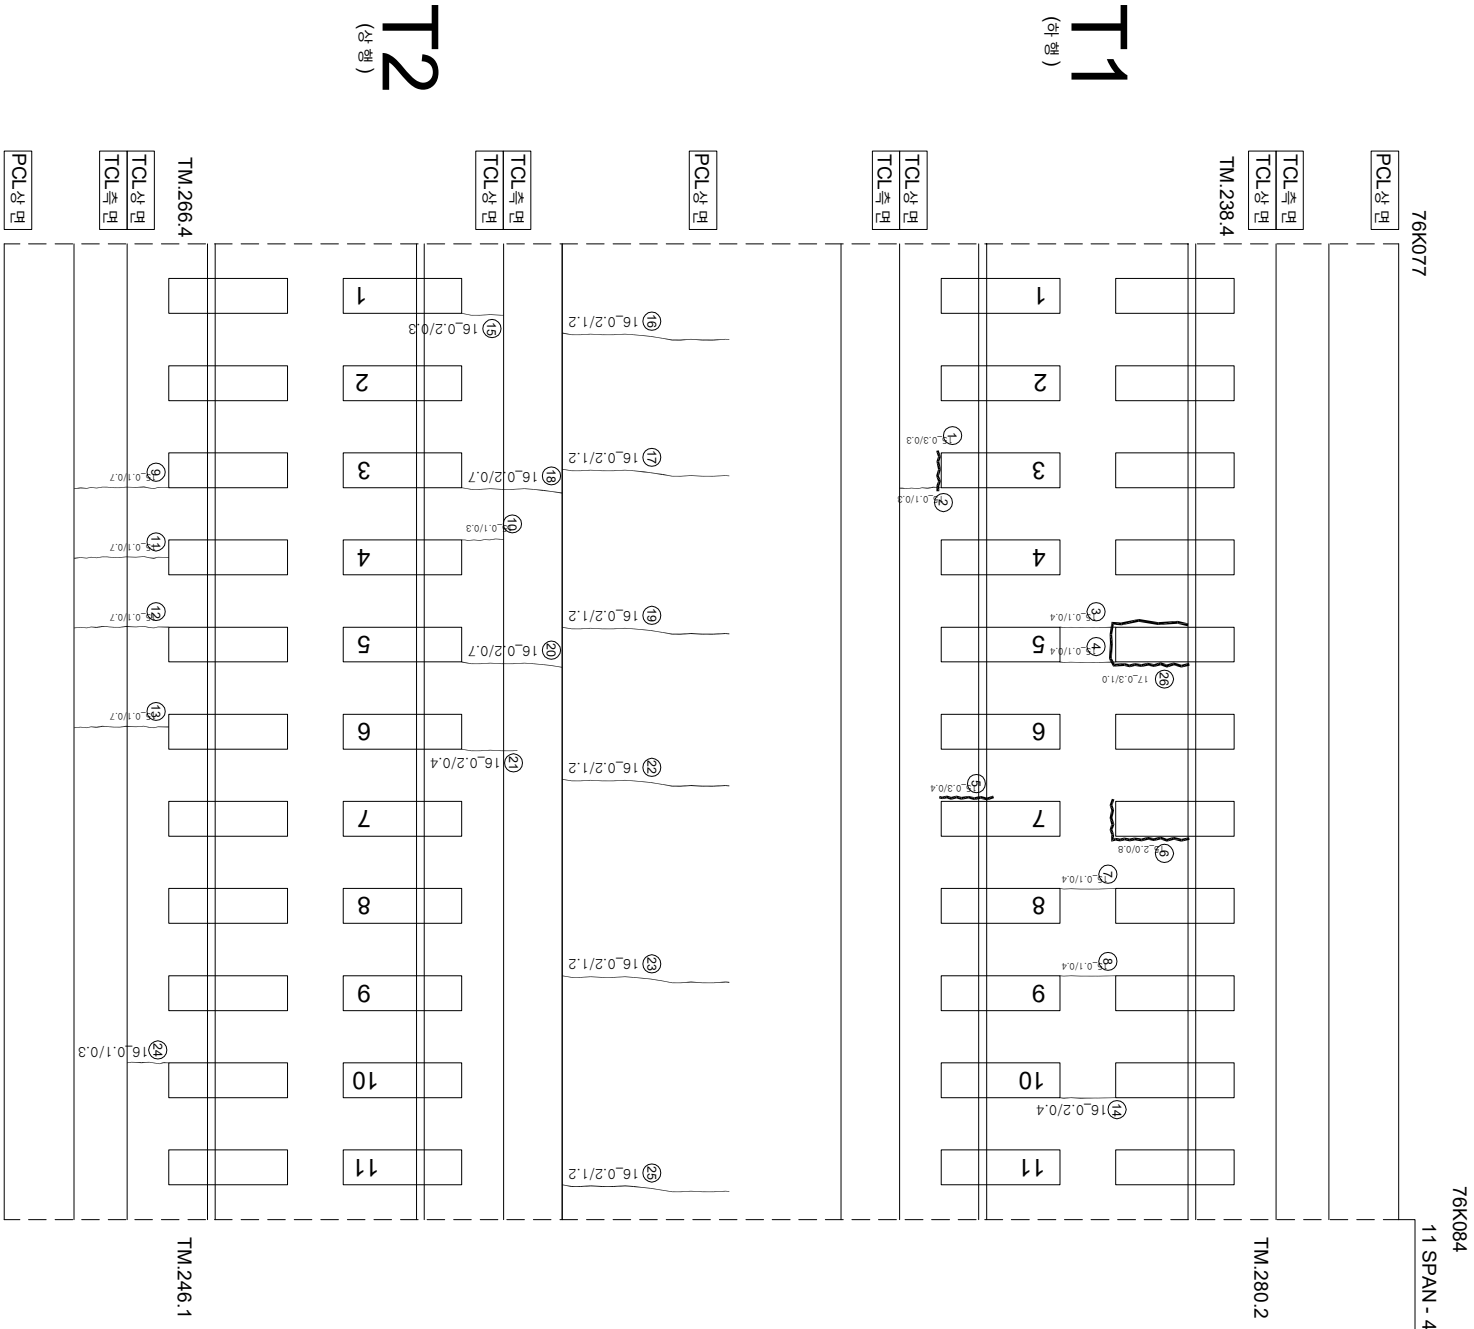
| 연번 | 순상 | 폭 | 연장 | 비고 | 연번 | 순상 | 폭 | 연장 | 비고 |
|---|---|---|---|---|---|---|---|---|---|
| 1 | 관측부 관월 | 0.3 mm | 0.3 m | | 55 | | | | |
| 2 | 관월 | 0.1 mm | 0.3 m | | 56 | | | | |
| 3 | 관월 | 0.1 mm | 0.4 m | | 57 | | | | |
| 4 | 관월 | 0.1 mm | 0.4 m | | 58 | | | | |
| 5 | 관측부 관월 | 0.3 mm | 0.4 m | | 59 | | | | |
| 6 | 관측부 관월 | 2.0 mm | 0.8 m | | 60 | | | | |
| 7 | 관월 | 0.1 mm | 0.4 m | | 61 | | | | |
| 8 | 관월 | 0.1 mm | 0.4 m | | 62 | | | | |
| 9 | 관월 | 0.1 mm | 0.7 m | | 63 | | | | |
| 10 | 관월 | 0.1 mm | 0.3 m | | 64 | | | | |
| 11 | 관월 | 0.1 mm | 0.7 m | | 65 | | | | |
| 12 | 관월 | 0.1 mm | 0.7 m | | 66 | | | | |
| 13 | 관월 | 0.1 mm | 0.7 m | | 67 | | | | |
| 14 | 관월 | 0.2 mm | 0.4 m | | 68 | | | | |
| 15 | 관월 | 0.2 mm | 0.3 m | | 69 | | | | |
| 16 | 관월 | 0.2 mm | 1.2 m | | 70 | | | | |
| 17 | 관월 | 0.2 mm | 1.2 m | | 71 | | | | |
| 18 | 관월 | 0.2 mm | 0.7 m | | 72 | | | | |
| 19 | 관월 | 0.2 mm | 1.2 m | | 73 | | | | |
| 20 | 관월 | 0.2 mm | 0.7 m | | 74 | | | | |
| 21 | 관월 | 0.2 mm | 0.4 m | | 75 | | | | |
| 22 | 관월 | 0.2 mm | 1.2 m | | 76 | | | | |
| 23 | 관월 | 0.2 mm | 1.2 m | | 77 | | | | |
| 24 | 관월 | 0.1 mm | 0.3 m | | 78 | | | | |
| 25 | 관월 | 0.2 mm | 1.2 m | | 79 | | | | |
| 26 | 관측부 관월 | 0.3 mm | 1.0 m | 신규 | 80 | | | | |
